Subject: GE Over/Under Voltage time delay relay PN: 12IAV69A1A

Project: DRE-76112, Revision 2

Subject: **Failure Analysis of:** Undervoltage Relay

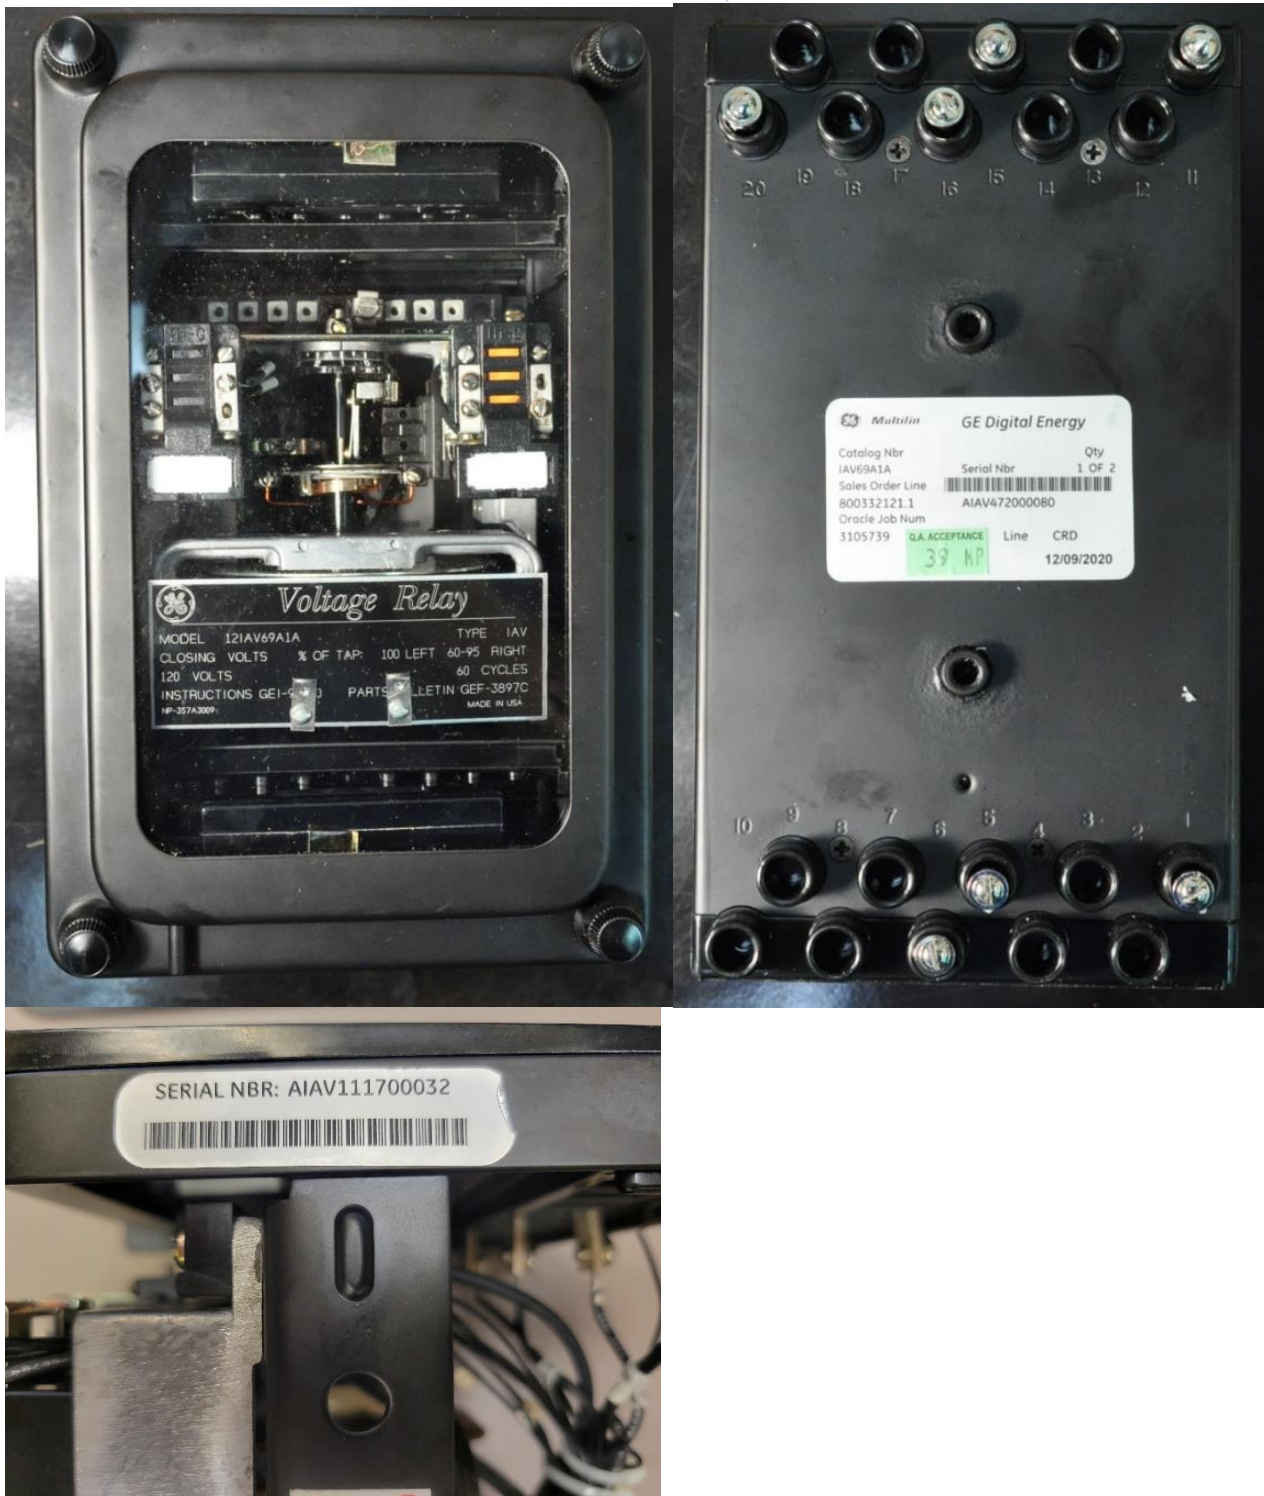
The as-received photographs of the front and back of the undervoltage relay are shown in Figure 1. The undervoltage relay was identified as a model 12IAV69A1A, with serial number AIAV111700032, and the manufacturer is General Electric. The relay case had a serial number of AIAV472000080. The station indicated that the relay was installed on 10/28/2020 so it was in service for approximately four years. The Closing Voltage was identified as 100% of the tap for the left overvoltage contactor and 60-95% of the tap for the right undervoltage contactor and the tap setting was set to 93 Volts. It is rated for 120 Volts and the instruction for this relay was identified as GEI-90810 which will be reference throughout this report. This information is also documented in Table 1.

Figure 1. As-received photographs of the front and back of the undervoltage relay are shown. The undervoltage relay was identified as a model 12IAV69A1A, with serial number AIAV111700032, and the manufacturer is General Electric. The relay case had a serial number of AIAV472000080. The Closing Voltage was identified as 100% of the tap for the left overvoltage contactor and 60-95% of the tap for the right undervoltage contactor. It is rated for 120 volts and the instruction for this relay was identified as GEI-90810 which will be reference throughout this report.

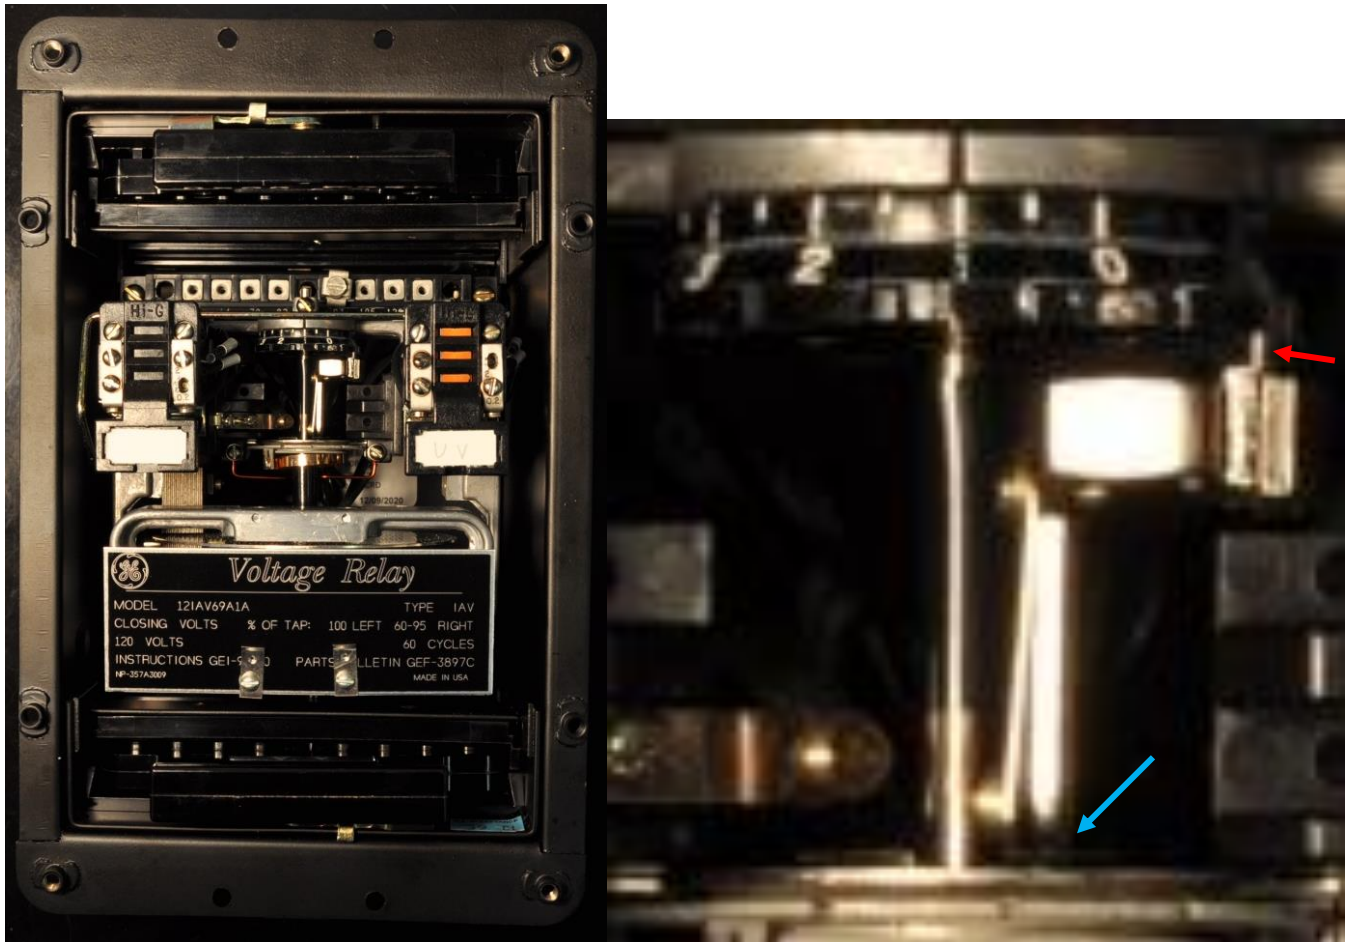
The cover of the relay was removed, and as-received photos of the internal relay were taken, as shown in Figure 2 in the photograph to the left. The photograph to the right highlights what caused the failure and is a close up of the as-received photograph to the left. It highlights the time dial shaft, as shown with the red arrow, that the stationary undervoltage contact assembly is clamped to. The stationary undervoltage contact was making contact with the plastic disc impeding its travel as shown with a blue arrow. Figure 3 was added from GEI-90810, the instruction for this style of relay, as a parts breakdown of the front and back of the relay. It will be referenced throughout the report.

Figure 2. As-received photographs of the front and back of the undervoltage relay are shown in the two photos above. The left photo is with the cover removed. The right photo is a close up of the time dial to show the time dial shaft, as shown with the red arrow, that the stationary undervoltage contact assembly is clamped to. The stationary undervoltage contact was making contact with the plastic disc impeding its travel as shown with a blue arrow.

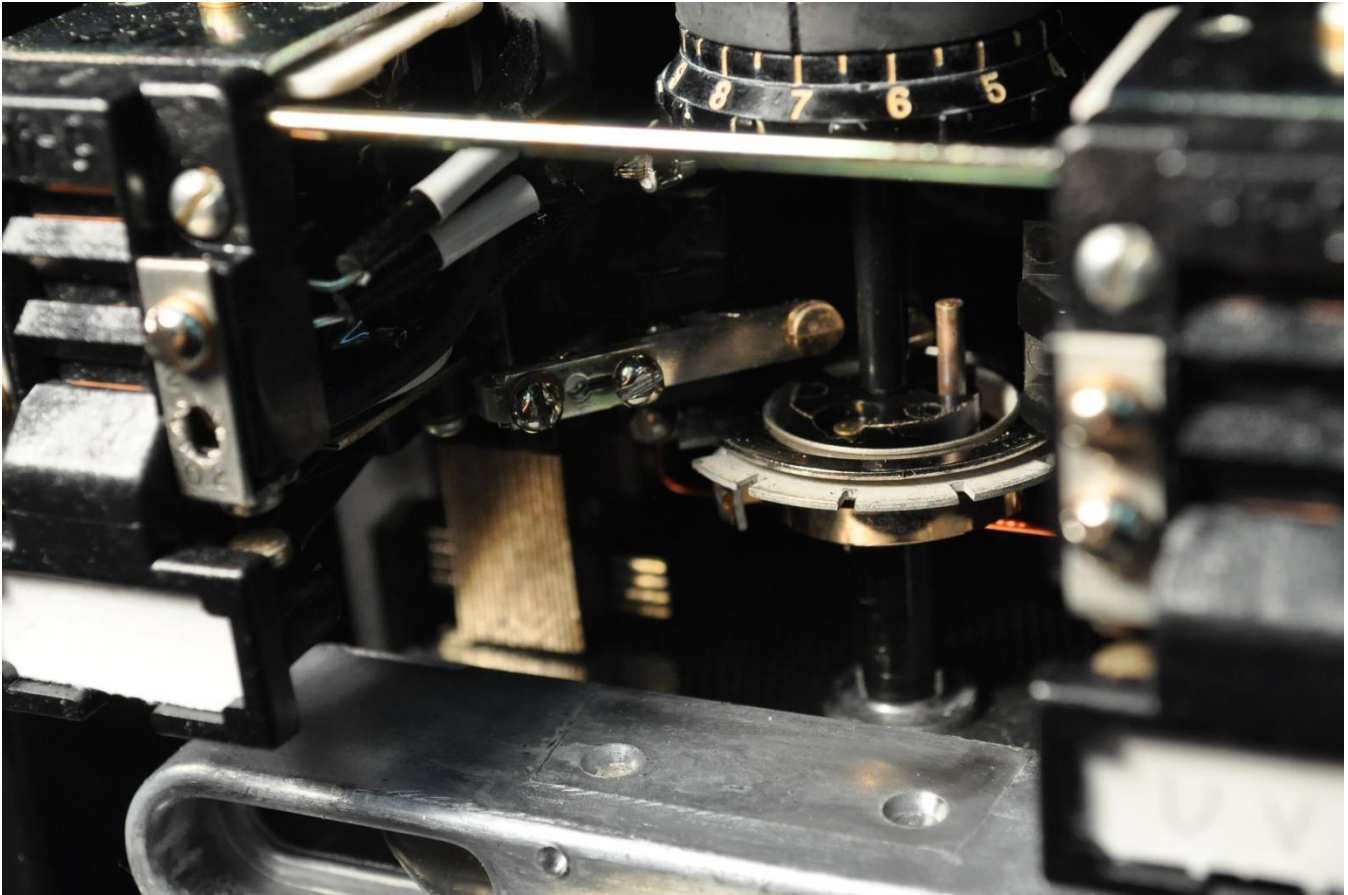
The undervoltage relay’s disc failed to rotate towards the stationary undervoltage contact at the station. This failure was replicated during the mechanical testing as shown in Figure 4. This test involves moving the stationary undervoltage contact further away from the main moving contact by increasing the time setting and allowing it to complete its travel while verifying there is no binding. During this test there was binding observed. After further investigation it was identified that the reason why the disc did not complete its travel was because the plastic disc, which is connected to the bigger disc by the shaft, was rubbing against the stationary undervoltage contact, as shown in Figure 5 with the yellow arrow.

The next functional test performed was a mechanical test that was referenced from instruction GEI-90810 from page 6 and it was the second step. This test involves rotating the time dial to the No. 7 setting and verifying that the disk rotates towards the stationary undervoltage contact without binding or touching the drag magnet or U-magnet. During this test the main moving contact, which is connected to the disc by the shaft, stopped halfway through its travel, as shown in Figure 4. This test was performed multiple times at various time settings and the disc would not complete its travel intermittently. The reason why its travel was impeded was that the plastic disc attached to the shaft was dragging on the stationary undervoltage contact as shown in Figure 5. The bottom left photo is of the stationary undervoltage contact clamp lower on the time dial shaft allowing the stationary undervoltage contact to make contact with the plastic disk, as shown with the yellow arrow. This was the as-received condition. The top left photo is the stationary undervoltage contact after it was moved up along the shaft to show how it should be positioned. The bottom right photo is of the backside of the stationary undervoltage contact clamp that fastens it to the time dial shaft, notice there is a gap, and it has slid down. The top right photo is after the clamp was moved up. The red arrow points to the stationary undervoltage contact assembly, the blue arrow points to the stationary undervoltage contact clamp, and the green arrow points to the time dial shaft. There was an attempt to torque the clamp screws, and they were able to be torqued slightly but the clamp would not fasten to the time dial shaft and was still able to be moved freely up and down by hand even after torquing.

Figure 4. The step in the bottom picture above was taken from the GEI-90810 instruction for this type of relay from page 6 and it is the second step of the “Mechanical Tests”. During this test the disc did not complete its travel by means of the main moving contact engaging the stationary undervoltage contact, it stopped halfway. This was repeatable intermittently. After a closer investigation of what was impeding the travel of the disc, as shown in Figure 5, it was discovered that the plastic disc was rubbing against the stationary undervoltage contact and dragging.

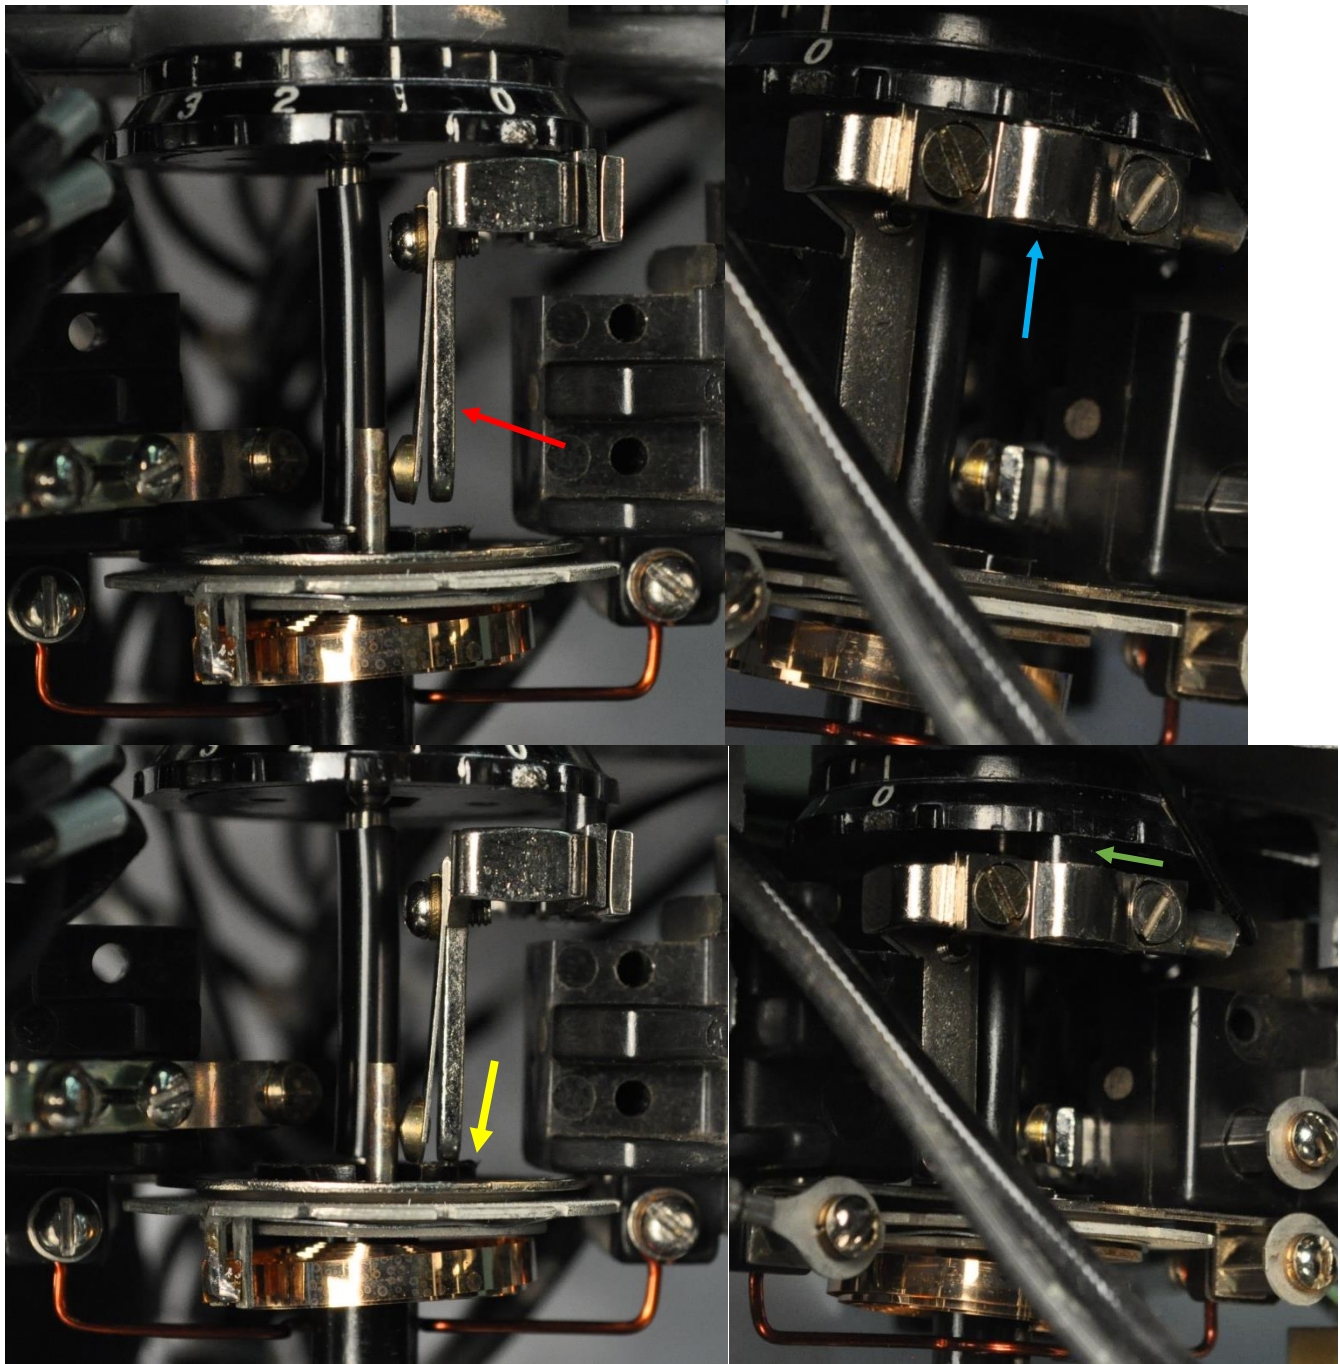
It was first assumed that the screws that secure the stationary undervoltage contact clamp to the time dial shaft, as shown in Figure 5 in the bottom right photograph, were loose. There was an attempt to torque these screws, and they were able to be torqued slightly but even after the screws were fully torqued the clamp would not hold and was able to be moved freely up and down. The stationary undervoltage contact clamp was then removed and the inside gap was measured at 0.138 in., as shown in Figure 6. The time dial shaft was measured at 0.134 in., as shown in Figure 7. The gap in the stationary contact clamp is 0.004” larger than the shaft which allowed it to slide down the shaft, impede the rotation of the disc, and prevented the relay from actuating.

Figure 5. The bottom left photo is of the stationary undervoltage contact clamp lower on the time dial shaft allowing the stationary undervoltage contact to make contact with the plastic disk, as shown with the yellow arrow. This was the as-received condition. The top left photo is the stationary undervoltage contact after it was moved up along the shaft to show how it should be positioned. The bottom right photo is of the backside of the stationary undervoltage contact clamp that fastens it to the time dial shaft, notice there is a gap, and it has slid down. The top right photo is after the clamp was moved up. The red arrow points to the stationary undervoltage contact assembly, the blue arrow points to the stationary undervoltage contact clamp, and the green arrow points to the time dial shaft. There was an attempt to torque the clamp screws, and they were able to be torqued slightly but the clamp would not fasten to the time dial shaft and was still able to be moved freely up and down by hand.

- 1) CW has modified the dedication plan to apply mild vertical force to assure that the clamp is secure as part of the dedication process.
- 2) End user should provide a similar mechanical test to be sure that the clamp remains secure during periodic surveillance and maintenance activities.

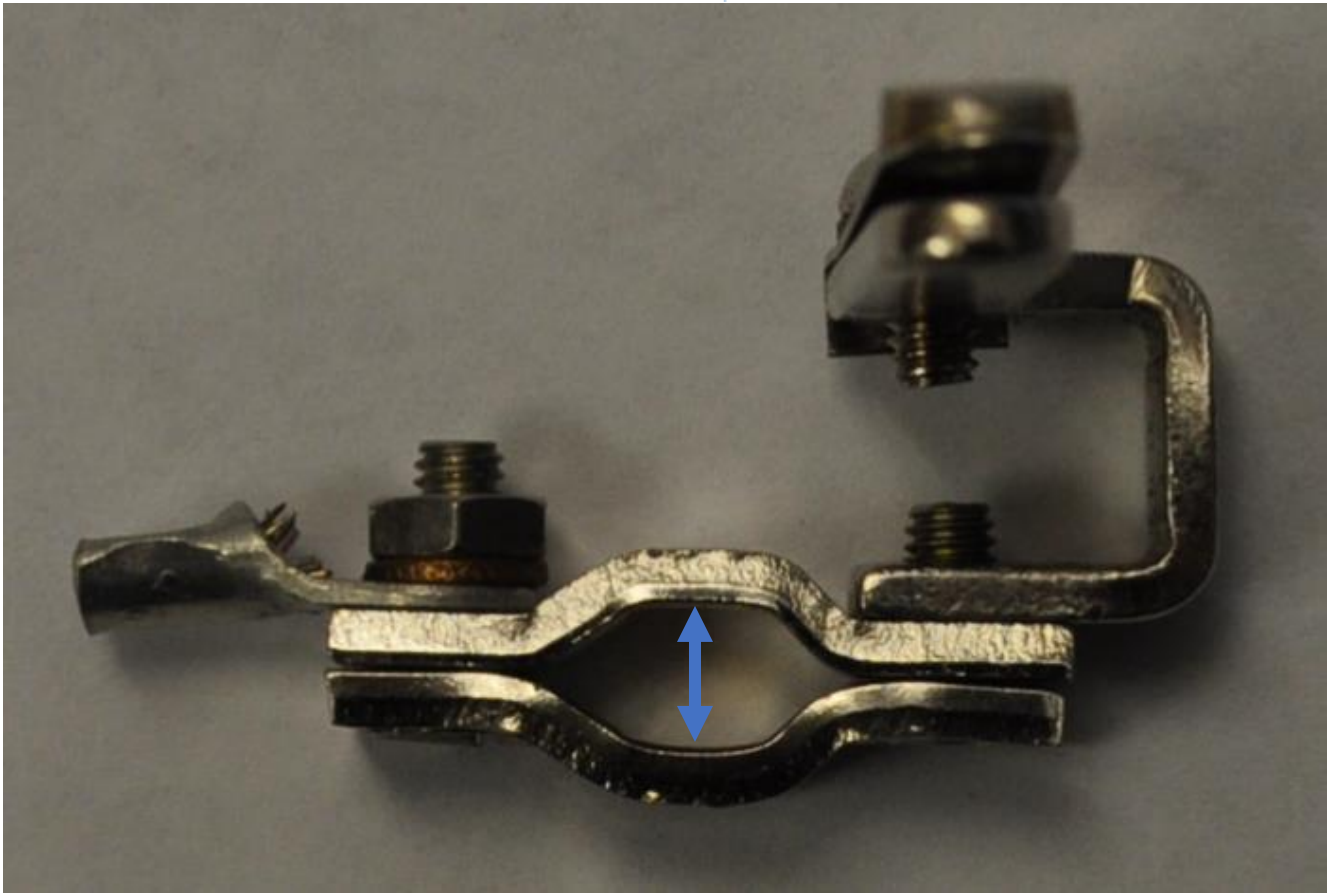
There is no guidance from instruction GEI-90810 on what the time dial shaft width measurement should be, or on what the stationary undervoltage contact clamp gap should be.

The stationary undervoltage contact clamp was removed from the shaft so the inside gap could be measured. The gap was measured at 0.138 in. after it was fully torqued, as shown in Figure 6. The time dial shaft, that the stationary undervoltage clamp tightens to and recorded at 0.134 in., as shown in Figure 7. The clamp was fully torqued, and it could still not be fastened to the time dial shaft and this makes sense since the clamp gap was measured at 0.138 in. fully tightened, and the time dial shaft width was measured at 0.134 in. During the removal of the stationary undervoltage contact clamp from the time dial shaft a wire tore apart from the ferrule it was crimped to, as shown in Figure 8.

Figure 6. The inside gap of the stationary undervoltage contact clamp was measured, as indicated by the blue arrow, and recorded at 0.138 in. This was with the clamp fully torqued.

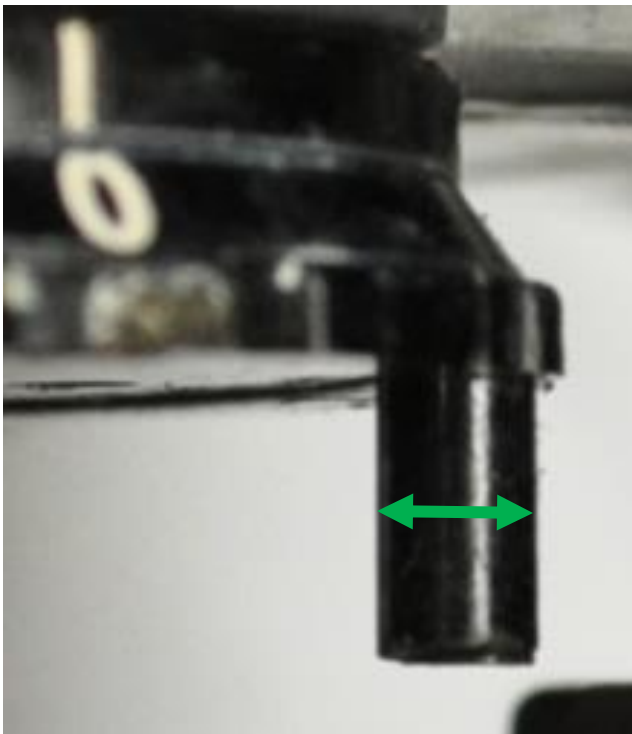
Figure 7. The time dial shaft that the stationary undervoltage contact clamp tightens to was measured, as indicated by the green arrow, and recorded at 0.134 in.

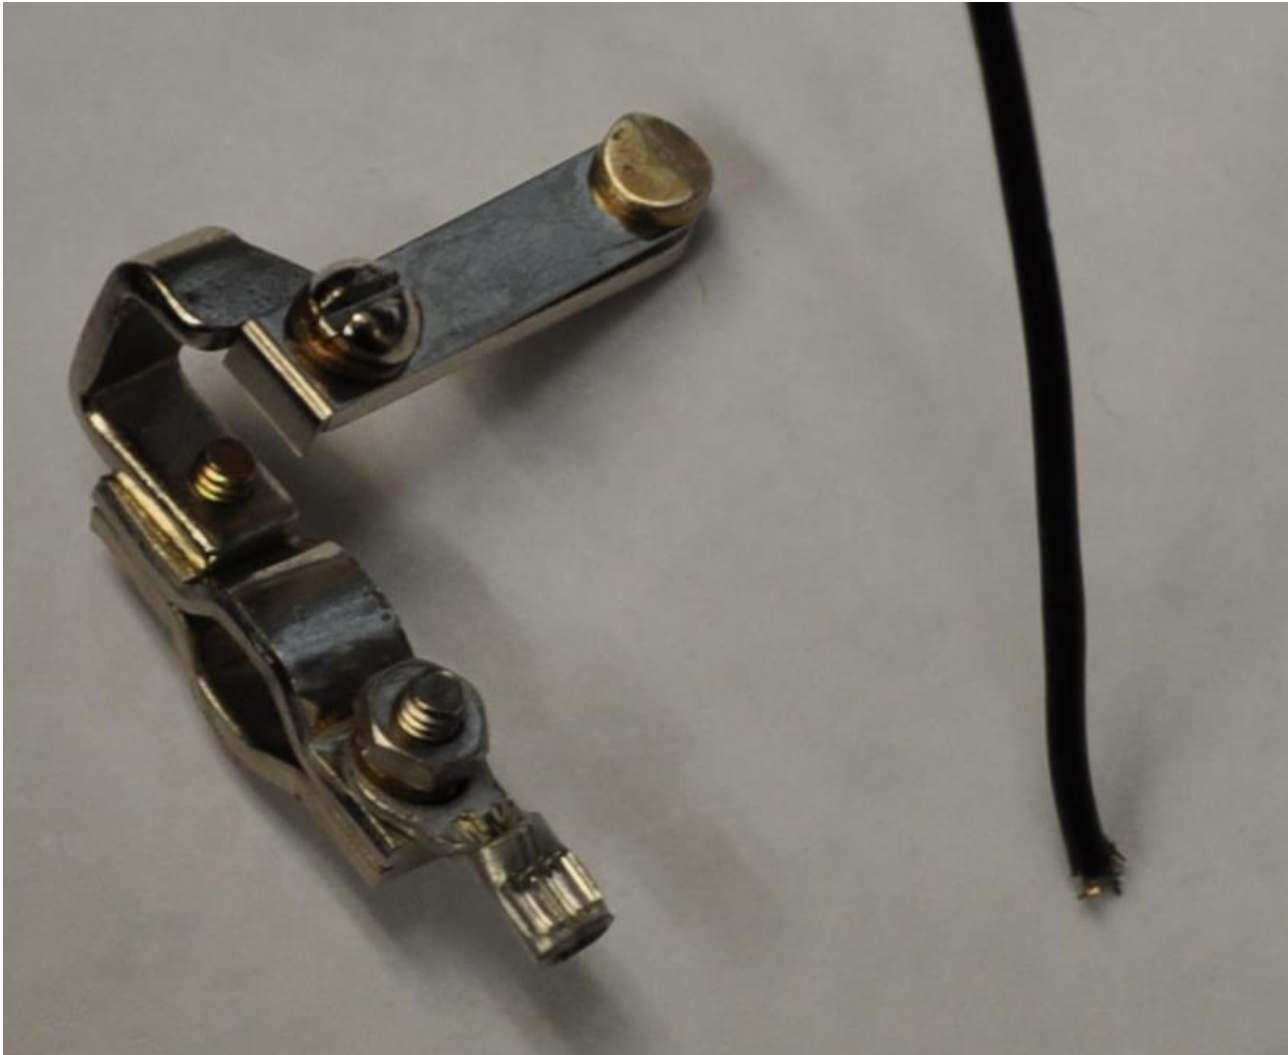
Figure 8. A wire tore apart from the ferrule that is connected to the stationary undervoltage contact assembly during removal from the time dial shaft as shown above.
