**SUBJECT: WATERFORD STEAM ELECTRIC STATION, UNIT 3 – NRC INSPECTION
REPORT 05000382/2025092 AND PRELIMINARY WHITE FINDING**

**U.S. NUCLEAR REGULATORY COMMISSION
Inspection Report**

Report Number: 05000382/2025092

Facility: Waterford Steam Electric Station, Unit 3

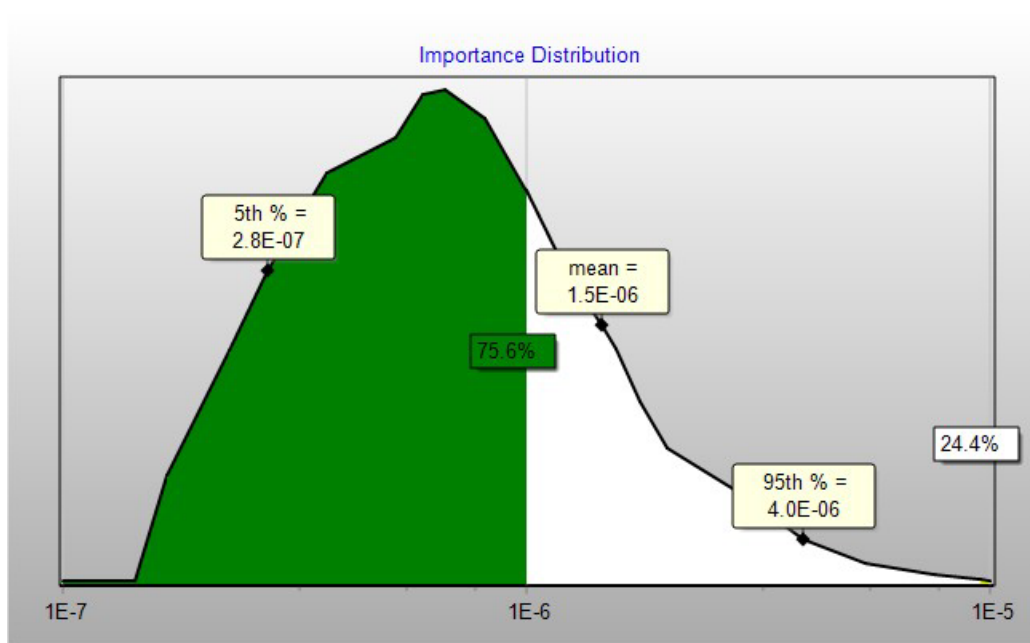
The analyst performed an uncertainty analysis using the Monte Carlo method with a sample size of 3,775 on the internal and external events results using the SAPHIRE ECA workspace.

5 th %	Median	Point Estimate	Mean	95 th %
2.76E-7	9.95E-7	1.45E-6	1.45E-6	3.95E-6

The above results reflect a simplified approach of combining the two exposure periods of 10.5 days and 13 days into one 24-day period of a failure-to-load-run condition for purposes of performing a single overall uncertainty estimation that reflects the approximate total risk estimate for this analysis. These results do not include the significant risk contribution from fire events (which was estimated separately based on review of licensee modeling results). The results represented above do include risk contribution from HWD events to serve as an approximate surrogate to offset the fire risk contribution that is not included in SPAR modeling, in an effort to estimate the uncertainty distribution associated with the approximate best-estimate total risk for this evaluation (it can be noted that the resulting point estimate reflected above is just slightly lower than the actual best-estimate total risk (delta-CDF) reported in Table 4 below).
