Subject: Reply to a Notice of Violation, EAF-RIV-2025-0090

Waterford Steam Electric Station, Unit 3
NRC Docket No. 50-382
Renewed Facility Operating License No. NPF-38

**Waterford Steam Electric Station, Unit 3
Reply to a Notice of Violation, EAF-RIV-2025-0090**

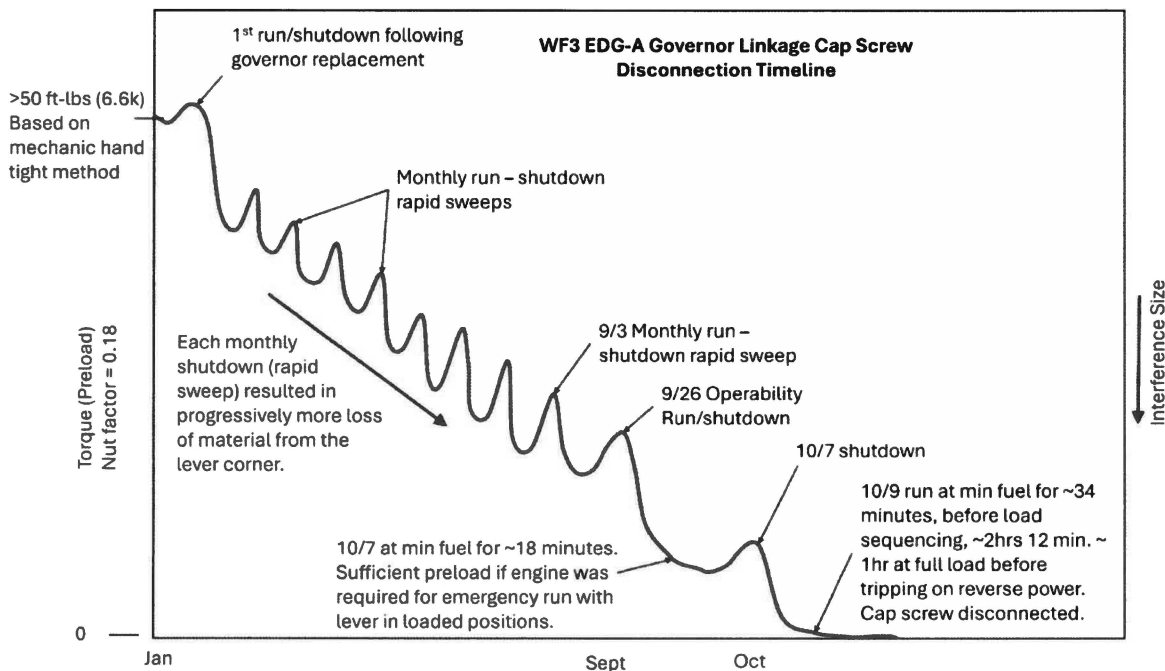
During the Regulatory Conference, Entergy provided evidence that once preload on the cap screw is lost, operational vibration will rapidly drive cap screw loosening and lead to disconnection of the joint. Before preload is lost, there is a high degree of confidence that the SSC remains operable. Studies demonstrated that the primary mechanism responsible for degrading the initial cap screw torque¹ (or more accurately, preload), was the repeated impact of the lever corner striking the chamfered edge of the Heim joint.² These impacts occurred during engine shutdown, when the lever rapidly swept from the minimum to maximum fuel positions.³ During the period in question, engine shutdown occurred on several occasions. Each adverse strike generated during engine shutdown incrementally reduced the joint preload and caused localized material removal at the point of contact. A conceptual illustration of the progressive preload loss resulting from each adverse strike is shown in Figure 1. Preload degradation occurred in discrete steps, coinciding with each engine shutdown event. Only after complete preload loss did engine vibration become a factor, at which point it initiated the unthreading of the cap screw.

Once the corner of the lever has been removed due to repeated adverse strikes, subsequent diesel generator operation under load does not contribute to further preload loss. Therefore, if the EDG starts with any remaining preload in the cap screw joint, there is no load transfer that would lead to additional preload degradation or unthreading of the cap screw. In other words, so long as preload remained, the possibility of failure of the EDG A linkage had increased, but not to the point of eroding confidence in the reasonable assurance that the EDG A remained operable.

Figure 1: Illustration of Progressive Preload Loss Consistent with EDG-A Shutdown Sweeps

First, the NRC questioned whether Entergy’s testing established the cause of preload loss, writing, “during discussion, no clear evidence was given for how the continued loss of preload on the bolt occurred once the corner of the lever arm was worn off from the interference with the Heim joint chamfer.”⁶ To the contrary, testing discussed during the Regulatory Conference demonstrated that ten adverse sweeps of the lever—from minimum to maximum fuel position—produced material loss at the lever corner consistent with the wear observed on the actual component. These sweeps occurred exclusively during shutdown events. Each rapid sweep event resulted in stepwise reductions in preload and localized material loss. This stepwise degradation pattern is evident in the progression shown in Figure 1. The number of adverse strikes observed under testing conditions (*i.e.*, ten) closely aligns with the operational history, with the final strike occurring during the October 7, 2024 shutdown and resulting in complete preload loss, as shown in Figure 1, aboveFigure 1. Following this loss of preload, engine-

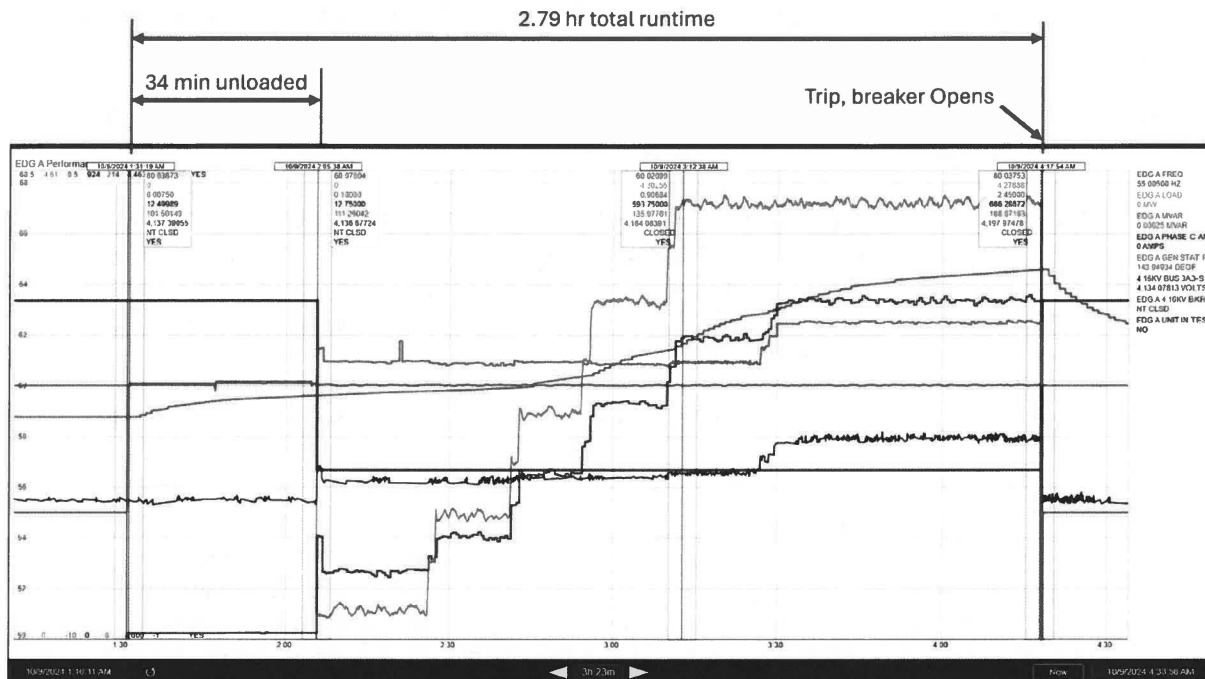
Testing provides reasonable assurance that, in the absence of preload, vibration alone is sufficient to cause the cap screw to back out within minutes to hours. This outcome is consistent with the October 9, 2024 run, during which the engine operated under load for approximately 2.2 hours before tripping on reverse power. Therefore, the time during which the cap screw was subject to unthreading forces from engine vibration alone is considered to be 2.79 hours, which is the total run time on October 9, 2024 before tripping on reverse power.

This comment implies that EDG-A completed a successful run on October 9, 2024. EDG-A did not complete a successful run, however, and instead tripped on reverse power 2 hours and 47 minutes into the planned 24-hour operation. (See Figure 2). This trip corresponds to the cap screw fully backing out, resulting in the loss of connection between the governor lever and the fuel rack. Put another way, this unsuccessful run actually proves that preload was already lost: without preload, operational vibration was sufficient to cause the cap screw to unthread completely.

Figure 2: Plot of EDG-A Run on October 9, 2024
