Incident Event

IE-2506-0051

Person Involved	Dale McGrath
Person Involved	Brandon MacManus
Person Involved	Andrew Yates
Person Involved	Dorian Medina
Person Involved	Xavier Flournoy
Incident Summary	Equipment Damage: Cranks melted - Source retrieval event!

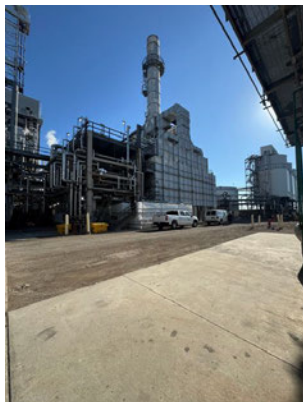
barricade view of area around C 2 heater in cooker unit .JPG

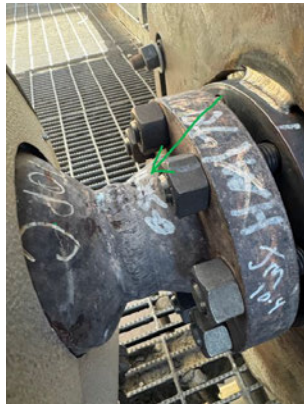
cable burn on piping.JPG

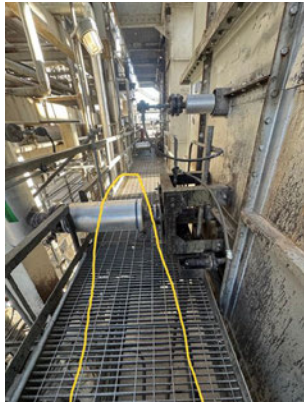
cable left on piping during RT setup. .JPG

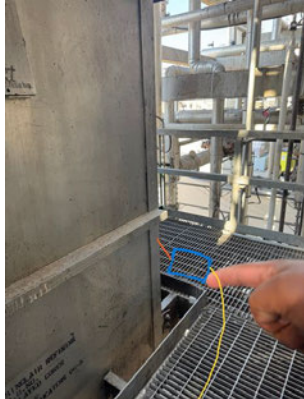
camera placement of time of exposure hangout. shielding available from furnace. .JPG

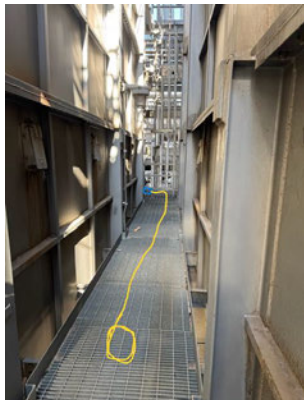
crankout lay out during exposure.JPG

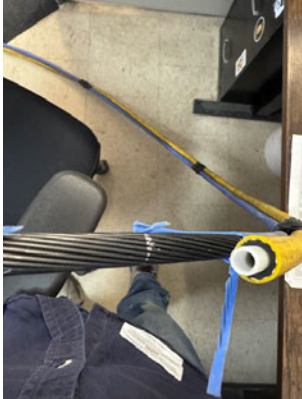
blue and yellow cable cut . Blue cable failed attempt to cut. .jpg

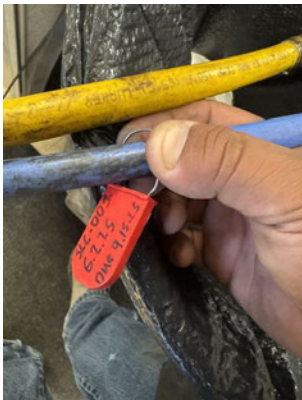
red quarterly tag showing Maintenance .jpg

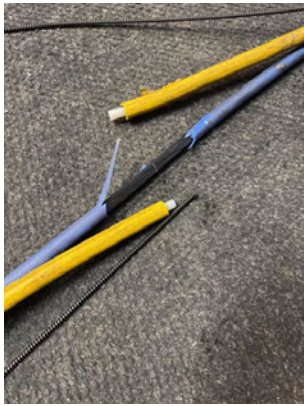
Cut cable to find bind inside blue cable, bind was at location of failed attempt to cut blue guide.jpg

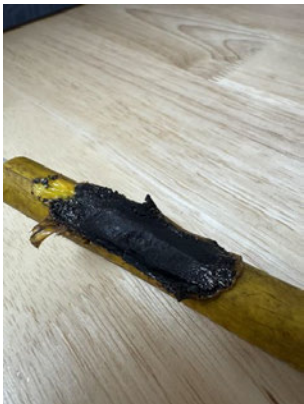
burn mark on yellow guide cable.jpg

Badge #	03288
Badge #	02112
Badge #	03439
Badge #	03205
Badge #	03438
Badge #	03441
Shift Start Time	7:00 AM
Shift End Time	3:30 PM
Additional Information	Source Retrieval performed: Remote handling cranks damaged due to surface contact with hot source melting the exterior coating and inner liner of the crank assembly melting the cable to the white plastic inside protective yellow.

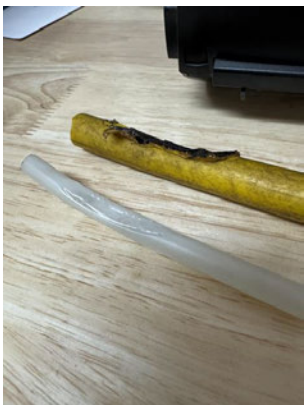
inner white sleeve melted into cable inside of yellow guide. .jpg
