SRMC-CWDA-2023-00032
Revision 0

**Conceptualization of Potential Leak Paths
Associated with Saltstone Disposal Unit 6 (SDU 6)**

April 2023

Prepared by: Savannah River Mission Completion LLC
Closure and Waste Disposal Authority
Aiken, SC 29808

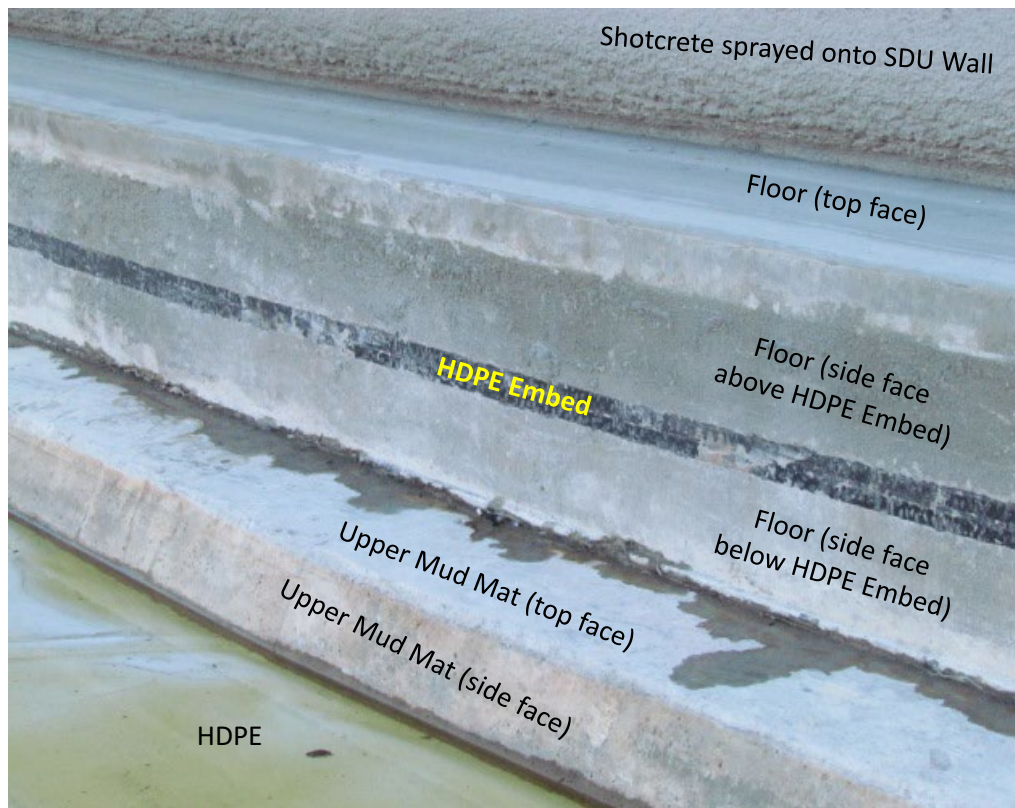
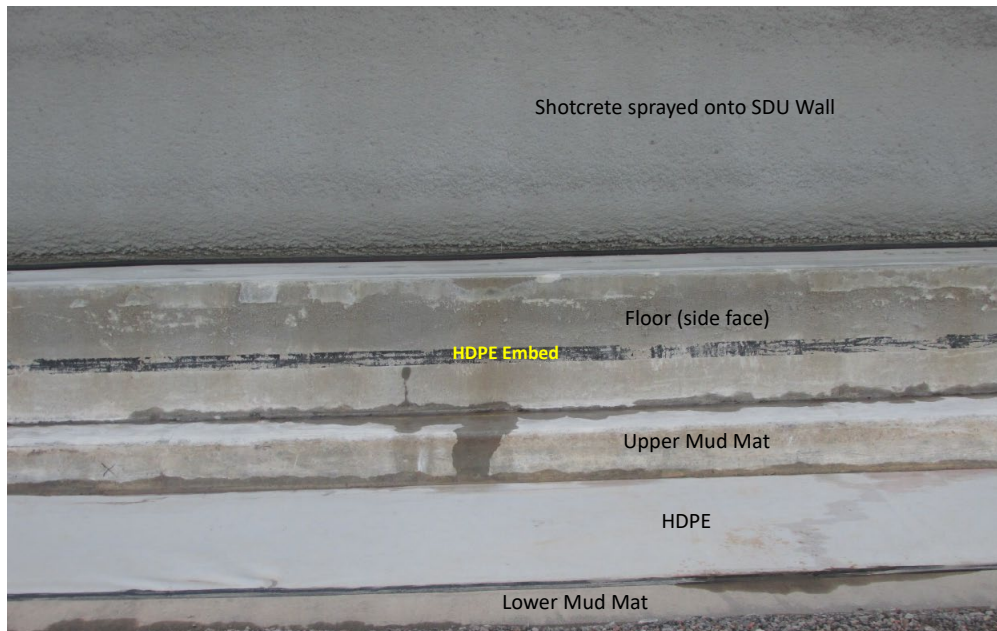
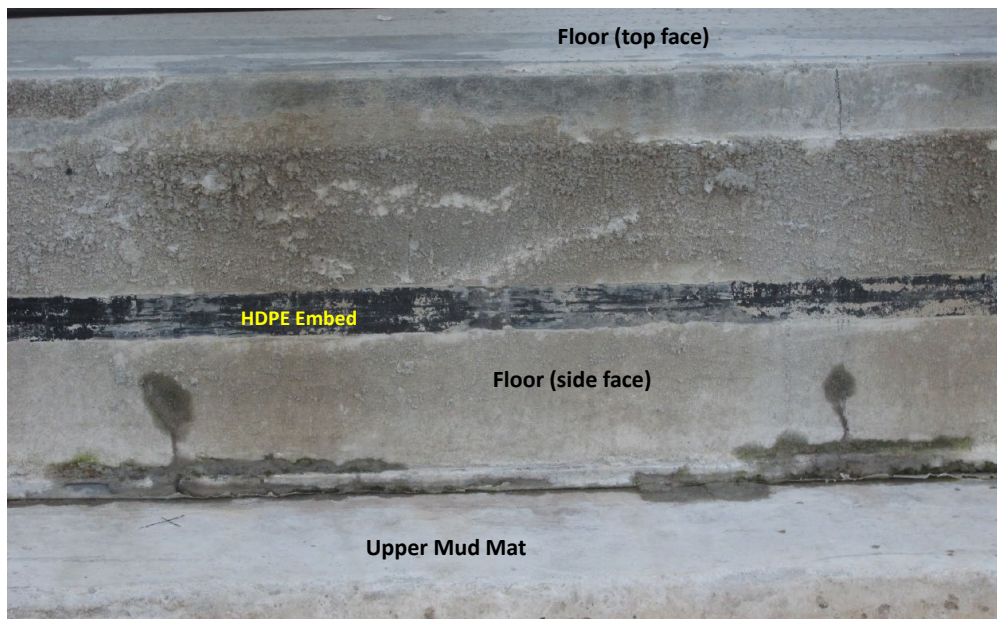
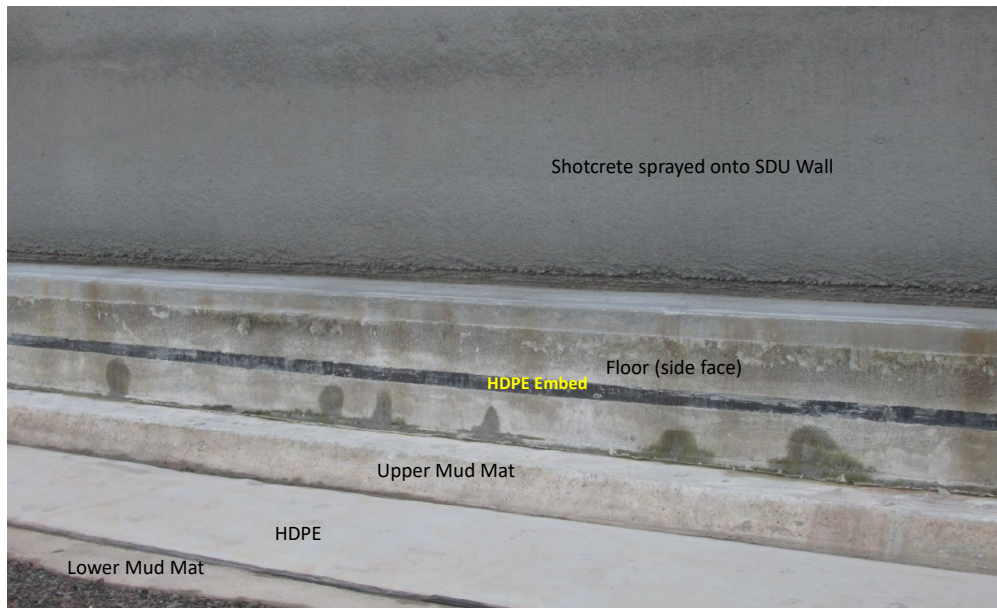
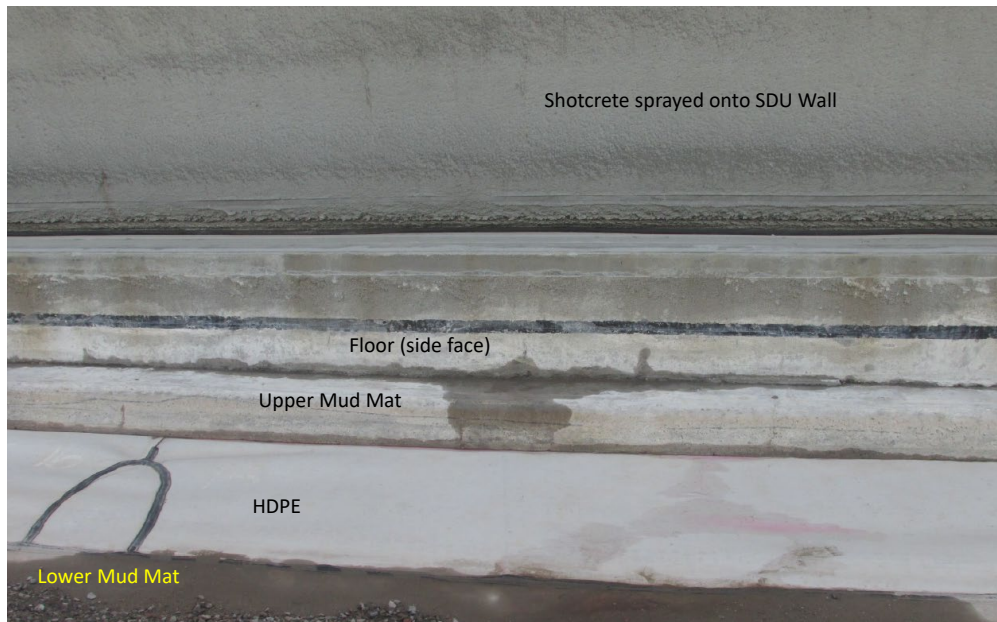
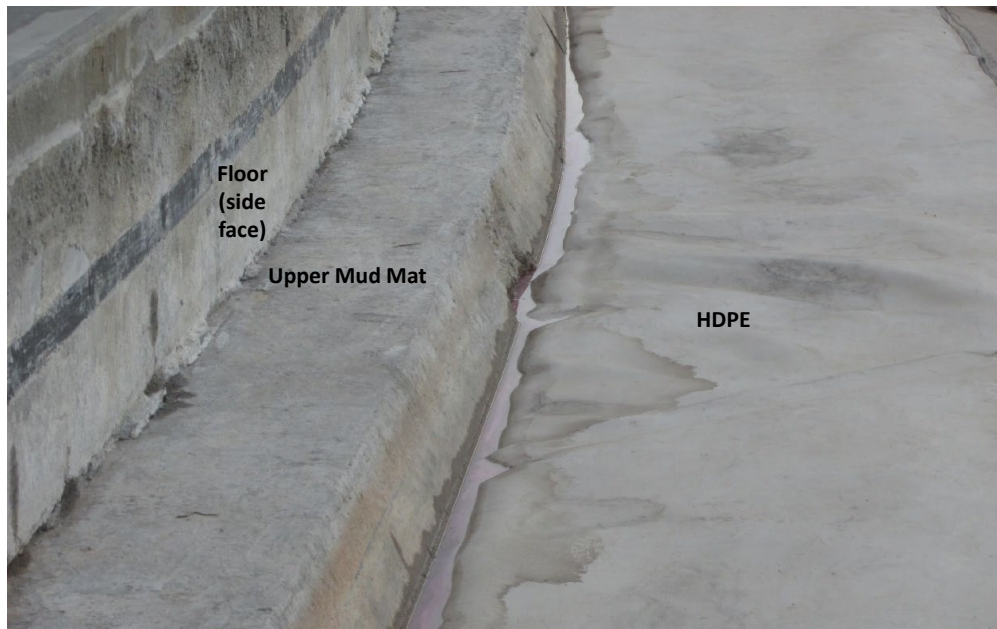
Red dye was added to the water (C-SPP-Z-00008) on the morning of November 5, 2015. Adding this dye allows for the identification of water coming from inside the SDU during the filling process (as opposed to water coming from other sources). However, in the afternoon of November 5, 2015, dyed water was already observed coming out of the bottom of SDU 6 at the interface between the floor and the upper mud mat. Based on observations, it was estimated that less than 4 liters per minute (or approximately 1,500 gal/day) was leaking from the SDU after it was filled to 41 feet (SRR-SDU-2017-00004).

The presence of dye at the SDU floor-to-upper mud mat interface resulted in a failed leak tightness test for SDU 6. Additional testing continued until November 11, 2015, at which point the dyed water within the SDU was pumped out. Figure 2.3-1 through Figure 2.3-6 show the leaks at the base of the SDU 6 floor. In each of these figures, the concrete structure with the black stripe is the outside edge of the SDU floor (the black stripe is the HDPE embed to be used for enclosing the SDU 6 leak detection system upon successful completion of leak testing). Most of these figures show water seeping from the side-face of the floor, indicating that the leak is coming from within the concrete of the SDU 6 floor.

**Figure 2.3-1: Observed Leak from First Leak Tightness Test of SDU 6, November 2015
(1 of 6)**

Figure 2.3-2: Observed Leak from First Leak Tightness Test of SDU 6, November 2015
(2 of 6)

Figure 2.3-3: Observed Leak from First Leak Tightness Test of SDU 6, November 2015
(3 of 6)

Figure 2.3-4: Observed Leak from First Leak Tightness Test of SDU 6, November 2015
(4 of 6)

Figure 2.3-5: Observed Leak from First Leak Tightness Test of SDU 6, November 2015
(5 of 6)

**Figure 2.3-6: Observed Leak from First Leak Tightness Test of SDU 6, November 2015
(6 of 6)**

After the first leak tightness test failed, a synthetic liner was installed inside SDU 6 (C-SPP-Z-00013). The liner material was a 3-mm-thick vulcanized rubber which was attached to the interior concrete surfaces of the SDU using an epoxy adhesive. Figure 2.3-7 shows the interior of SDU 6 after the liner installation. The liners are visible as black panels on the walls and floors.

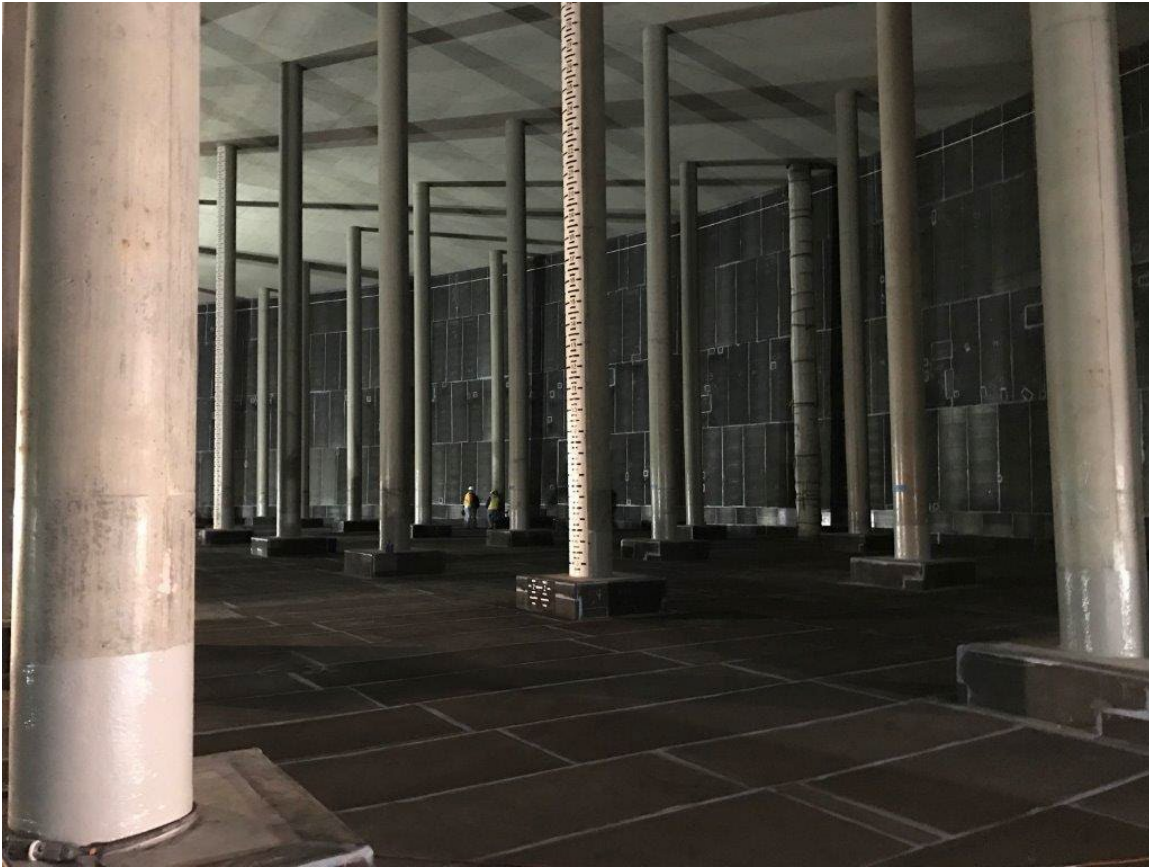
Figure 2.3-7: Interior of SDU 6 After Liner Installation (Fall 2016)

Leak Paths 5 and 6 are considered plausible because, unlike the walls and floor, the roof support columns inside SDU 6 are not protected by the interior liner system (as shown in Figure 2.3-7).

Leak Paths 7 and 8 are considered plausible because, unlike the walls and floor, the top surface of the column pedestals inside SDU 6 are not protected by the interior liner system (as shown in Figure 2.3-7).

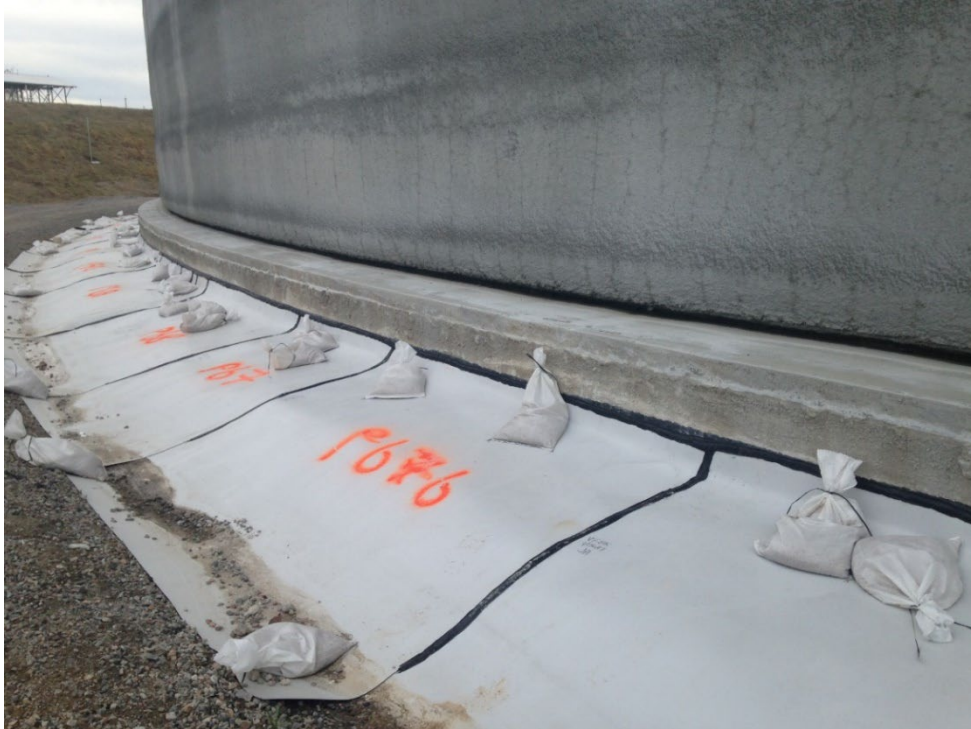
Figure 2.3-8: Installation of HDPE Over the Mud Mats

In March 2017, SDU 6 was transferred from the SDU 6 Project Team (construction) to the SDF Operations. It was immediately noted that the East Sump alarm was actuated almost continuously (Riley, 2022). When the sump was pumped and the alarm cleared, it would re-actuate within an hour (Riley, 2022). Since this was prior to the start of disposal operations, it was assumed that the water in the sump was due to remnant construction water trapped within the leak detection system or due to rainwater that had been received while the HDPE liner around the perimeter of the SDU was being welded. It may be noted that the soils surrounding the HDPE appear to be damp in Figure 2.3-8, supporting this hypothesis.

After the second leak tightness test, the SDU 6 leak detection system was enclosed beneath an additional layer of HDPE as shown in Figure 2.3-8 and Figure 2.3-9. The black lines between the different sheets of HDPE and around the sump piping are HDPE extrusion welds.

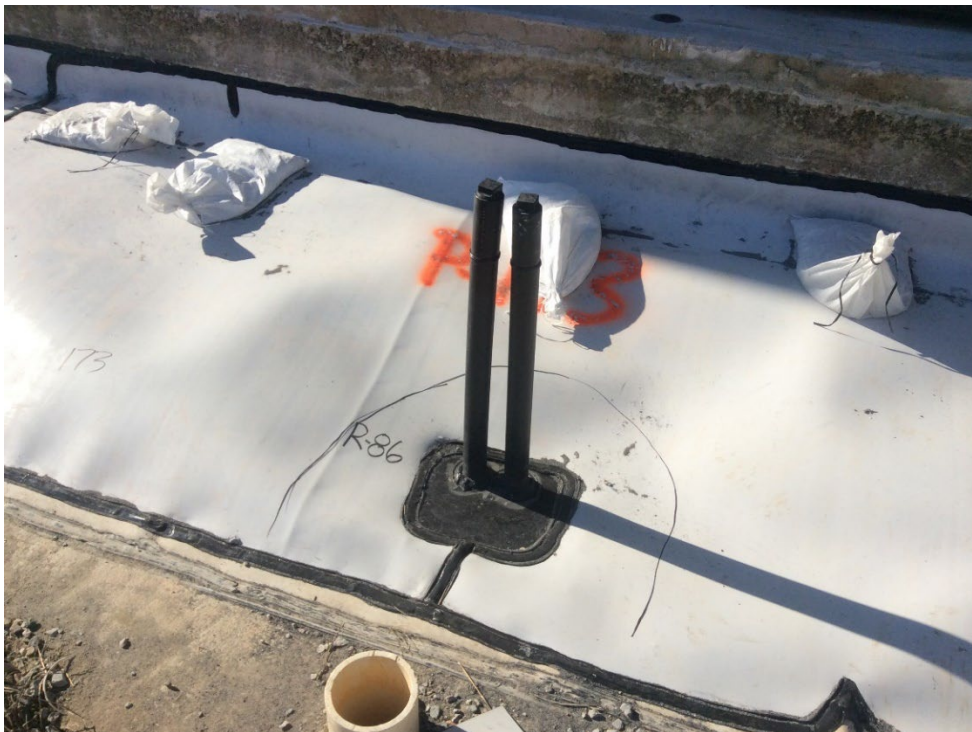
Figure 2.3-9: Installation of HDPE Over the Mud Mats at East Sump

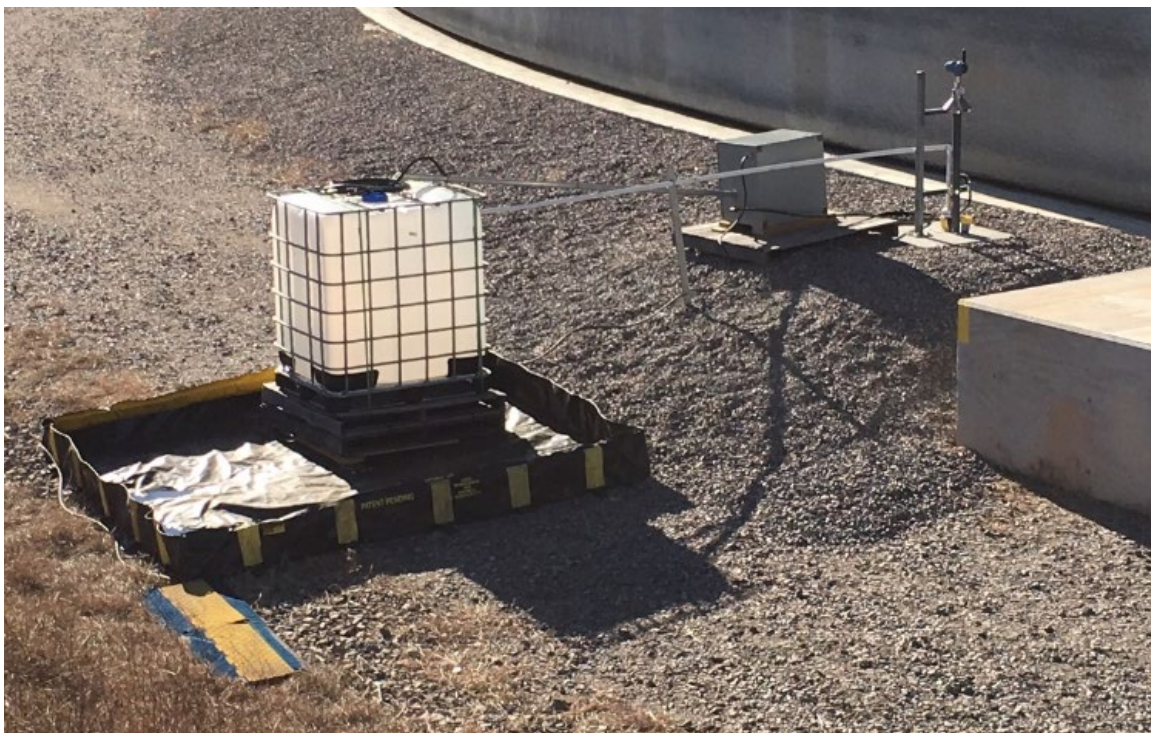
Figure 3.2-1: SSF-TMC-18-003, De-Watering Pump at the East Sump of SDU 6

This leak path is considered plausible because a portion of the top surface of the floor remains exposed (for example, refer to the base of SDU 6 depicted in Figure 3.2-1).

In July 2018, a temporary modification SSF-TMC-18-003 was installed at the East Sump to reduce the effort required for dewatering the sump (shown in Figure 3.2-1). In January 2022, the temporary modification was converted into permanent modification M-DCP-Z-20001 (shown in Figure 3.2-2). After contamination was detected in March 2022, pumping ceased. In August 2022, temporary modification M-TMOD-Z-00002 was installed, which feeds the sump water directly back to the primary containment system inside SDU 6.

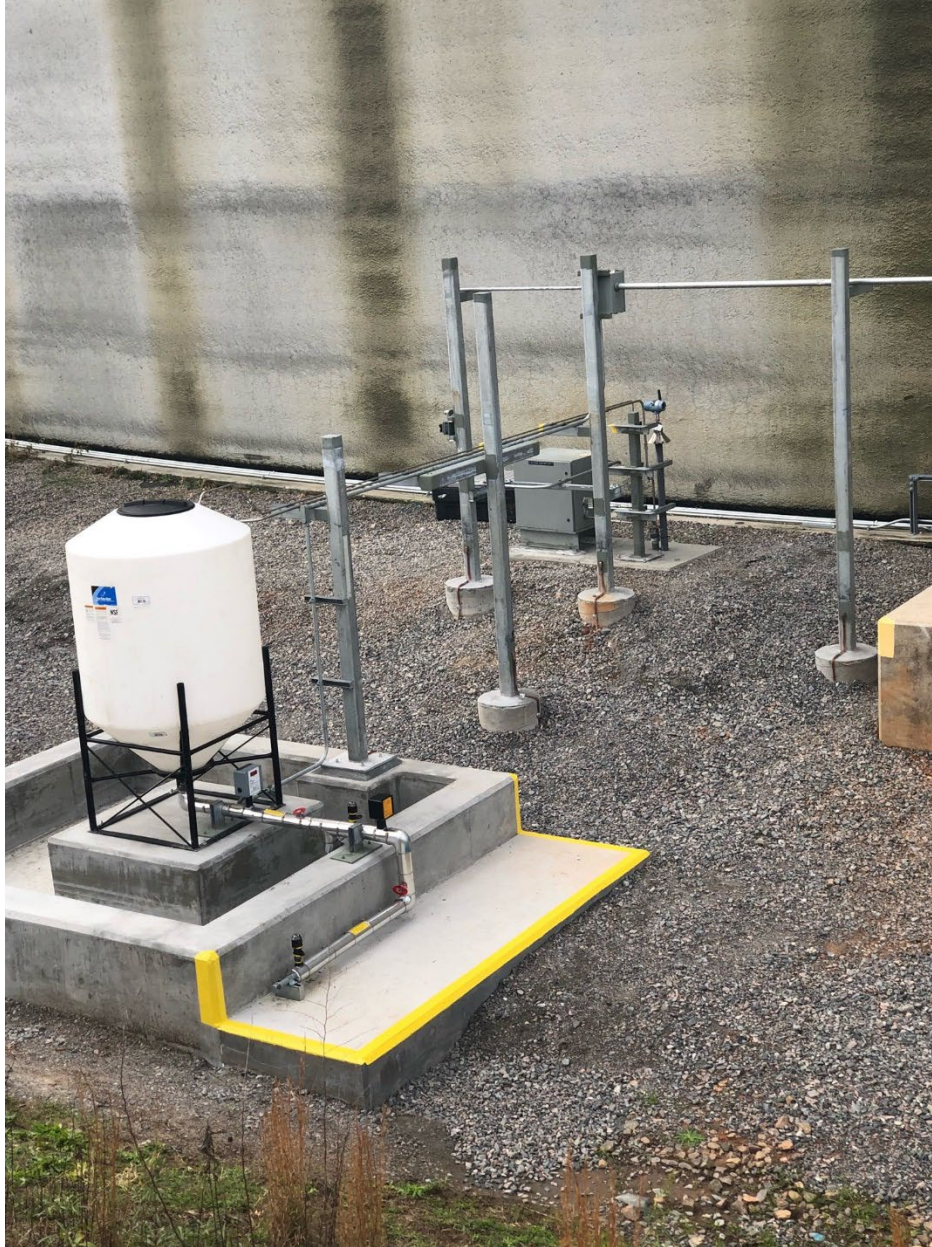
Figure 3.2-2: M-DCP-Z-20001 De-Watering Pump at the East Sump of SDU 6

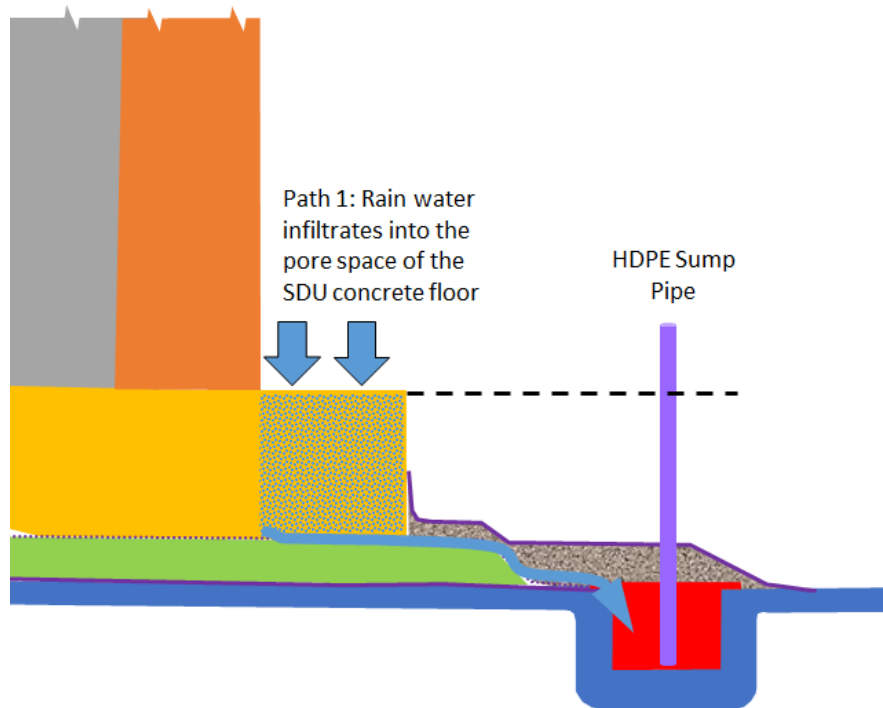
Figure 4.1-1: Leak Path 1

Figure 4.1-1 illustrates Leak Path 1. In this conceptualization, rainwater collects on the top surface of the exposed SDU concrete floor. This water then infiltrates through the surface and into the concrete; this may be through cracks or through interconnected pore spaces within the matrix of the concrete. Once the water reaches the bottom of the floor, the 10-mil liner then diverts the water laterally towards the outside edges of the SDU where the water can then collect into the sump.

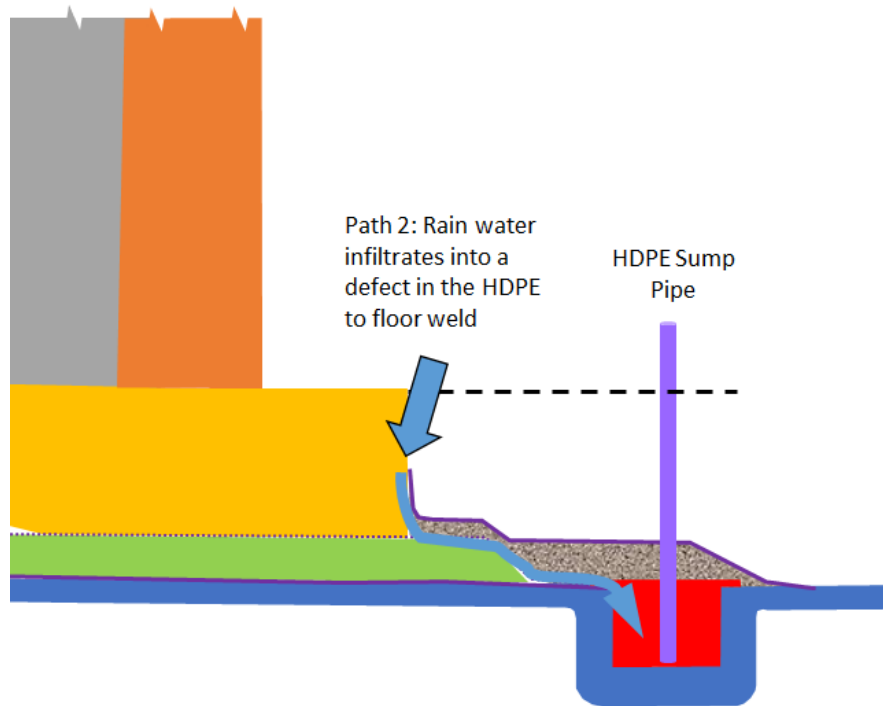
Figure 4.2-1: Leak Path 2

Figure 4.2-1 illustrates Leak Path 2. In this conceptualization, it is assumed that a portion of HDPE-to-floor weld has become defective, leaving an opening for rainwater ingress. This water then moves down the side of the floor to the top of the upper mud mat. The upper mud mat then diverts the water laterally towards the outside edges of the SDU where the water can then collect into the sump.

Leak Path 2 is considered plausible because the HDPE-to-floor welds are extrusion welds that must be installed vertically; this means that gravity is always working against the weld. Figure 2.3-8 and Figure 2.3-9 showed the HDPE during this installation. Once this installation was completed, this HDPE was buried beneath a layer of backfill to bring the grade up to be level with the top surface of the SDU floor. It is possible that the added weight of the backfill material over the top of the HDPE could have been sufficient to potentially separate some of these welds in isolated locations.

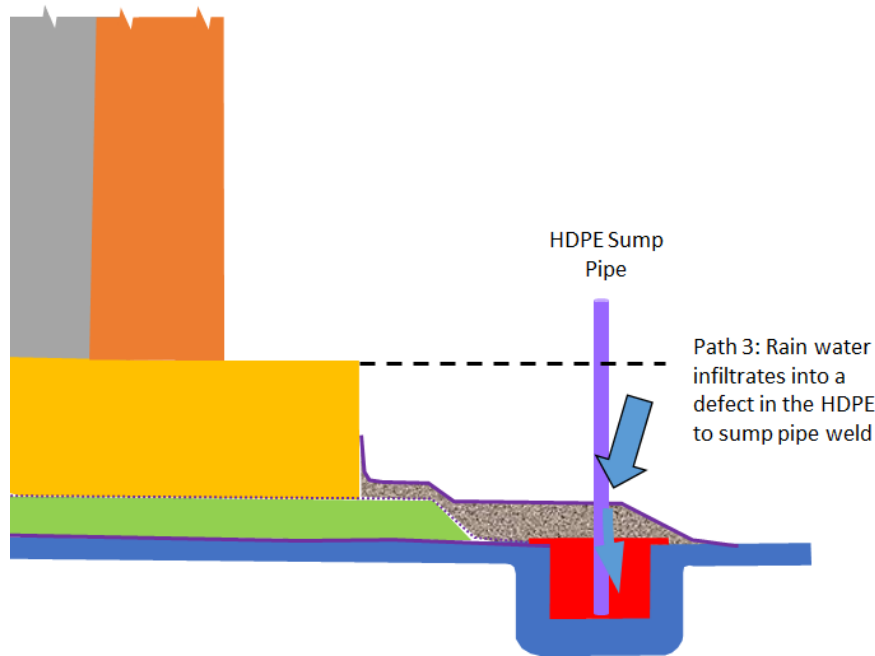
Figure 4.3-1: Leak Path 3

Figure 4.3-1 illustrates Leak Path 3. In this conceptualization, it is assumed that a portion of HDPE weld around the HDPE sump pipe (or any other part of the HDPE not already addressed via Leak Paths 1 and 2) has become defective, leaving an opening for rainwater ingress. In the case of the HDPE sump pipe, the water then moves down the pipe and directly into the sump. HDPE defects at other locations would require some transport for the water to reach the sump. Figure 2.3-9 showed an example of these extrusion welds, which visually appear to be complete and robust extrusion welds. Regardless, because this has the potential to be the most direct path for water to reach the sump, it is included as a potential path.

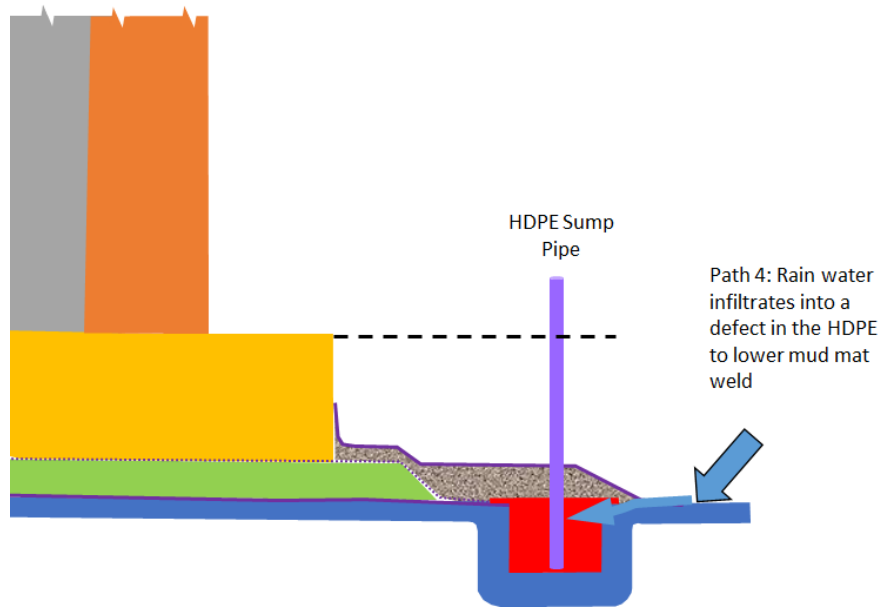
Figure 4.4-1: Leak Path 4

Figure 4.4-1 illustrates Leak Path 4. In this conceptualization, it is assumed that a portion of HDPE-to-lower mud mat weld has become defective, leaving an opening for rainwater ingress. This water then moves inward (towards the SDU), where the water can then collect into the sump. This leak path is considered less likely than Leak Paths 2 and 3 because this leak path does not rely on vertical welds. Along the HDPE-to-lower mud mat weld, the HDPE is expected to lay relatively flat against the lower mud mat; this means that the extrusion welds (as shown in the lower portion of Figure 2.3-9) are less likely to undergo strain that could damage the weld.

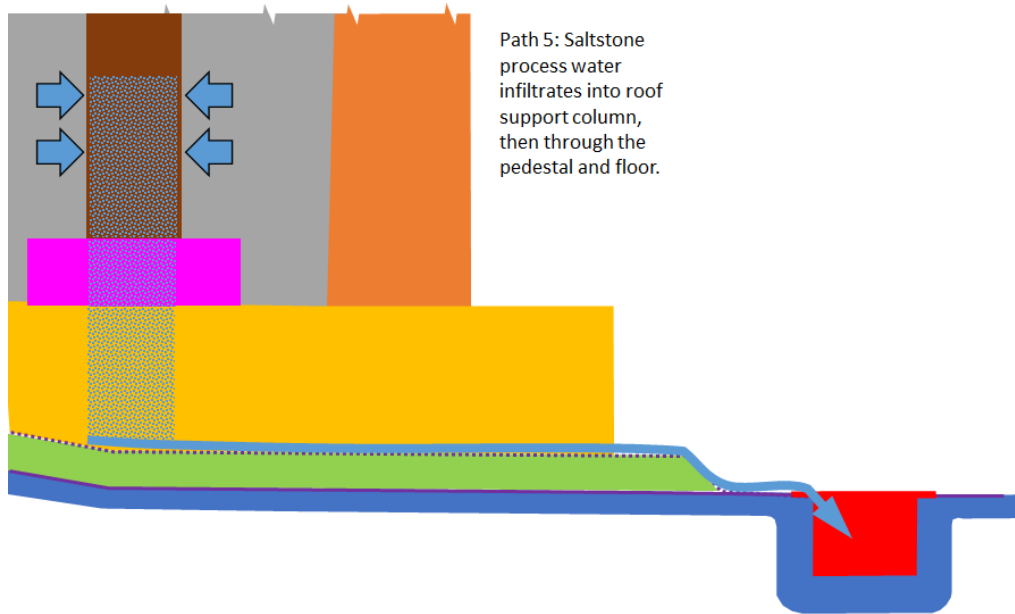
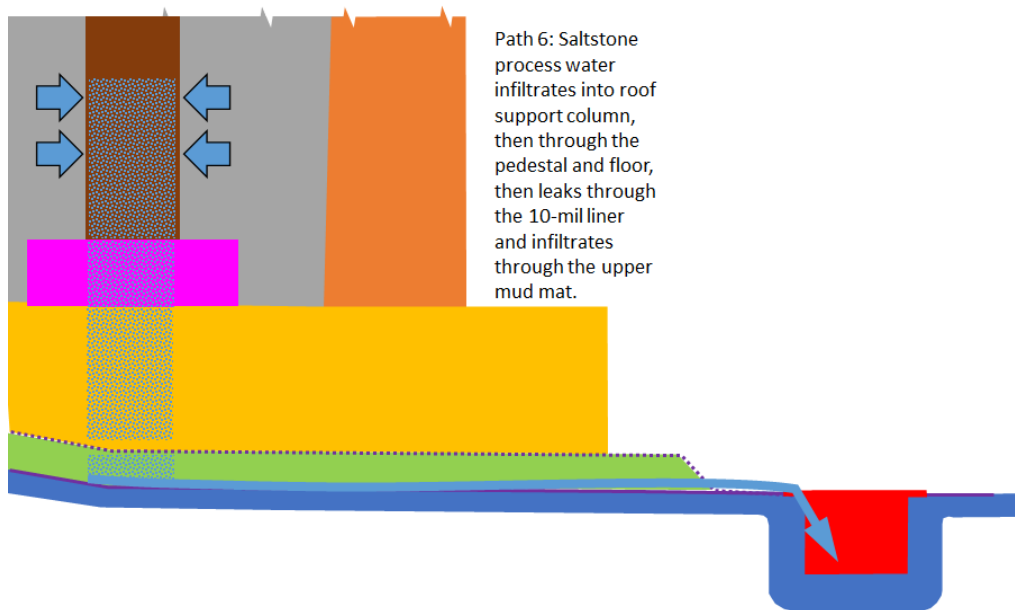
Leak Paths 5 and 6 are nearly identical to one another. These leak paths are illustrated by Figure 4.5-1 and Figure 4.5-2, respectively. In these conceptualizations, saltstone process water infiltrates through the vertical surface of the roof-support columns (shown as the brown feature in Figure 4.5-1 and Figure 4.5-2). This water then percolates down, through the column pedestals (the pink feature) and into the SDU floor. For Leak Path 5, it is assumed that the saltstone process water reaches the top of the 10-mil liner where it is diverted laterally towards the outside edges of the SDU, where the water can then collect into the sump. For Leak Path 6, it is assumed that the 10-mil liner has defects that allows the water to penetrate the upper mud mat. It is then assumed that the saltstone process water reaches the top of the HDPE where it is diverted laterally towards the outside edges of the SDU, where the water can then collect into the sump.

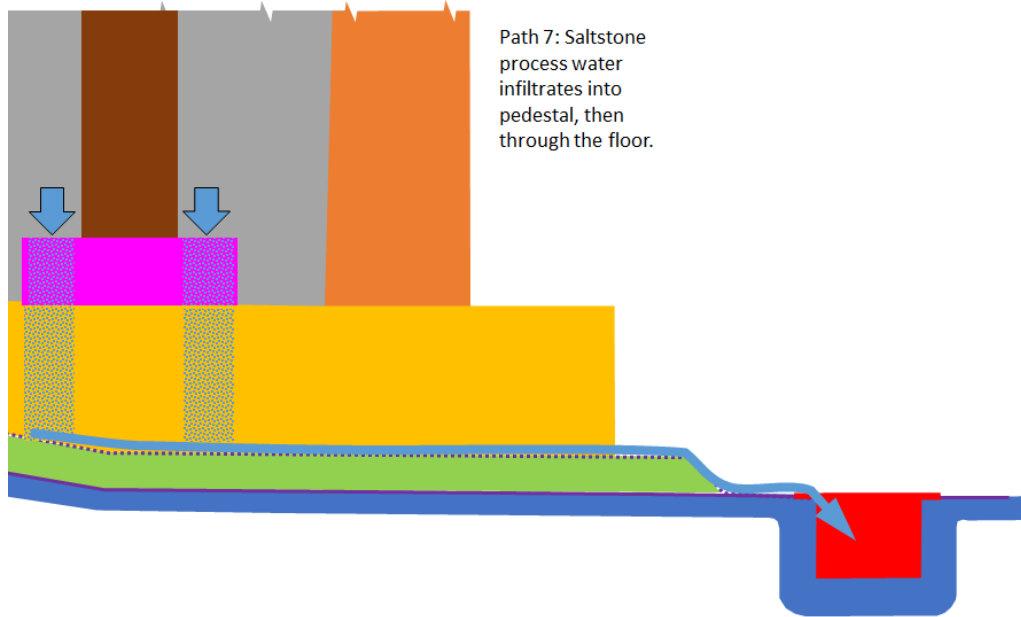
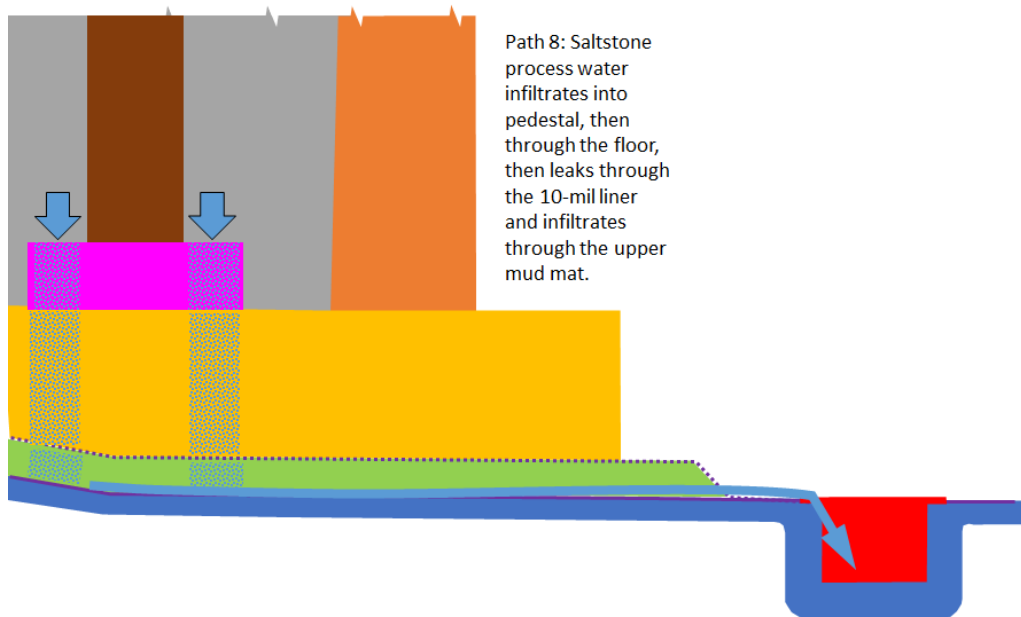
Leak Paths 7 and 8 are nearly identical to one another. These leak paths are illustrated by Figure 4.6-1 and Figure 4.6-2, respectively. In these conceptualizations, saltstone process water infiltrates through the top surface of the column pedestals (shown as the pink feature in Figure 4.6-1 and

Figure 4.6-2), then percolates down, through the column pedestals (the pink feature) and into the SDU floor.

For Leak Path 7, it is assumed that the saltstone process water reaches the top of the 10-mil liner where it is diverted laterally towards the outside edges of the SDU, where the water can then collect

into the sump. For Leak Path 8, it is assumed that the 10-mil liner has defects that allows the water to penetrate the upper mud mat. It is then assumed that the saltstone process water reaches the top of the HDPE where it is diverted laterally towards the outside edges of the SDU, where the water can then collect into the sump.

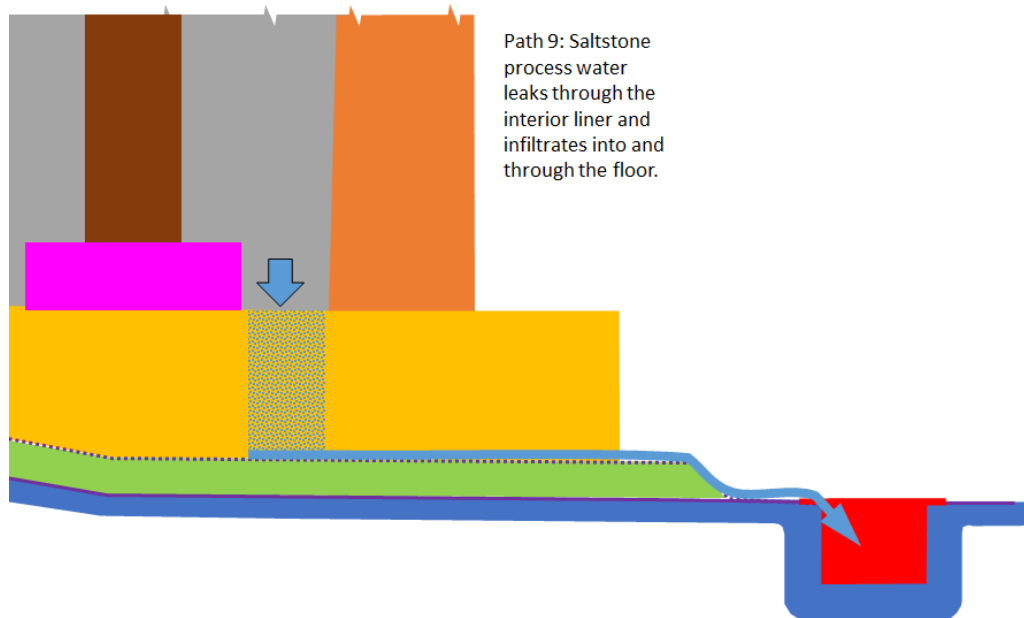
Figure 4.7-1: Leak Path 9

Leak Paths 9 and 10 are nearly identical to one another. These leak paths are illustrated by Figure 4.7-1 and Figure 4.7-2, respectively. In these conceptualizations, it is assumed that there is a defect (or defects) in the interior liner system. The saltstone process water leaks through the defect(s) then infiltrates through the top surface of the SDU floor and percolates down. For Leak Path 9, it is assumed that the saltstone process water reaches the top of the 10-mil liner where it is diverted laterally towards the outside edges of the SDU, where the water can then collect into the sump. For Leak Path 10, it is assumed that the 10-mil liner has defects that allows the water to penetrate the upper mud mat. It is then assumed that the saltstone process water reaches the top of the HDPE where it is diverted laterally towards the outside edges of the SDU, where the water can then collect into the sump.

Path 9: Saltstone process water leaks through the interior liner and infiltrates into and through the floor.

Since SDU 6 passed the second leak tightness test, it is proposed that while Leak Paths 9 and 10 are possible, they are probably less likely than the other leak paths.
