UNITED STATES
NUCLEAR REGULATORY COMMISSION
REGION III
2056 WESTINGS AVENUE, SUITE 400
NAPERVILLE, IL 60563-2657

SUBJECT: NRC SPECIAL INSPECTION REPORT NO. 03038841/2025002(DRSS) –
CURIUM US, LLC

Addendum to IR 03038841/2025002(DRSS) Fault Tree Analysis

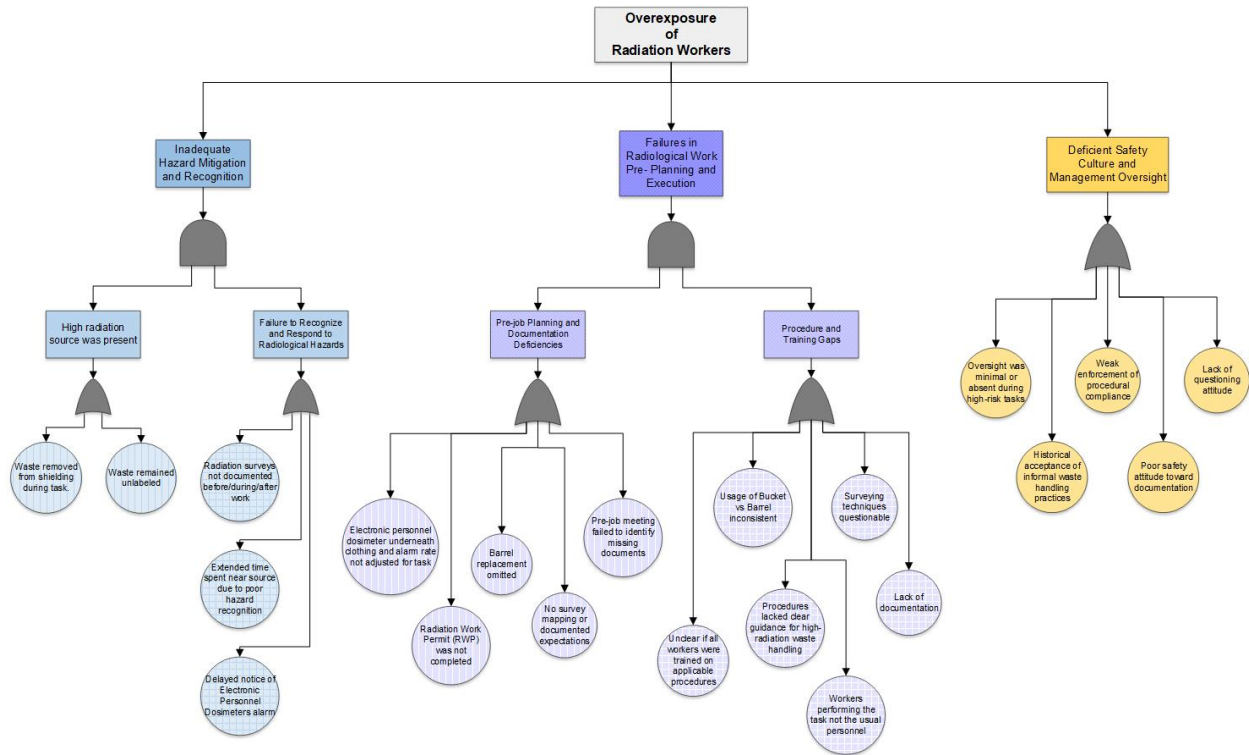
The inspectors performed a root cause analysis for the incident using fault tree analysis, supplemented by barrier analysis and the five whys technique. The inspectors concluded that the direct cause of the exposures above limits was the removal of the waste container, and the 210 curies of rubidium radionuclides inside, from shielding at the beginning of work in the east basement.

The inspectors concluded that the root cause of the incident was the licensee's failure to implement and maintain an effective radiation safety program, due to insufficient management oversight and accountability.

The inspectors also noted the following contributing factors: Inadequate recognition and mitigation of hazards, deficiencies in planning and execution of radiological activities, insufficient training and failure to ensure personnel competency in radiation safety procedures, and a deficient safety culture that failed to prioritize radiological risk and procedural compliance and failed to effectively manage operational changes (see the Addendum to this report for more detail).

Gate 1: Inadequate Hazard Mitigation and Recognition (AND gate)

- Gate 1.1: High radiation source was present (OR gate)
 - 1.1.1: Waste removed from shielding during task.
 - 1.1.2: Waste remained unlabeled
- Gate 1.2: Failure to Recognize and Respond to Radiological Hazards (OR gate)
 - 1.2.1: Radiation surveys not documented before/during/after work.
 - 1.2.2: Extended time spent near high radiation source due to poor hazard recognition
 - 1.2.3: Delayed notice of Electronic Personnel Dosimeters alarm
