Technical Letter Report
TLR-RES/DE/MEB-2025-04
PNNL-37055

Alloy 690/152(M)/52(M) SCC Initiation Test 5.7-Year Summary Report

September 2025

Pacific Northwest National Laboratory

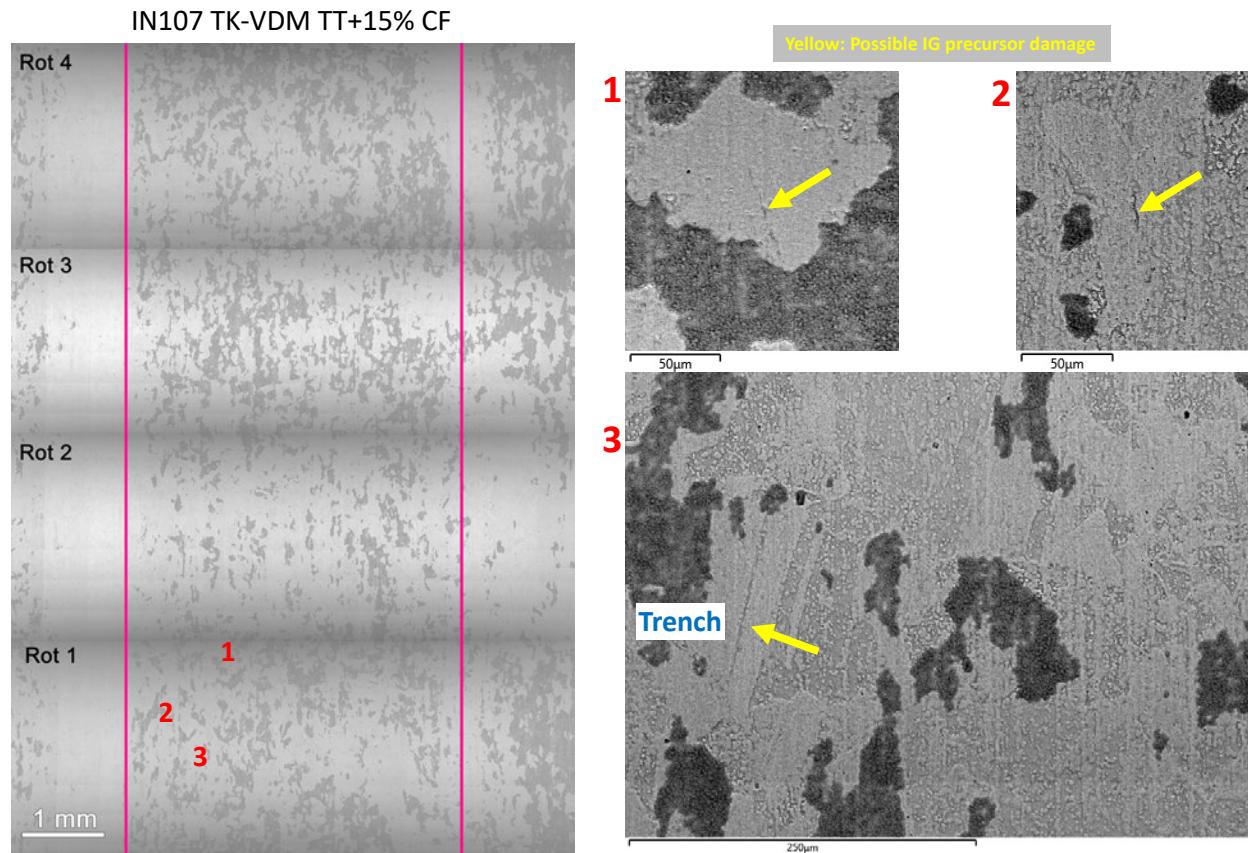
Figure 27. IN107 TK-VDM 114092-gauge surface summary.

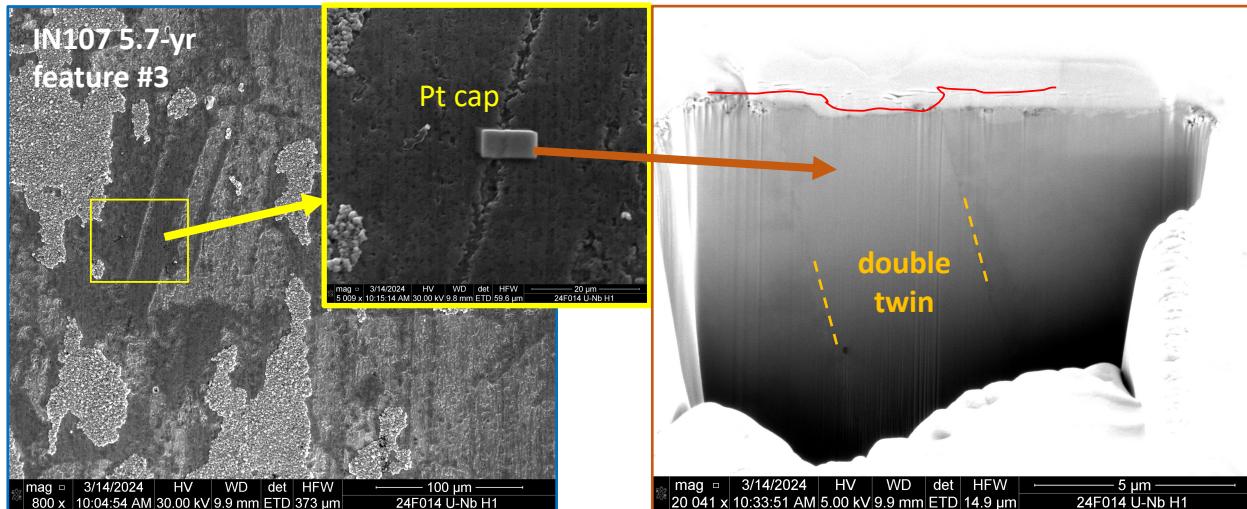
Figure 28. FIB trench of feature #3 observed on IN107 (heat 114092) after 5.7 years.

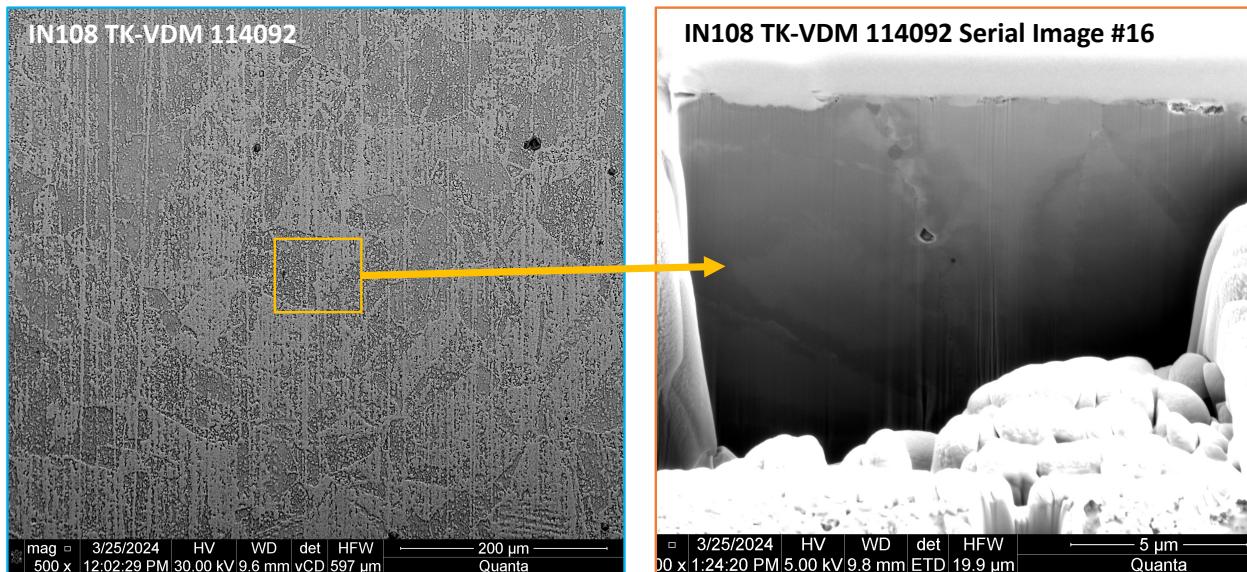
Figure 29. FIB trench cross-section image of a GB in IN108 showing worst-case cavity formation after 5.7 years.

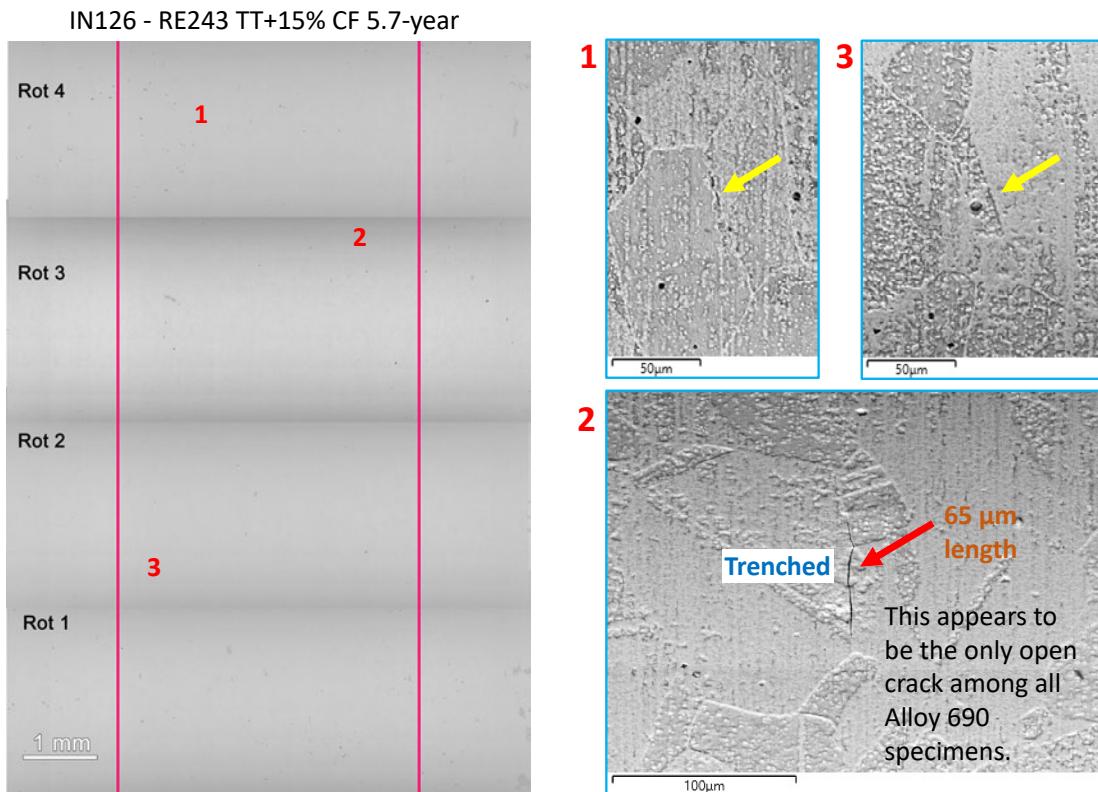
Figure 30. Gauge surface summary of IN126 which is heat R243. Three features of interest were observed with one appearing to be an obvious crack.

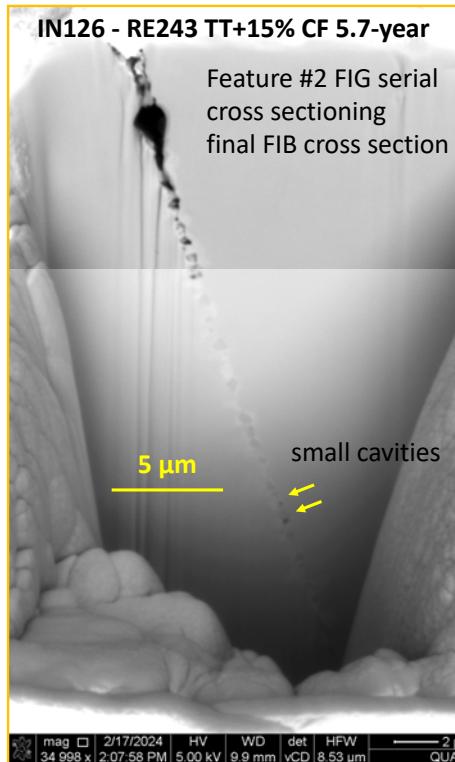
Figure 32. IN126 (RE243) feature #2 final cross-section showing cavities to a depth of >15 μm .

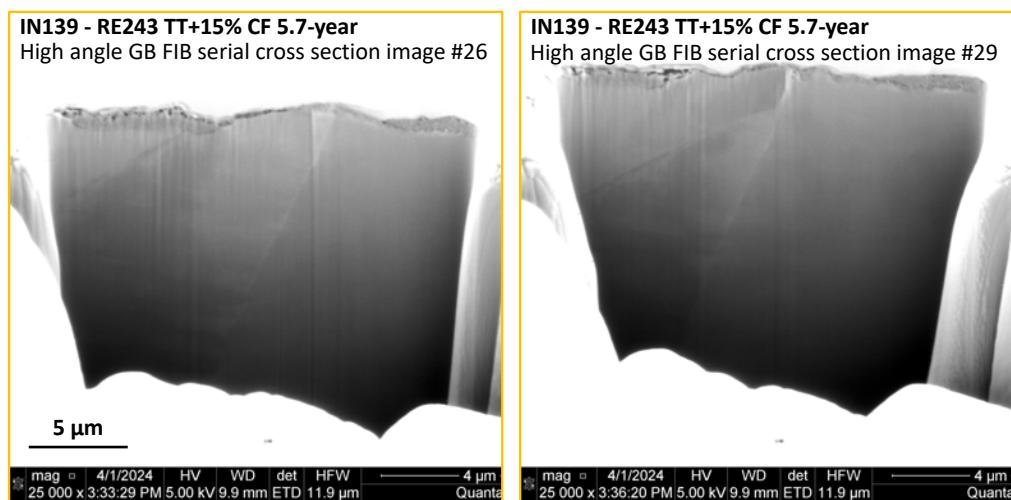
Figure 34. IN139 B25K-2 select FIB serial cross-section images of a high angle GB showing no carbides and no creep cavities.

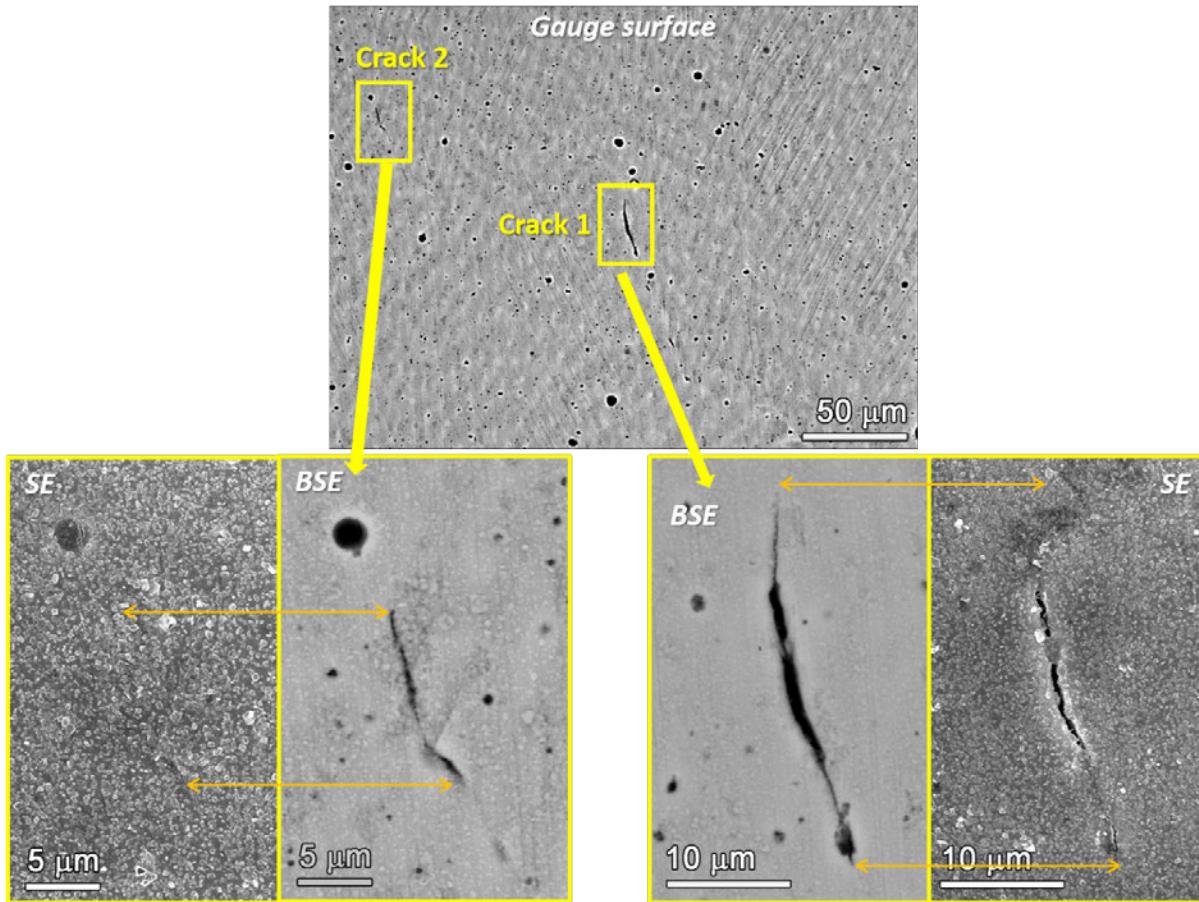
Figure 43. SEM-BSE/SE images of the two small cracks identified in the gauge surface of the 15% CF Alloy 152M IHI specimen IN128 after 20,659 hours of exposure.

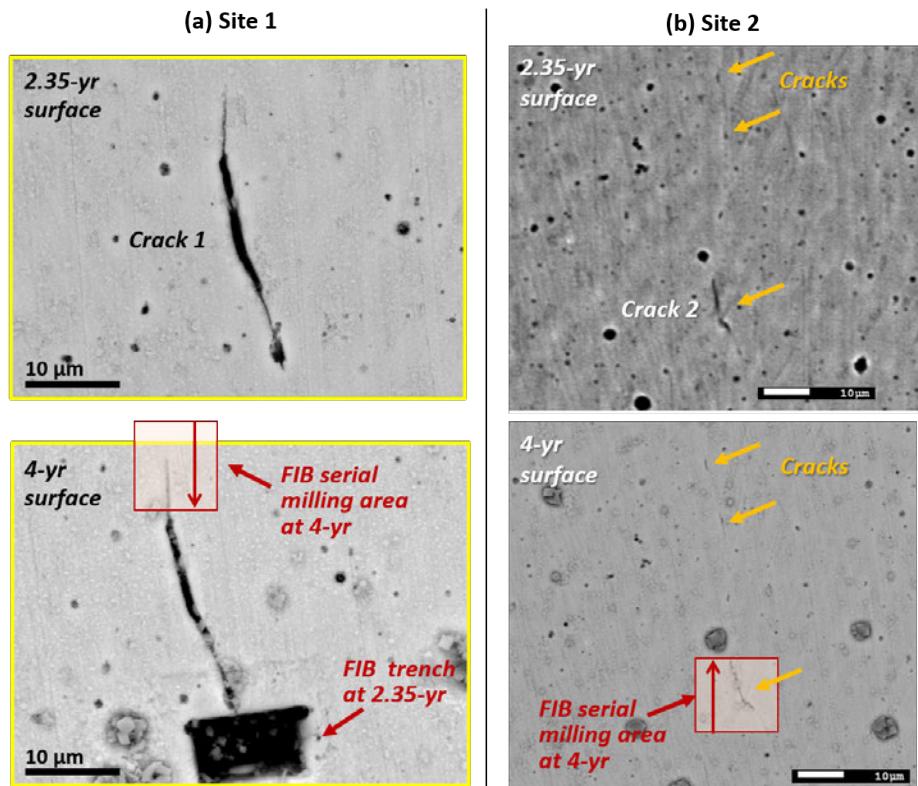
Figure 47. Comparison of the surface morphology of cracks observed at Sites 1 and 2 in IN128 after 2.4- and 4.0-year exposures.

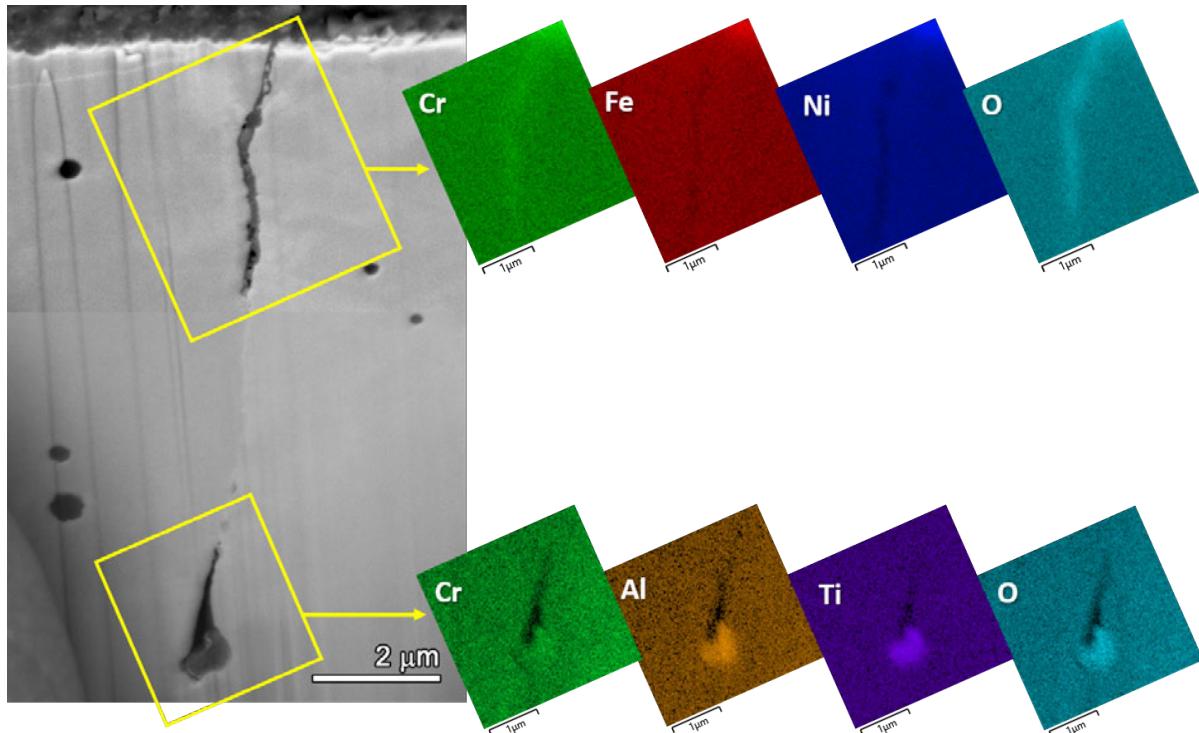
Figure 51. SEM-BSE image of the final milling face of the trench made on Crack 2 in IN128. Electron dispersive spectroscopy elemental maps also are shown for the short crack linking to the surface and the defect found below the crack on the same GB.

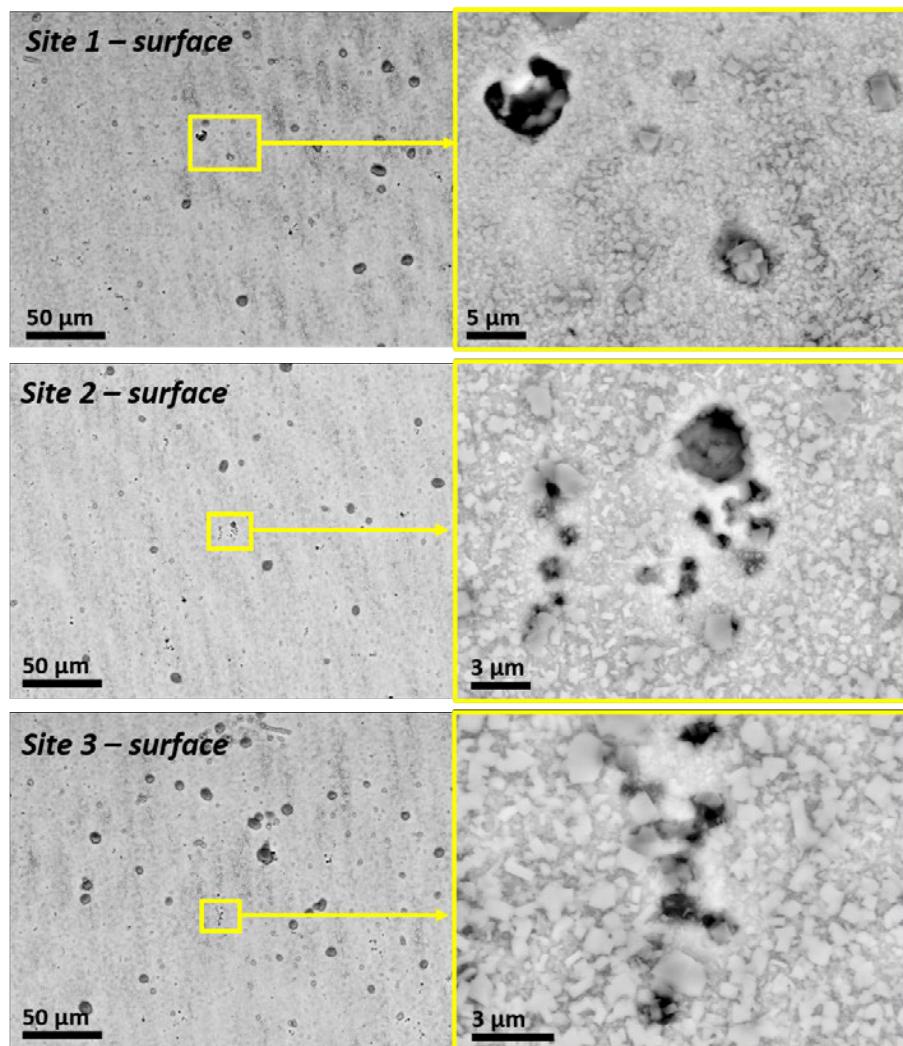
Figure 54. Higher magnification SEM-BSE images of the surface morphology at the three sites highlighted in Figure 53. Small pits/holes were observed at all three sites.

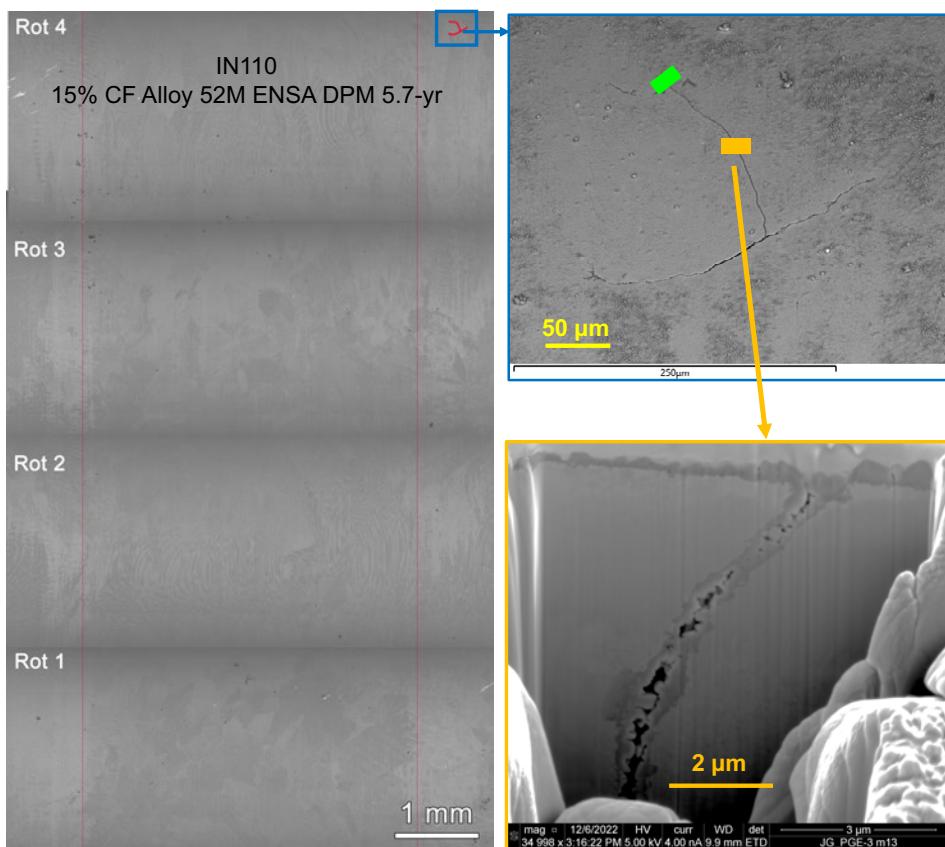
Figure 55. IN110 Alloy 52M ENSA DPM 5.7-yr FIB gauge surface and FIB trench. The morphology reveals that this was a preexisting weld fabrication crack.

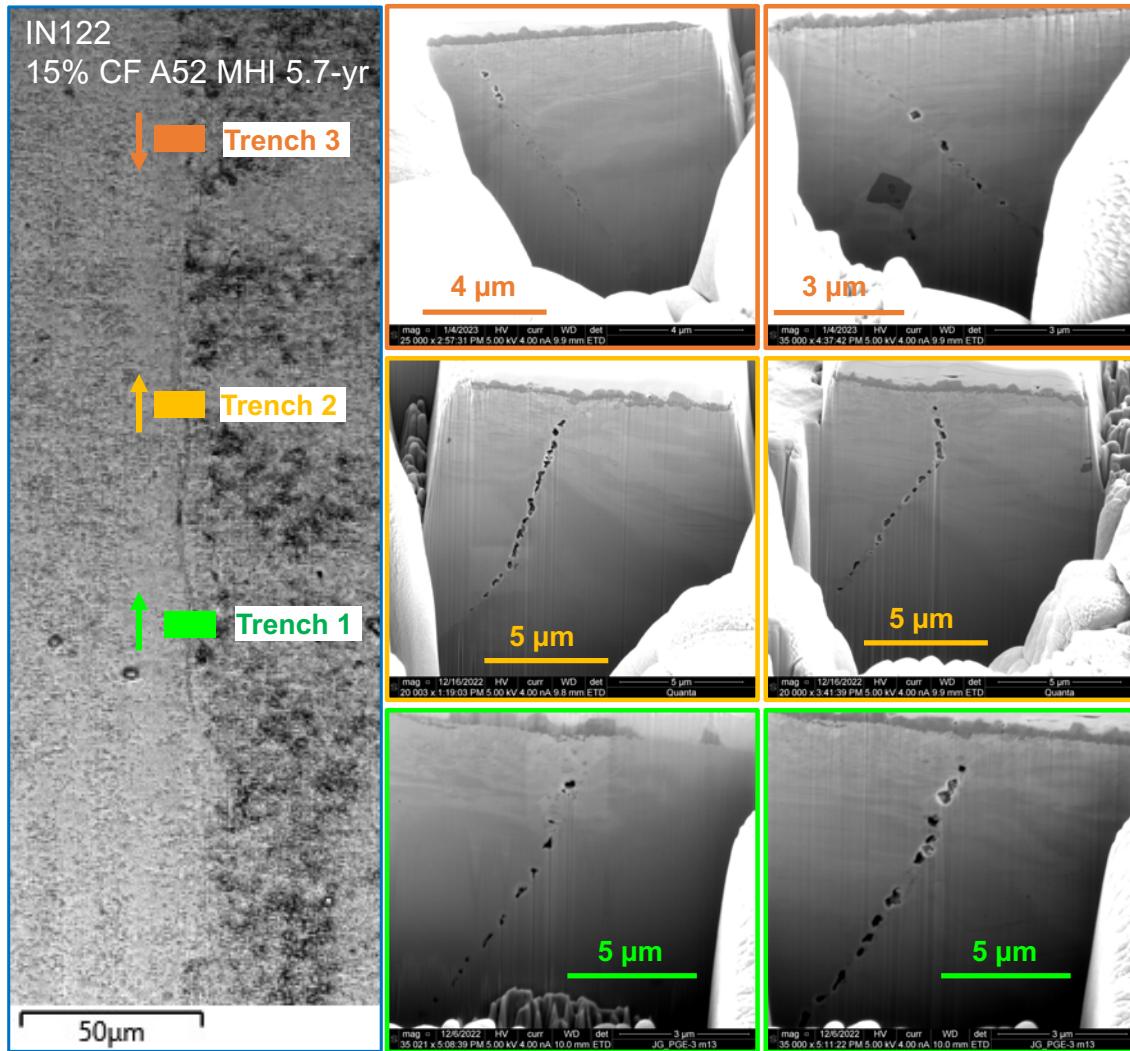
Figure 58. IN122 Alloy 52 MHI specimen showing FIB trench cross-sections of the only obvious crack in the specimen.

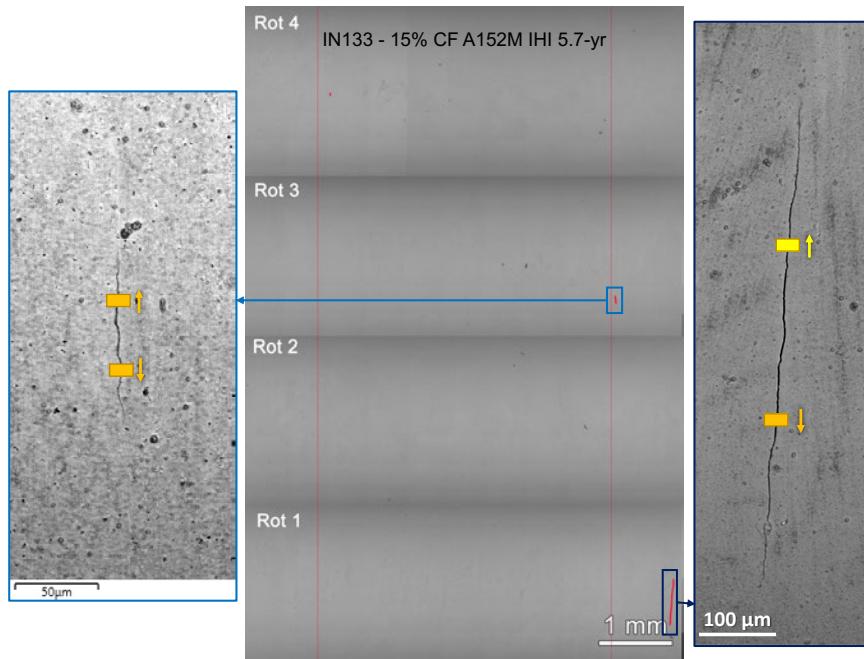
Figure 64. IN133 Alloy 152M IHI after 5.7 years showing the gauge surface montage and the location of two crack-like features.

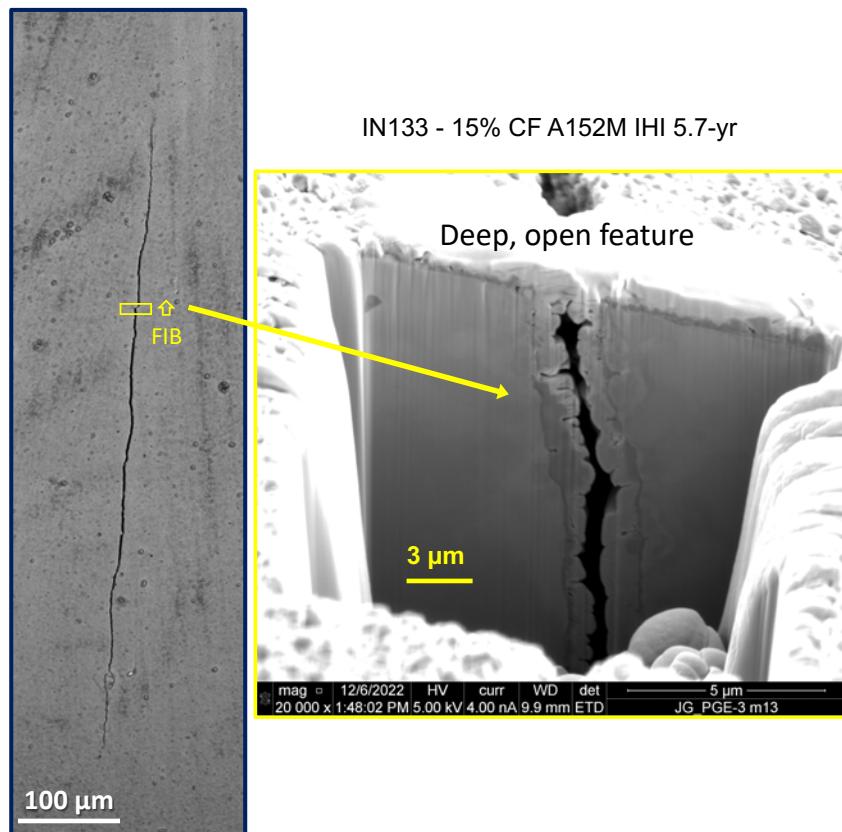
Figure 65. IN133 Alloy 152M IHI after 5.7 years showing the surface and FIB trench cross-section morphology of the larger crack-like feature.

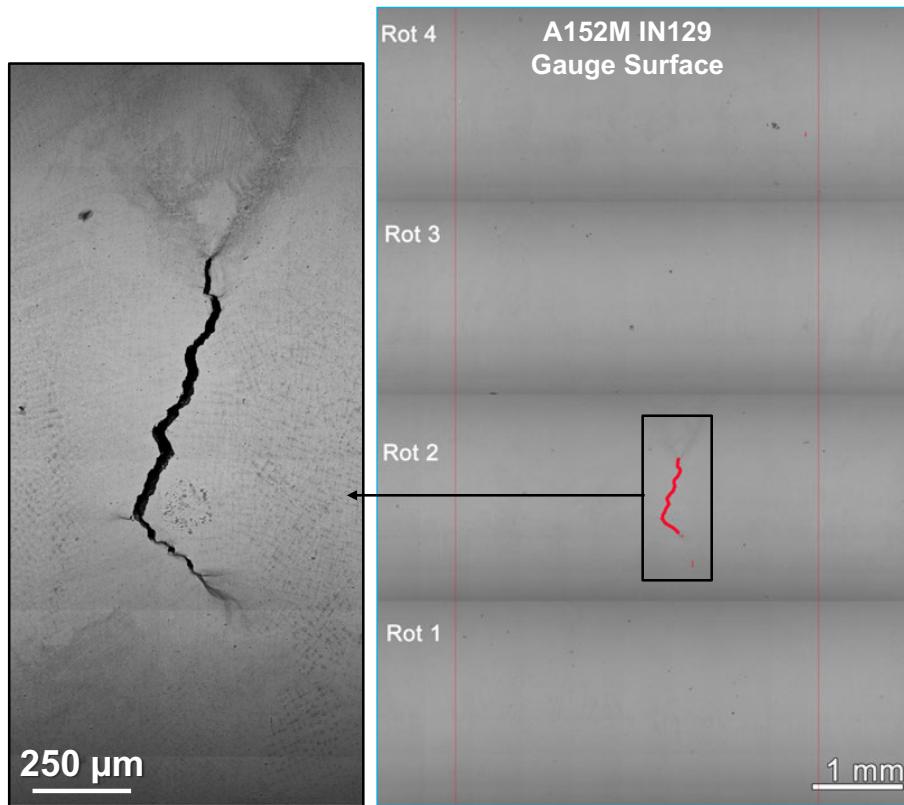
Figure 66. IN129 Alloy 152M IHI gauge surface montage and close-up of a single very large surface-breaking crack.

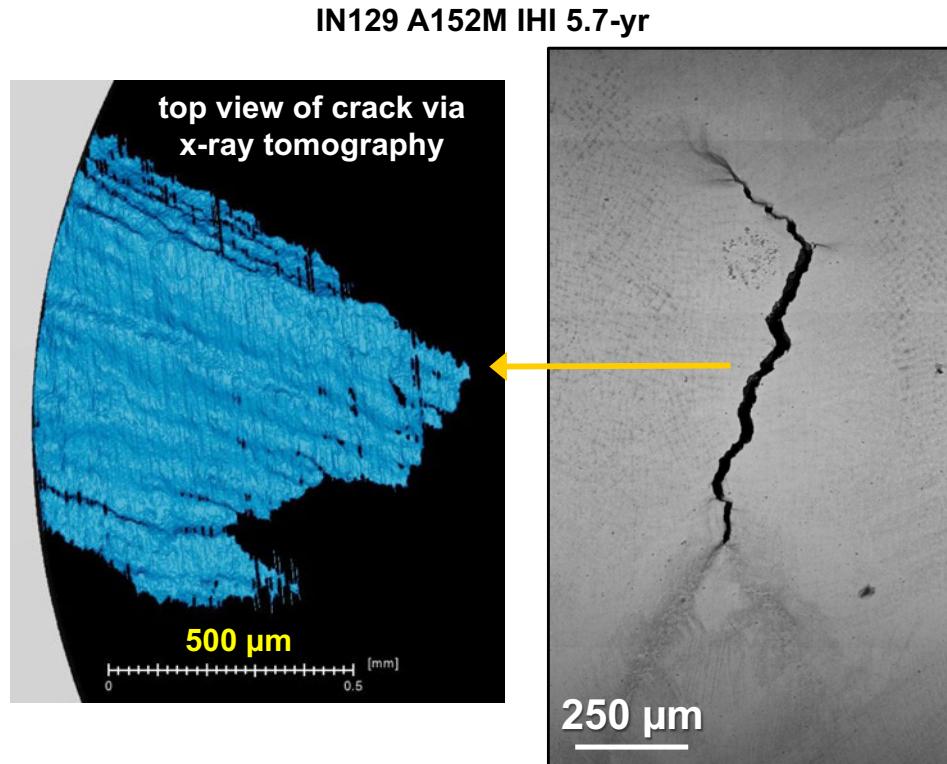
Figure 67. IN129 Alloy 152M IHI specimen showing very large crack after 5.7 years of SCCI testing.
