Document No.: 51-9394013-002

Palisades Steam Generator Operational Assessment for Cycle 29

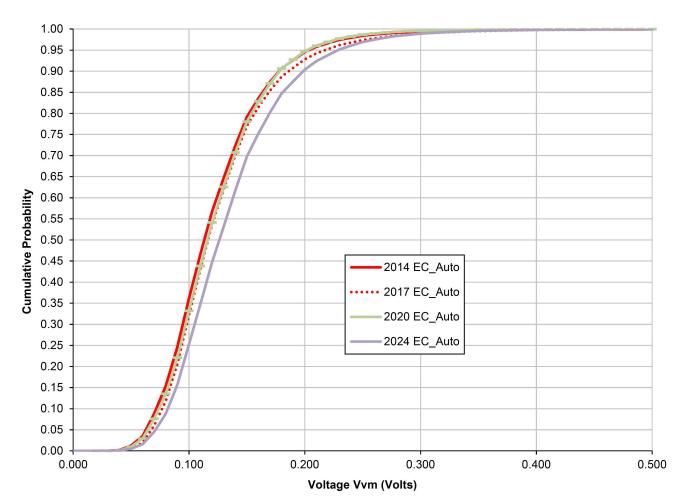
Figure 6-1: Eggcrate Bobbin Noise Comparison – 2014 through 2024 (Limiting SGs)

Review of the Palisades noise in 1D28 showed no significant change in noise has occurred since 1R21 providing the basis for the continued use of the POD assumptions used in previous and current Palisades operational assessments.

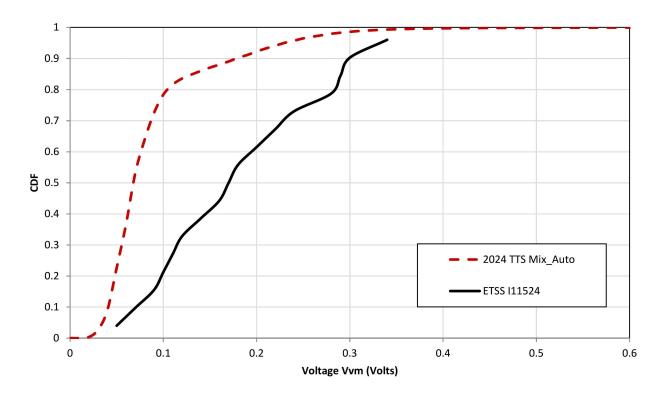
Figure 6-5: ETSS I11524 to 2020 TTS Noise Comparison (Limiting SG)

1R23 was the first outage at Palisades where ETSS I11524 (Appendix I technique for detection of circumferential PWSCC at TTS) was used, and as illustrated in Figure 6-5 the ETSS I11524 noise levels are bounding for the Palisades TTS noise measurements. Bobbin probe ETSS I-28413 is the principal detection technique for axial ODSCC in the tube freespan and supports (i.e. eggcrate and vertical strap) which can be adjusted using Palisades noise at each ROI to generate various POD distributions as is done in the Degradation Assessment which determined the bounding POD used in the operational assessment [8.a, Section 12.0 and Figure 12-3]. Including vertical strap noise into the comparison results in a POD which is still bounded by the POD used in the OA.

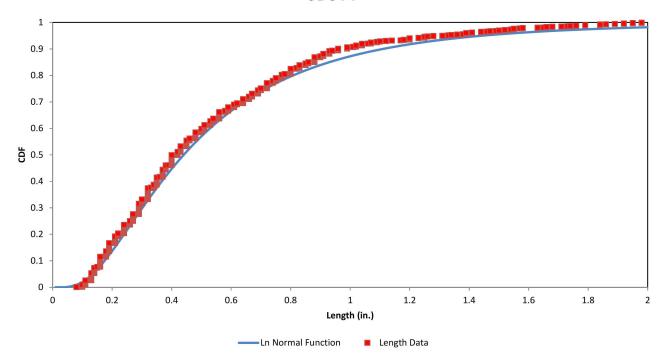
Figure 6-12: Initial Crack Length Distribution: Eggcrate, Vertical Strap, and Freespan Axial ODSCC

The distribution of eggcrate, vertical strap and freespan axial ODSCC lengths measured by NDE during 1D28 and previous Palisades outages along with the Ln normal function used in the model is provided in Figure 6-12. Because the +Point sizing technique tends to overestimate overall crack length, this distribution is a conservative bound of the actual crack length at the next outage (1R29). For this reason, no length growth is applied within the probabilistic evaluation. It is also noted that the eggcrate crack length is bounding for other axial ODSCC within the Palisades SGs (e.g., vertical strap or sludge pile cracks). The eggcrate / freespan crack lengths were modeled using a Ln-Normal distribution with a median of 0.44 and Ln-Normal standard deviation of 0.721.

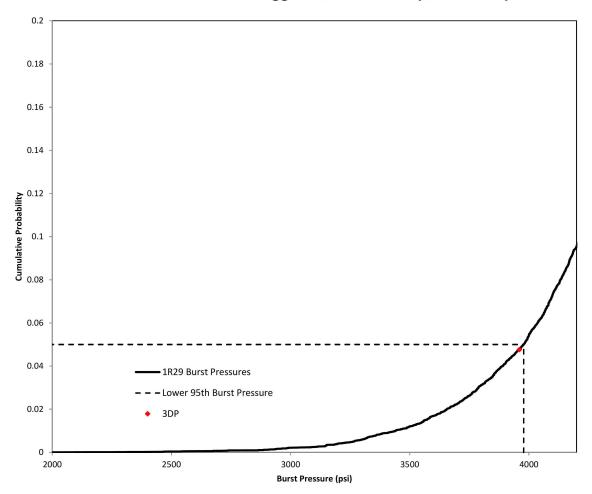
Figure 6-14: Burst Pressure Evaluation: Eggcrate, Vertical Strap, and Freespan Axial ODSCC

Palisades outages 1R20 through 1R29 were simulated 50,000 times while benchmarking the detected eggcrate, vertical strap and freespan axial ODSCC indication history. The resulting distribution of 1R29 worst case degraded tube burst pressures is shown in Figure 6-14. As specified in [2.a], acceptable OA structural integrity is demonstrated if the lower 95th percentile value of this distribution meets or exceeds the SIPC limit of 3960 psi. For the Palisades eggcrate, freespan and axial ODSCC, the lower 95th percentile of worst case burst pressure projected for 1D28 is 3978 psi; therefore, operational assessment structural integrity is projected with margin. The corresponding projected upper 95th percentile leak rate at SLB conditions is zero.

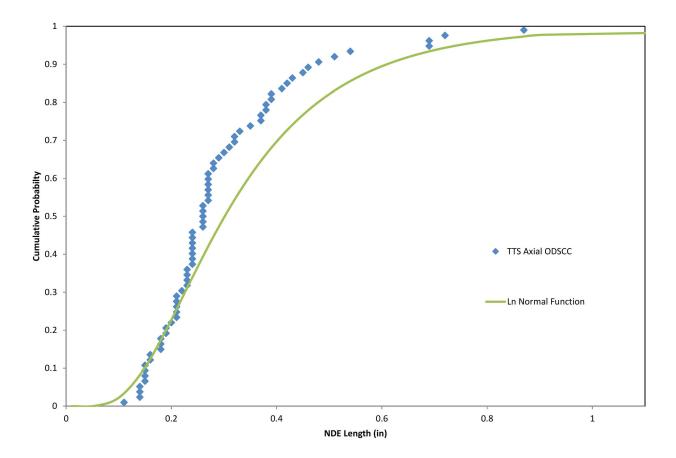
Figure 6-16: Top of Tubesheet Axial ODSCC Lengths (Includes 1D28)

The distribution of TTS axial ODSCC lengths as measured by NDE during 1D28 and previous Palisades outages is provided in Figure 6-16 Because the +Point sizing technique tends to overestimate overall crack length, this distribution is a conservative bound of the actual crack length at the final outage (1D28). For this reason, no length growth is applied within the probabilistic evaluation. The input parameters are provided in Table 6-8 and Table 6-9.

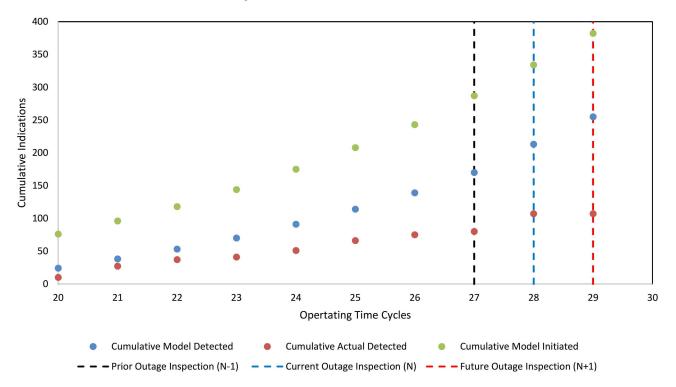
Figure 6-17: Model Indications and Detections vs. Actual Detections:

Figure 6-17 illustrates that the Weibull function used to model TTS axial ODSCC indications conservatively represents the actual detection history for this degradation mechanism on a cumulative indication basis. This is shown by the cumulative model detected data bounding the cumulative actual detected (flaws found in inspection).

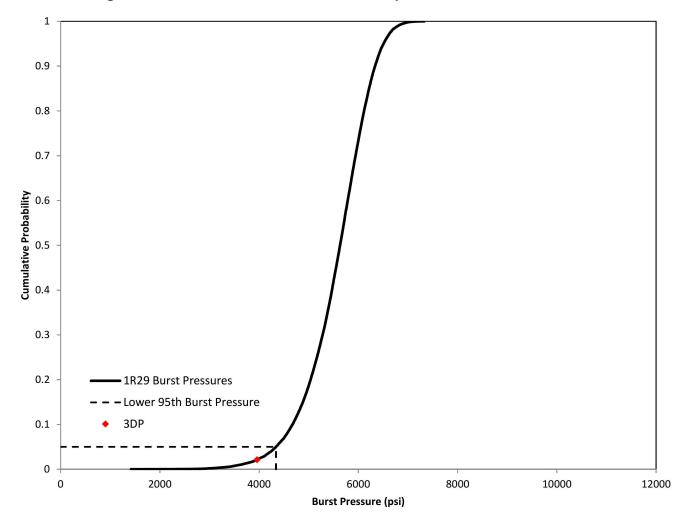
Figure 6-19: Burst Pressure Evaluation: Top of Tubesheet Axial ODSCC

The resulting distribution of 1R29 worst case degraded tube burst pressures is shown in Figure 6-19. The lower 95th percentile of worst case burst pressure projected for EOC29 is 4340 psi; therefore, operational assessment structural integrity is projected with ample margin above the SIPC limit of 3960 psi. The corresponding projected upper 95th percentile leak rate at SLB conditions is zero.

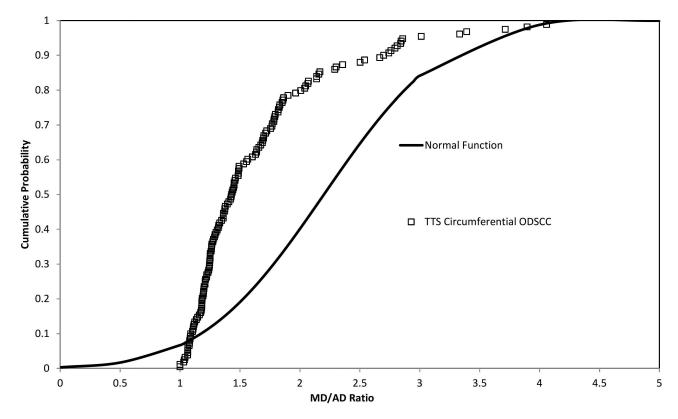
Figure 6-22: TTS Circumferential ODSCC MD/AD Ratio

The characteristic ratio of maximum depth to average depth for circumferential TTS cracks was evaluated based on the results of the last seven inspections including 1D28. 1D28 MD/AD data calculated an average of 1.67 with a standard deviation of 0.78. To conservatively bound all MD/AD ratios found for Circumferential TTS ODSCC this parameter was modeled as a normal distribution with a mean of 2.2 and a standard deviation of 0.8 as shown in Figure 6-22.

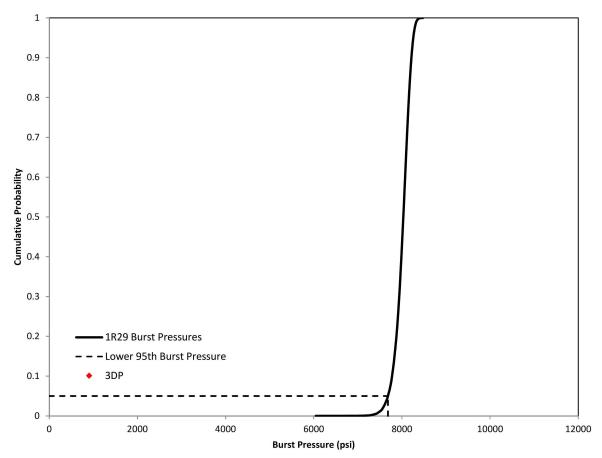
Figure 6-25: Burst Pressure Evaluation: Circumferential TTS ODSCC

Note: The lowest predicted burst pressure plotted was higher than the SIPC limit (3DP) of 3960 therefore the SIPC limit data point (red diamond) is not shown on Figure 6-25
