Subject: Response to Request for Additional Information by the Office of Nuclear Reactor Regulation to support Review of TMI-1/ Crane (Cycle 22) Steam Generator Inspection Report

TMI-1/CRANE (CYCLE 22) STEAM GENERATOR INSPECTION REPORT

Condition Monitoring and Operational Assessment of TMI-1 Steam Generators 2024 Inspection

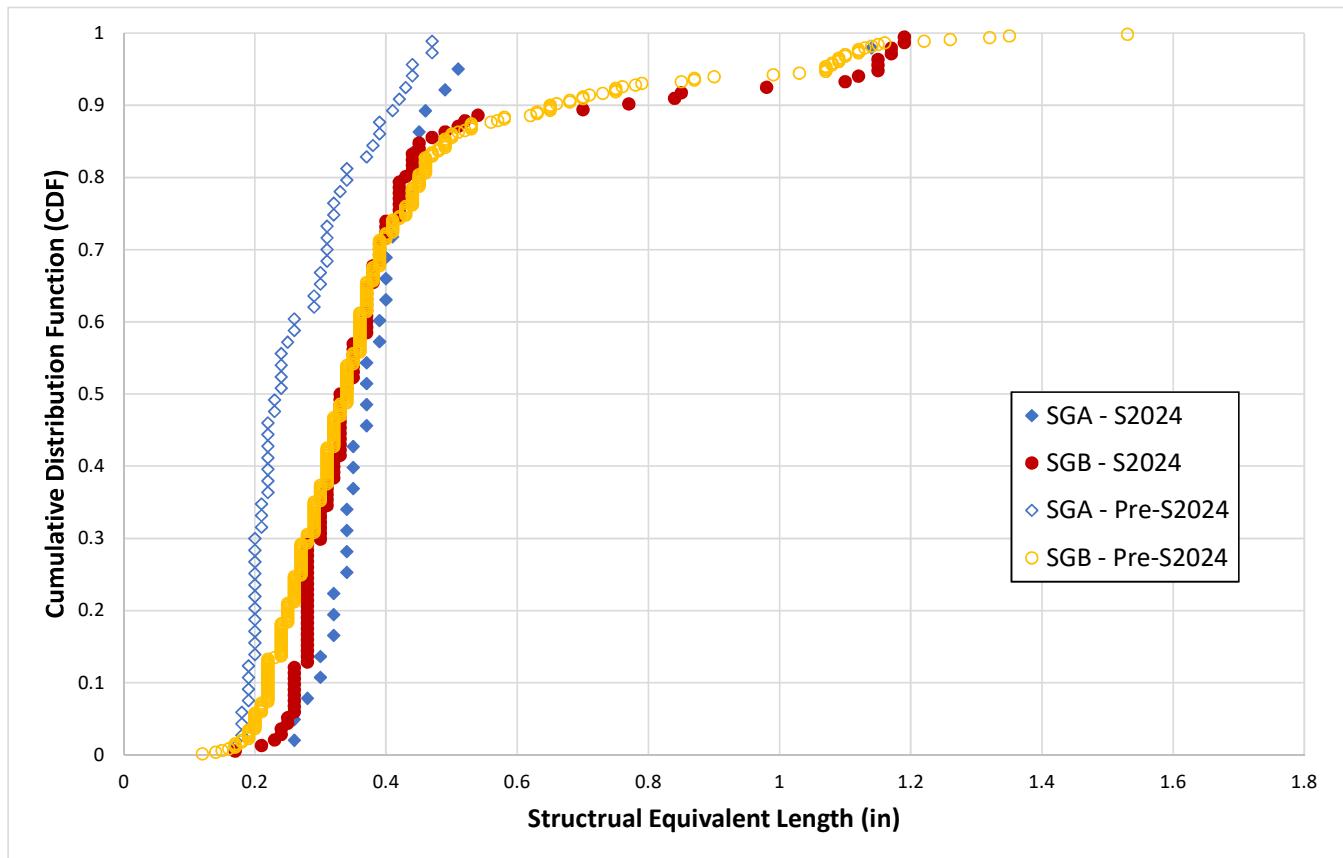
Figure 4-3: TMI Distribution of Structural Lengths – Both SGs

TSP wear flaws greater than or equal to 30% through wall depth (TWD), measured with the bobbin probe, were structurally profiled to establish the number of flat vs. tapered wear flaws and to determine if wear was occurring on multiple lands. The majority of the broached TSP wear indications had tapered flaw shapes, with the largest growth from a repeat indication also tapered. The deepest single flaw, SG B, R4-T1 at 12S, had a distinctly tapered profile resulting in a maximum depth of 45% TW and structurally equivalent depth of 38.7% as sized with Array. The figure below (Figure 4-3 taken from the 2024 CMOA) shows a distribution of structural lengths for the deepest flaws for both SGs. The population is tightly grouped up to approximately 0.5" in length, indicative of tapered wear, with flaws greater than 0.5" in length being flat or nearly flat.

It is noted that the flaws with the largest growth in 1R22 (2017) and largest depth from Array had tapered flaws (Tubes R5-T11 at 11S, R5-T14 at 11S, and R17-T74 at 11S). The largest new flaw and largest depth from bobbin in 1R22 (2017) were flat (Tubes R105-T3 at 14S and Tube R105-C4 at 15S).

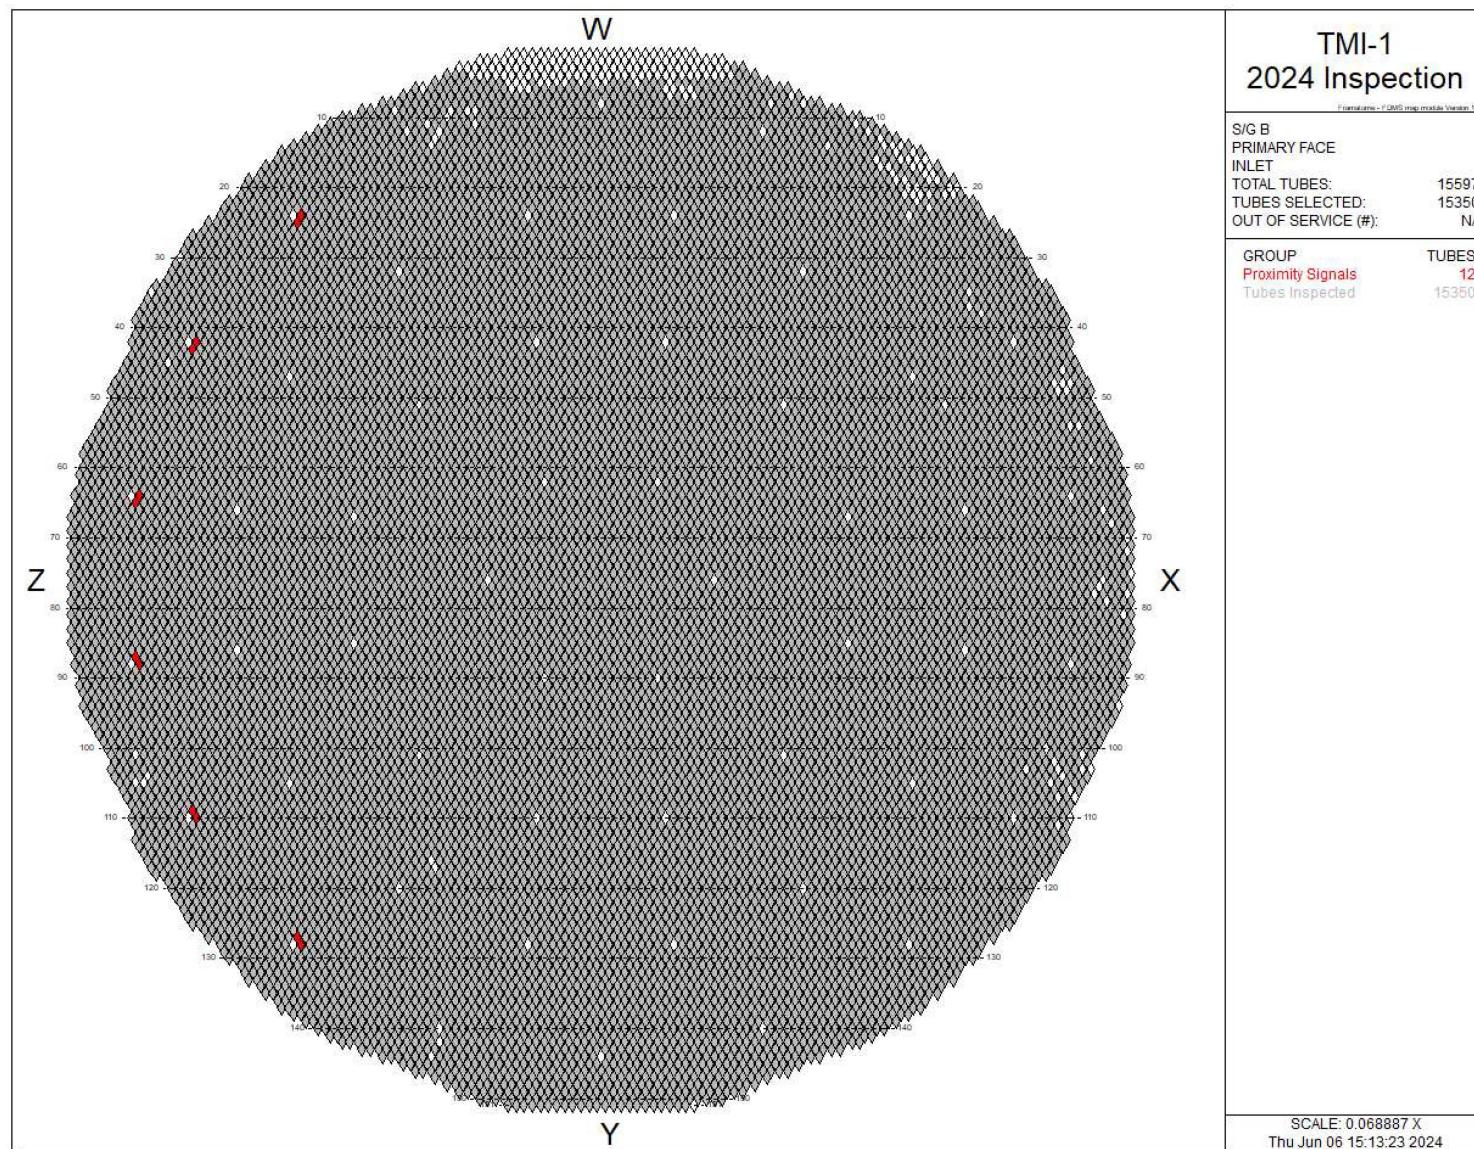
Figure 4-21: Tie Rod Proximity Indications in SG B

Twelve tubes in SG B were identified as having proximity signals adjacent to tie rod locations (PTR). The locations are shown in Figure 4-21. No tubes in SG A exhibited proximity signals of any kind.

CR 2024-1630 was initiated to document the identification of Tie Rod Bowing. This is discussed fully in section [4.1.5]. The overall conclusion is that it is not unreasonable for tie rod bowing to occur at TMI-1 and that the magnitude of the tie rod bowing at TMI-1 is not expected to result in tie rod to tube contact over the projected 1-cycle of operation assuming 2 cooldowns per cycle. Similar to ANO-1, tie rod bowing is expected to be managed by regular inspection intervals as determined by an operational assessment.

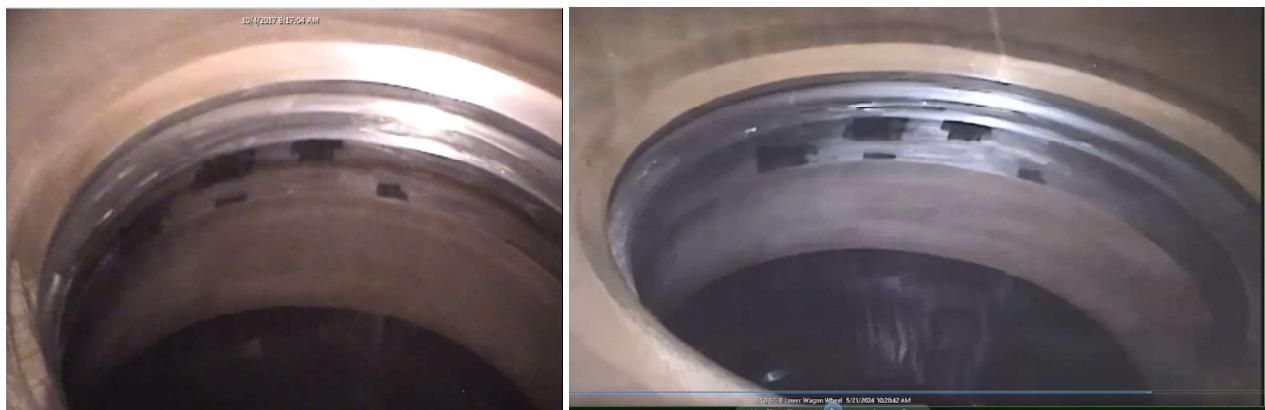
Figure 4-26: CR 2024-1333: SG B Cold Leg Nozzle Blemishes as seen in 2017 (l) and 2024 (r)

In the course of as-found examinations, three relevant condition reports (CRs) were initiated in response to conditions identified, CR 2024-1333, CR 2024-1448, and CR-2024-1630. Additionally, three CRs were initiated related to issues with threaded fasteners as listed in Table 4-11 for tracking purposes.

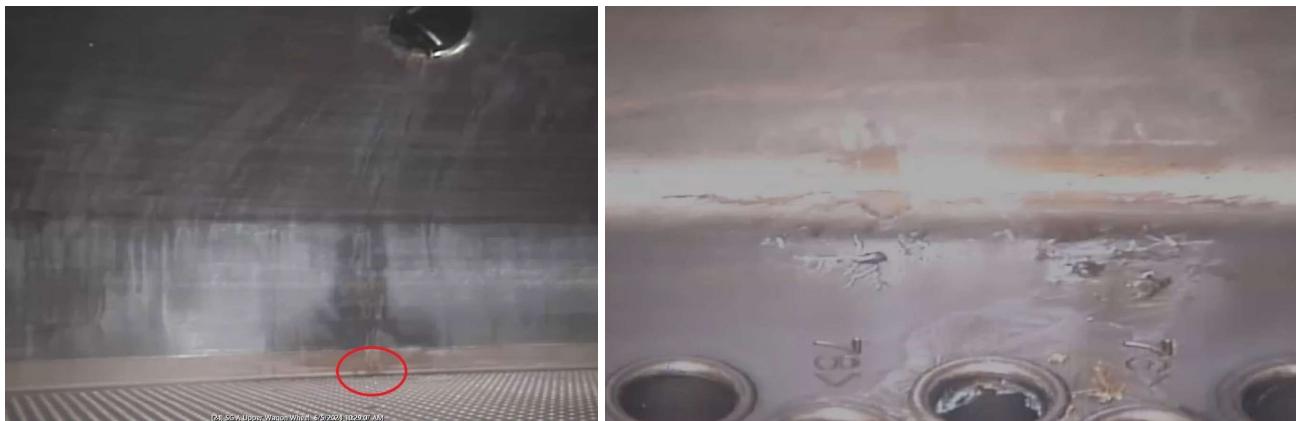
Figure 4-27: CR 2024-1448: Suspect Foreign Material in SG A Upper Head

While performing a preliminary review of the TTS on the Upper Channel head of SG A, in the region below the Primary Handhole (also referred to as Inspection Port) a localized area of discoloration was seen. The localized discoloration started from the handhole along the ID of the channel head and down onto the tubesheet (~R60-90T1-10). Near R78 T01 and R76 T01 along the periphery region of the tubesheet a more localized anomaly was visible, covering an area of approx. 1" long x 2" wide. Based on the actions prescribed in the CR (i.e., scraping the area with a putty knife blade on a pole) the material on the tubesheet was identified as boron and condensation that dripped down from the primary handhole. No further actions are required based on the action taken. See Figure 4-27.

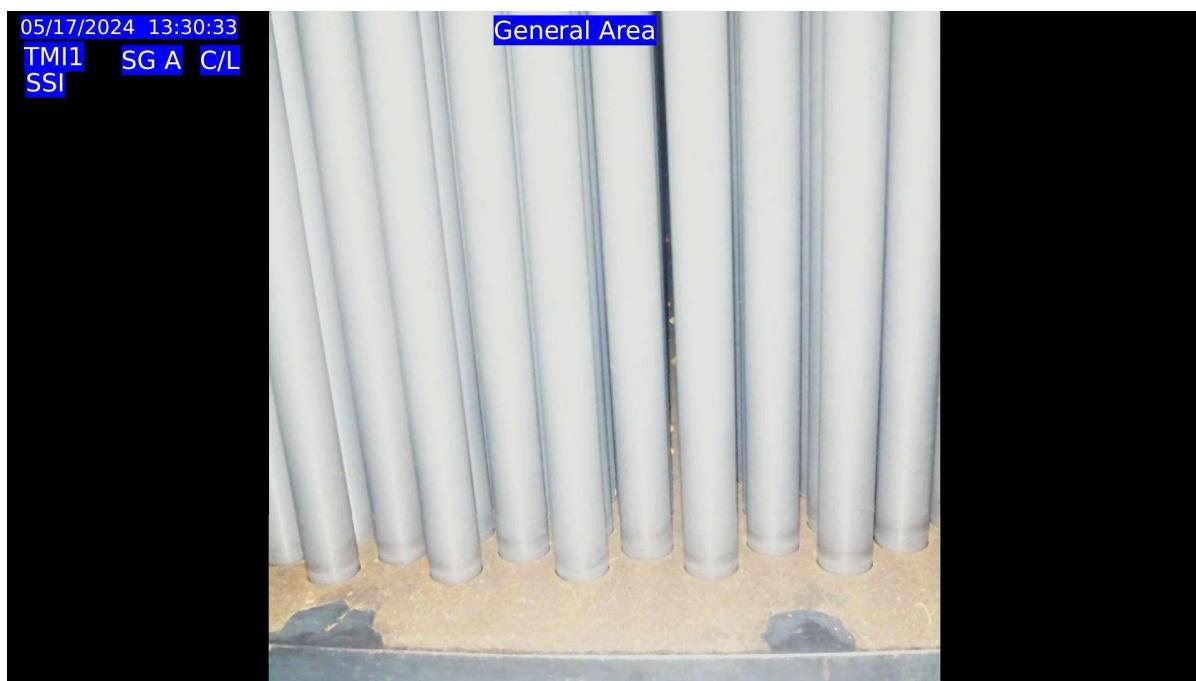
Figure 6-1: TMI-1 SG A Secondary Side As-Found View

In response to the extended shutdown with a lack of a managed layup on the secondary side, visual inspections were performed in the secondary side of both SGs [29, 33]. This was the first time since the preservice inspection that the secondary side of these SGs was inspected.
