Subject: IWB-3142.4 Analytical Evaluation Performed to Accept ASME Section XI Code  
Case N-885 Identified Hard Facing Indications

Enclosure: Core Barrel Upper Core Plate Alignment Keys Analytical Evaluation of H1R26 Hard Facing Indications

**Core Barrel Upper Core Plate Alignment Keys Analytical Evaluation of H1R26 Hard  
Facing Indications**

**Shearon Harris Nuclear Power Plant, Unit 1**

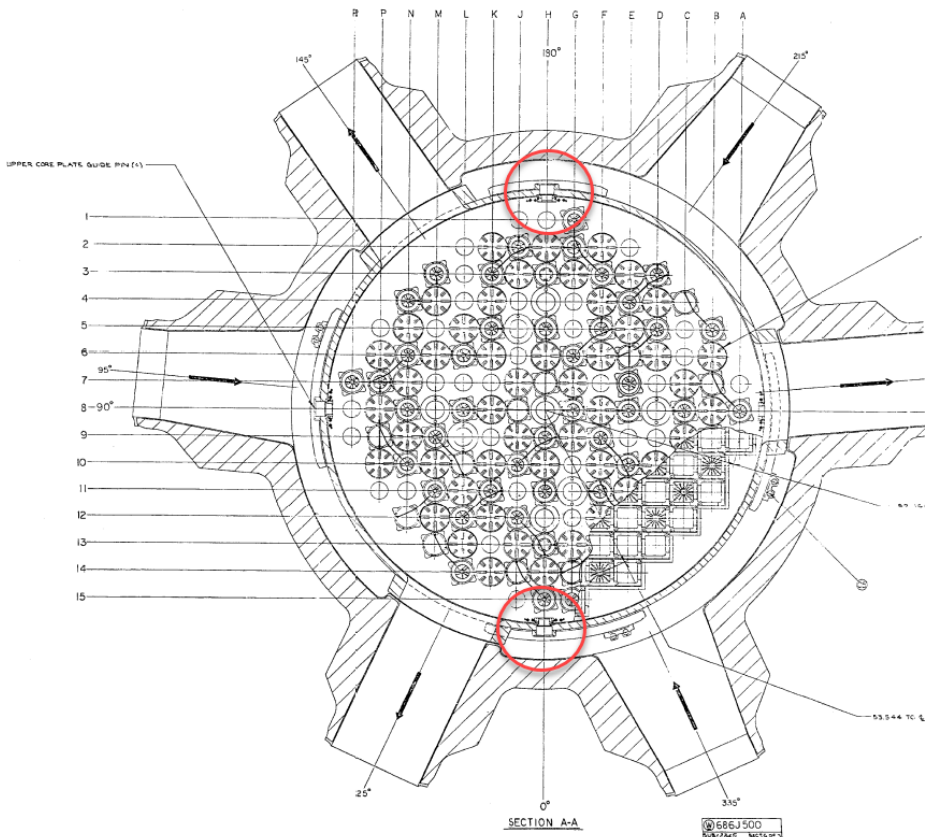
The UCP Alignment Pins referenced in this AR are identified by their azimuthal location. A map of the affected UCP alignment pins is shown below for reference.

As stated in INR-H1R26-01, the specific indications identified during the VT-3 visual examinations of the UCP alignment pins were three indications on the left side of the 0-degree key, one indication on the right side of the 0-degree key, and one indication on the right side of the 180-degree key. Below are noteworthy observations of the indications described in INR-H1R26-01:

- All indications may be characterized as “perpendicular” to the axis of the UCP alignment pin hard facing, are oriented horizontally (parallel to each other), and do not change direction.
- All indications are bound within the Stellite material and do not propagate into the base material.
