Robert F. Saunders
Vice President - Nuclear Site Operations

SUSQUEHANNA STEAM ELECTRIC STATION
LICENSEE EVENT REPORT 50-387/99-006-00
PLA - 5122 FILE R41-2

TITLE (4)
 'C' And 'D' ESW Pumps Inoperable Greater Than 7 Days Due To Interaction With 'A' And 'B' Pumps

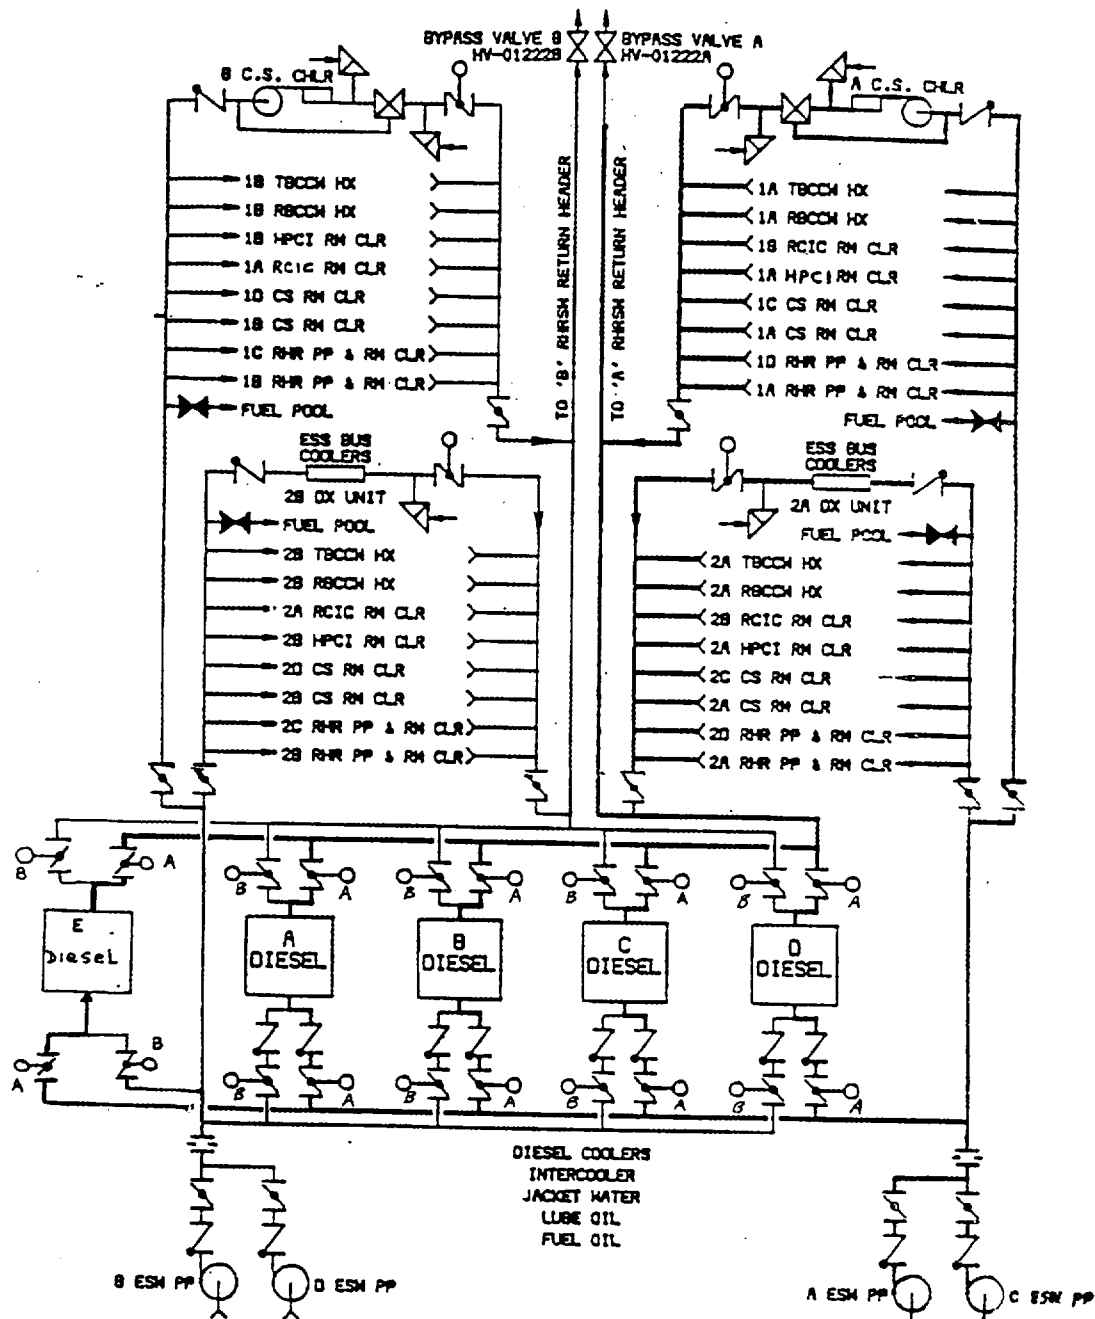
FIGURE 1
EMERGENCY SERVICE WATER

The ESW system is designed to take water from the spray pond, pump it to various heat exchangers and return the water to the spray pond by way of a network of sprays that dissipate the heat to the atmosphere. The system consists of two loops with two pumps per loop. The system is designed to supply 100 percent of the ESW cooling flow to the required heat exchangers in both Units and to the common Diesel Generators during design basis accidents. See Figure 1.

To better understand the condition of the 'C' and 'D' pumps, a quarterly flow In-Service Test (IST) was performed on August 27, 1999 to assess the performance of the individual pumps. The purpose of the IST is to trend a pump's individual performance by monitoring discharge pressure while operating within a predetermined flow range. Each ESW pump was tested at a flow range of 5500 gpm to 5700 gpm while the system is aligned for normal power operations. System alignment for normal power operations included the following loads for each ESW loop respectively (See Figure 1):
