LICENSEE EVENT REPORT (LER)

Susquehanna Steam Electric Station - Unit 1

Loss Of Both Loops Of Residual Heat Removal - Low Pressure Coolant Injection

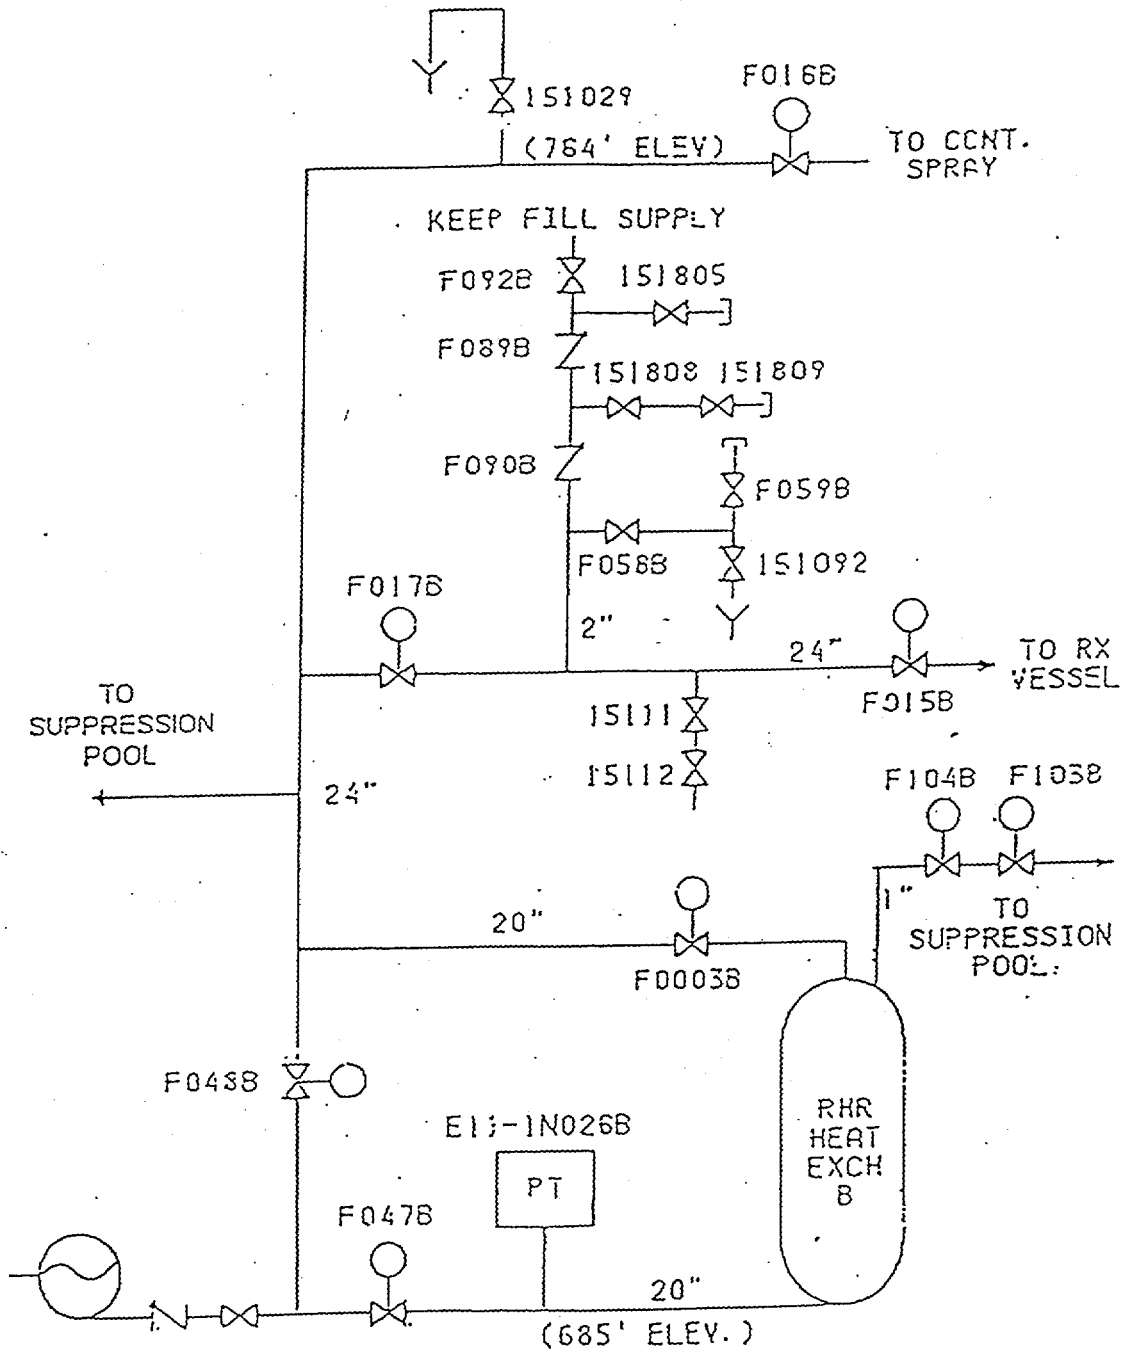
FIGURE 1

A schematic diagram of the applicable portion of the Unit 1 'B' Loop of RHR is provided as the last page of this LER. ECCS systems at Susquehanna SES are continuously supplied with condensate water at approximately 150 psig by a Condensate Transfer system. This "keep-fill" system assures that the ECCS discharge lines are full of water thereby ensuring that the ECCS will perform properly by injecting its full capacity into the Reactor Coolant system upon demand. This system also prevents water hammer following an ECCS initiation signal. Due to this design, the RHR discharge piping is pressurized to approximately 150 psig. For the Unit 1 B Loop of RHR this pressure is measured at a pressure instrument located at the RHR heat exchanger. (PT E11-1N026B on the diagram.) Pressure is continuously displayed in the control room.

The automatic RHR LPCI injection valve (F015) is normally closed. The RHR LPCI throttle valve (F017) is normally open. The Condensate Transfer system taps into the RHR system between the normally closed F015 valve and the normally open F017 valve. The piping system that contains the F015 valve and F017 valve is the injection flow path for RHR LPCI and the return path for RHR Shutdown Cooling.
