**LICENSEE EVENT REPORT (LER)**

Susquehanna Steam Electric Station - Unit 1

Loss Of Both Loops Of Residual Heat Removal - Low Pressure Coolant Injection

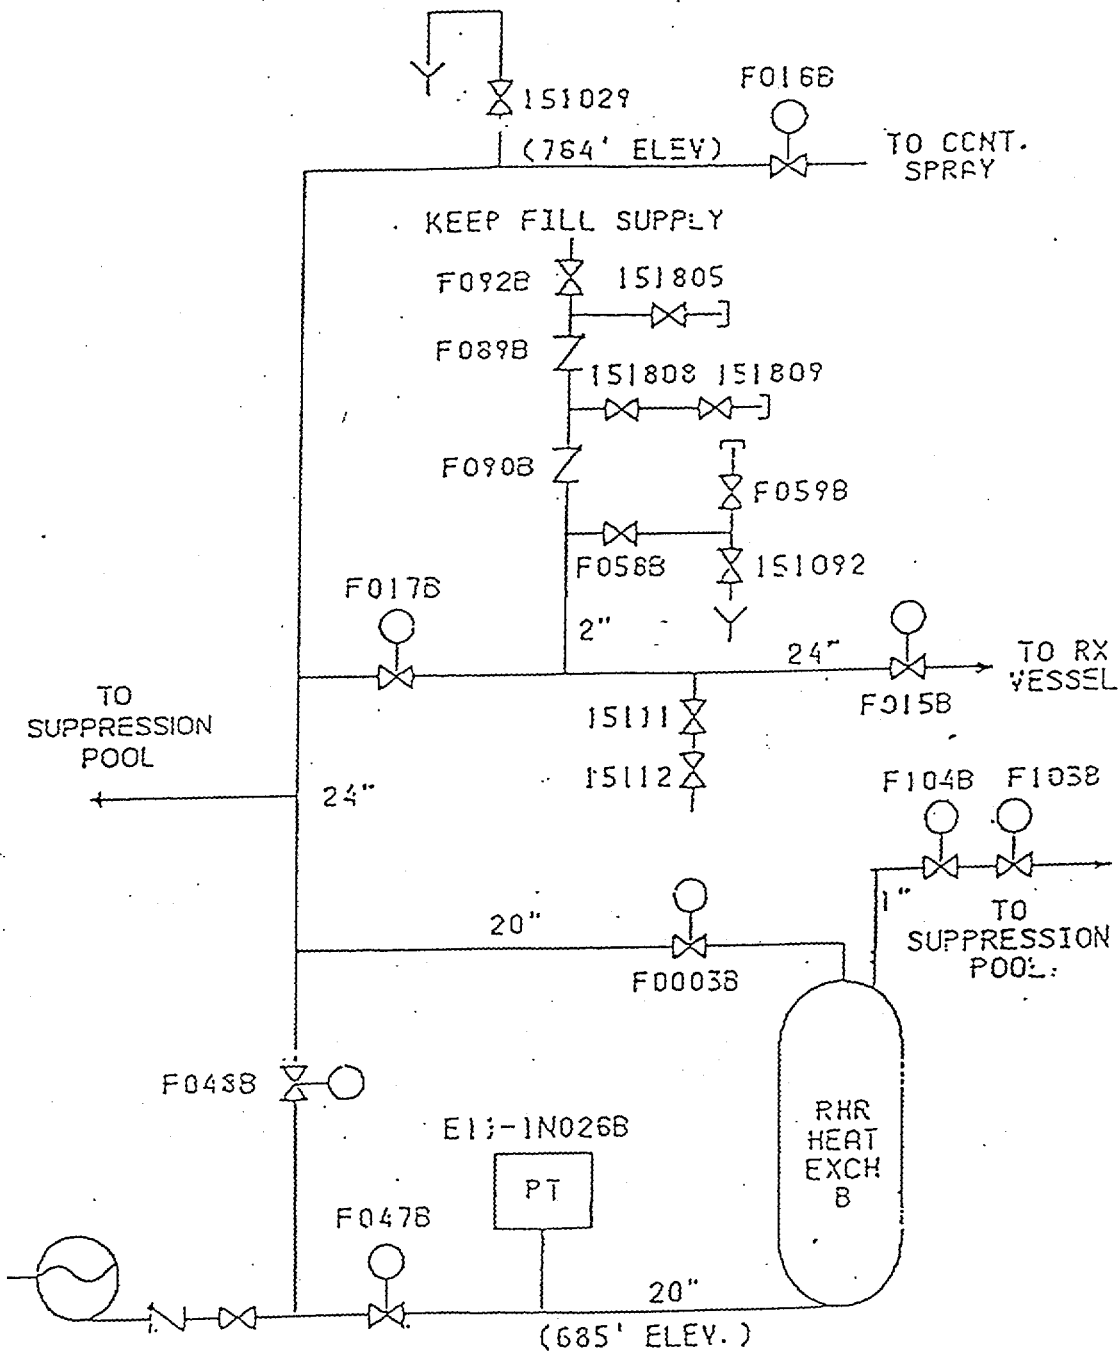
FIGURE 1

A schematic diagram of the applicable portion of the Unit 1 'B' Loop of RHR is provided as the last page of this LER. ECCS systems at Susquehanna SES are continuously supplied with condensate water at approximately 150 psig by a Condensate Transfer system. This "keep-fill" system assures that the ECCS discharge lines are full of water thereby ensuring that the ECCS will perform properly by injecting its full capacity into the Reactor Coolant system upon demand. This system also prevents water hammer following an ECCS initiation signal. Due to this design, the RHR discharge piping is pressurized to approximately 150 psig. For the Unit 1 B Loop of RHR this pressure is measured at a pressure instrument located at the RHR heat exchanger. (PT E11-1N026B on the diagram.) Pressure is continuously displayed in the control room.

The automatic RHR LPCI injection valve (F015) is normally closed. The RHR LPCI throttle valve (F017) is normally open. The Condensate Transfer system taps into the RHR system between the normally closed F015 valve and the normally open F017 valve. The piping system that contains the F015 valve and F017 valve is the injection flow path for RHR LPCI and the return path for RHR Shutdown Cooling.
