**Florida  
Power**

CORPORATION  
Crystal River Unit 3  
Docket No. 50-302  
Operating License No. DPR-72

November 5, 1999  
3F1199-03

Subject: Crystal River Unit 3 - Special Report 99-03: Once Through Steam Generator (OTSG) Notifications Required Prior to MODE 4 and Results of OTSG Tube Inspections that Fall into Category C-3

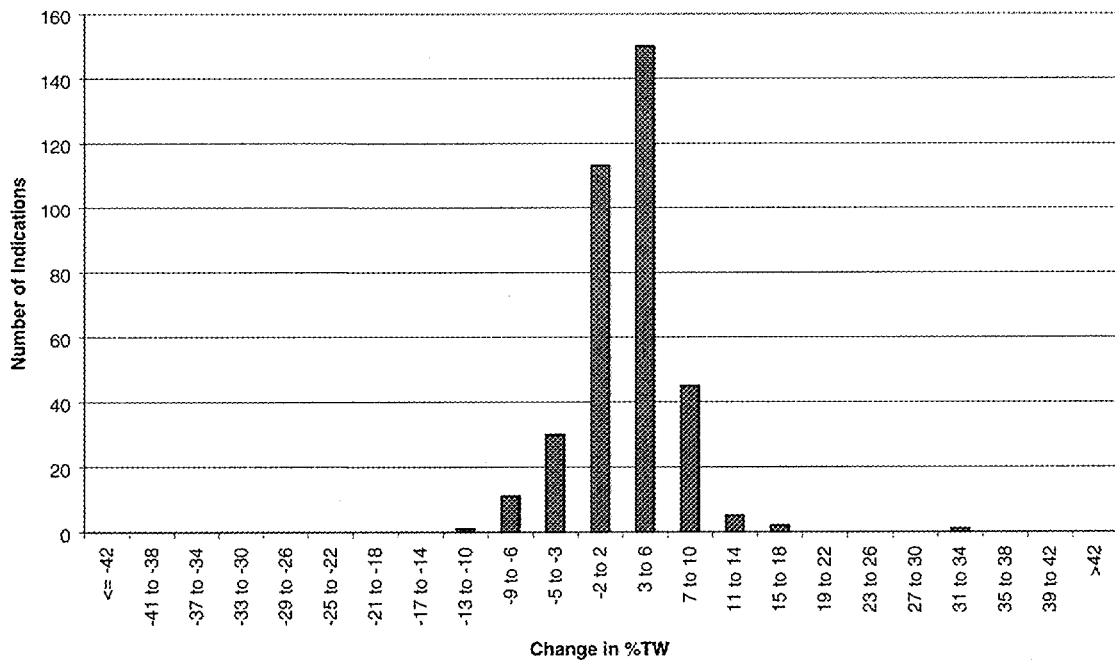
**Figure 1: 1999 to 1997 IGA Percent Through-wall**

In 1999, CR-3 examined apparent growth of the first span pit-like intergranular attack (IGA) indications in OTSG-B. The regression technique indicated percent through-wall (TW) for 1999 was compared to the regression technique indicated percent TW from the 1997 inspection. All regression data was obtained using a high frequency bobbin probe. Figure 1 below provides a graphical presentation of this comparison.

The growth of first span pit-like IGA in OTSG-B continues to be essentially zero with the majority of indications exhibiting a - 2% to + 6% change in indicated percent TW. The slightly positive increase in indicated percent through-wall is within the accuracy of the measurement technique used to establish the percent TW depth of the indications.

Nine (9) first span IGA tubes were plugged in OTSG-B due to an assigned percent through-wall of  $\geq 40\%$ . Eight (8) first span IGA tubes, which had percent through-wall penetrations of  $< 40\%$ , were conservatively plugged in OTSG-B due to an estimated increase in growth of greater than 10% since the last inspection. Twenty (20) first span IGA tubes were plugged due to a lack of historical data for the indications and four (4) tubes were conservatively plugged due to the presence of multiple IGA indications. A total of 157 tubes containing first span IGA indications remain in service in OTSG-B.

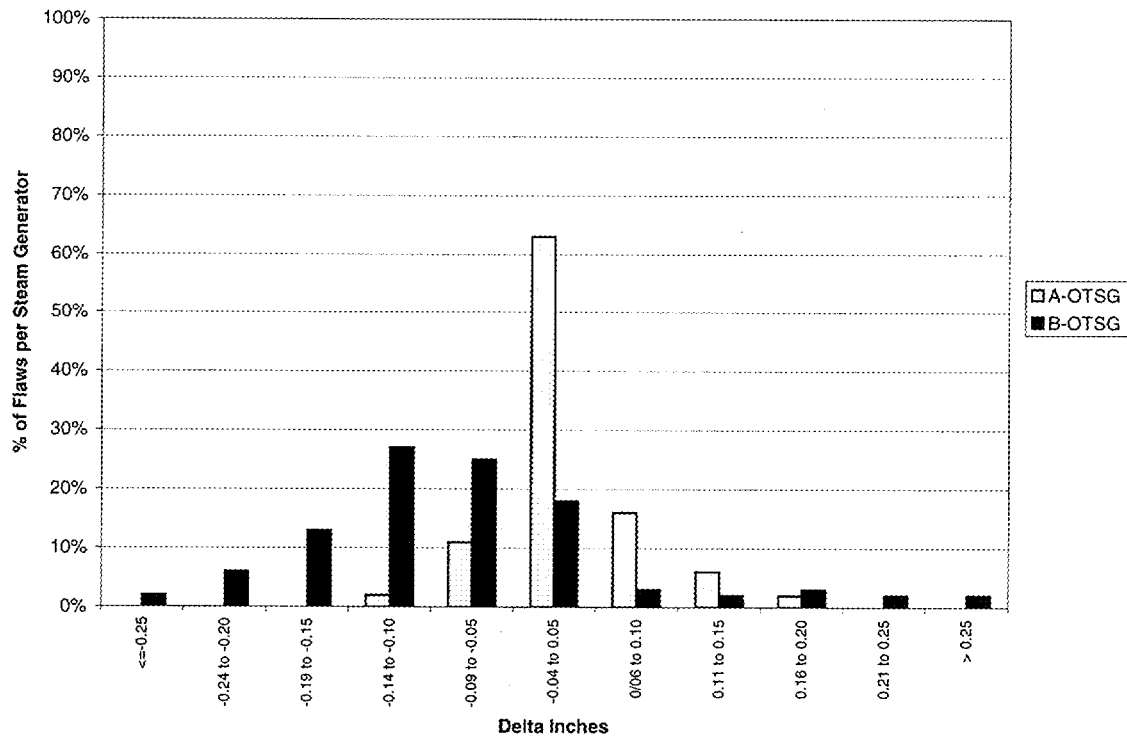
Figure 2: 1999 Flaw Tip Growth

An assessment of growth for TEC indications observed in 1997 was performed to confirm that the indicated location of the flaw tip relative to the clad/carbon steel interface (CCI) had not shown any significant growth towards the interface. Figure 2 below provides a graphical representation of this growth assessment comparing the 1997 flaw tip location to the 1999 flaw tip location. The change in indicated location from the tip of the flaw to the CCI is normally distributed around zero change in location. Therefore, it is concluded that the growth rate of the indications toward the CCI is insignificant.
