U.S. NUCLEAR REGULATORY COMMISSION

Report No: 50-305/99010(DRP)

Facility: Kewaunee Nuclear Power Plant

Dates: September 11 through October 19, 1999

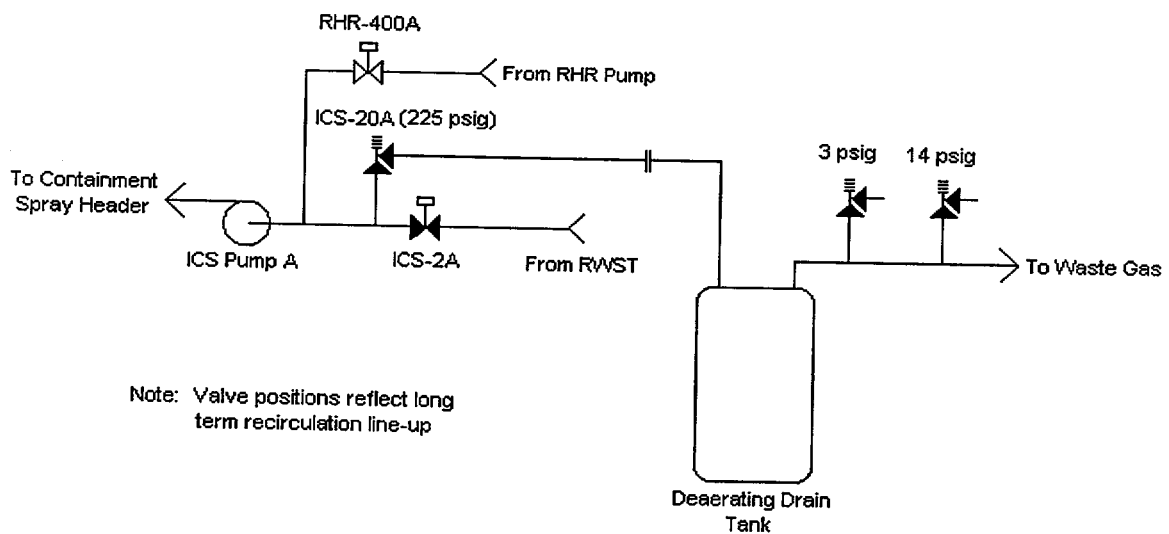
Simplified Drawing

During the observations of the SP, the inspectors noted that the boric acid residue on a coupling downstream of the relief path for relief Valve ICS-20A could be indicative of premature valve lifting or weepage past the valve. This was discussed with licensee personnel for evaluation. Operation personnel had also previously identified the boric acid residue as a recurring condition and were tracking this condition in the Boric Acid Leak Tracking Log. The relief valve was located on the suction piping of ICS Pump A, as shown on the simplified system drawing below:

Additionally, the inspectors questioned licensee personnel regarding the relief valve setpoint. During normal plant operations, the system pressure at the relief valve is the nominal Refueling Water Storage Tank pressure of 25-30 pounds per square inch gage (psig). During the performance of Procedure SP 34-099, the pressure at the relief valve is approximately 180 psig due to the residual heat removal pump providing the supply to the ICS pump, as in the long-term recirculation mode of operation. The relief valve discharge was routed to the deaerating drain tank, which could be potentially pressurized up to 14 psig. The inspectors questioned the licensee as to whether the drain tank back-pressure had been accounted for in the setpoint determination for the relief valves in each ICS train (Valves ICS-20A/B). This was of concern since the relief valve setpoint was set at 225 psig and the ICS pump suction piping design pressure was also 225 psig, as discussed in USAR Section 6.4.2.

The licensee initiated KAP 3480 to document the inspectors concerns. The licensee's prompt operability determination in KAP 3480 was that Valve ICS-20A was operable based on satisfactory leak tests which had been previously performed. Additionally, premature lifting of the relief valve was unlikely based on insignificant changes in drain tank levels logged prior to and following the performance of Procedure SP 34-099. However, the licensee acknowledged that weepage past the valve could occur and that continued evaluation was necessary. The inspectors did not identify any deficiencies with the licensee's operability determination. With respect to the relief valve setpoint, the licensee determined that the drain tank back-pressure had not been accounted for in the determination of the relief setpoint of Valve ICS-20A, but that pipe stress limits would not be exceeded if the relief valve lifted at a higher pressure than 225 psig.

The above issue will be documented as an Unresolved Item (URI) pending further NRC review of the licensee's evaluations of whether the failure to include the back-pressure in the setpoint determination of Valves ICS-20A/B constituted a violation of the licensee's In-Service Test plan (URI 50-305/99010-02, Effect of Back-pressure in the Determination of ICS Relief Valve Setpoint).
