U. S. NUCLEAR REGULATORY COMMISSION

Report No: 50-373/99020(DRS); 50-374/99020(DRS)

Facility: LaSalle Nuclear Generating Station, Units 1 and 2

LaSalle Nuclear Generating Station, Units 1 and 2
NRC Inspection Report 50-373/99020(DRS); 50-374/99020(DRS)

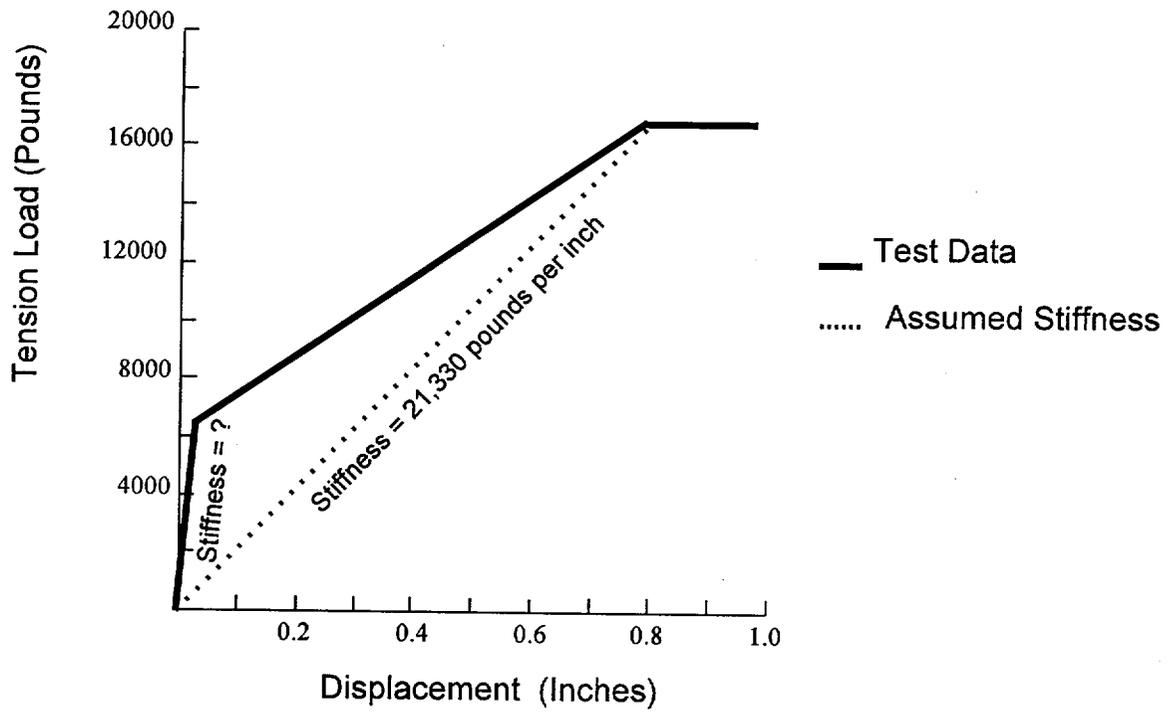
Figure 1. Representative Load vs Displacement Plot for 3/4-inch Concrete Expansion Anchor

In reviewing analyses for detailed baseplate evaluations, the inspector questioned the relatively low stiffness value of 21,330 pounds per inch for 3/4-inch diameter concrete expansion anchors. In response, the licensee provided the load-displacement curve

from prior anchor bolt tests that was the basis for the stiffness value given in Structural Design Standard SDS E-11.0, "Hilti Kwik Bolt Design." An approximate representation of the load-displacement plot provided by the licensee is given in Figure 1 below. The anchor bolt stiffness value of 21,330 pounds per inch was roughly derived by using the anchor bolt displacement at the ultimate load. However, as can be seen in Figure 1, the initial portion of the load-displacement plot is a significantly steeper line compared to the assumed line, indicating a much stiffer behavior. Since allowable anchor bolt loads are defined as one-fourth of the ultimate load, the anchor bolt will not exhibit the flexibility assumed in the licensee's calculations unless the anchor bolt load substantially exceeds the allowable load. In some applications, significantly underestimating the anchor bolt stiffness will result in underestimating the anchor bolt load, potentially affecting the design adequacy of the support. The failure to verify the adequacy of design is a violation of 10 CFR 50, Appendix B, Criterion III, "Design Control" (50-373/374-99020-02). This Severity Level IV violation is being treated as a Non-Cited Violation, consistent with Appendix C of the NRC Enforcement Policy. This violation is in the licensee's corrective action program as PIF L1999 - 04779.
