U.S. Department of Energy

OCT 22 1997

1997 Annual Prelicensing Inspection of the Falls City, Texas, UMTRA Title I Disposal Site

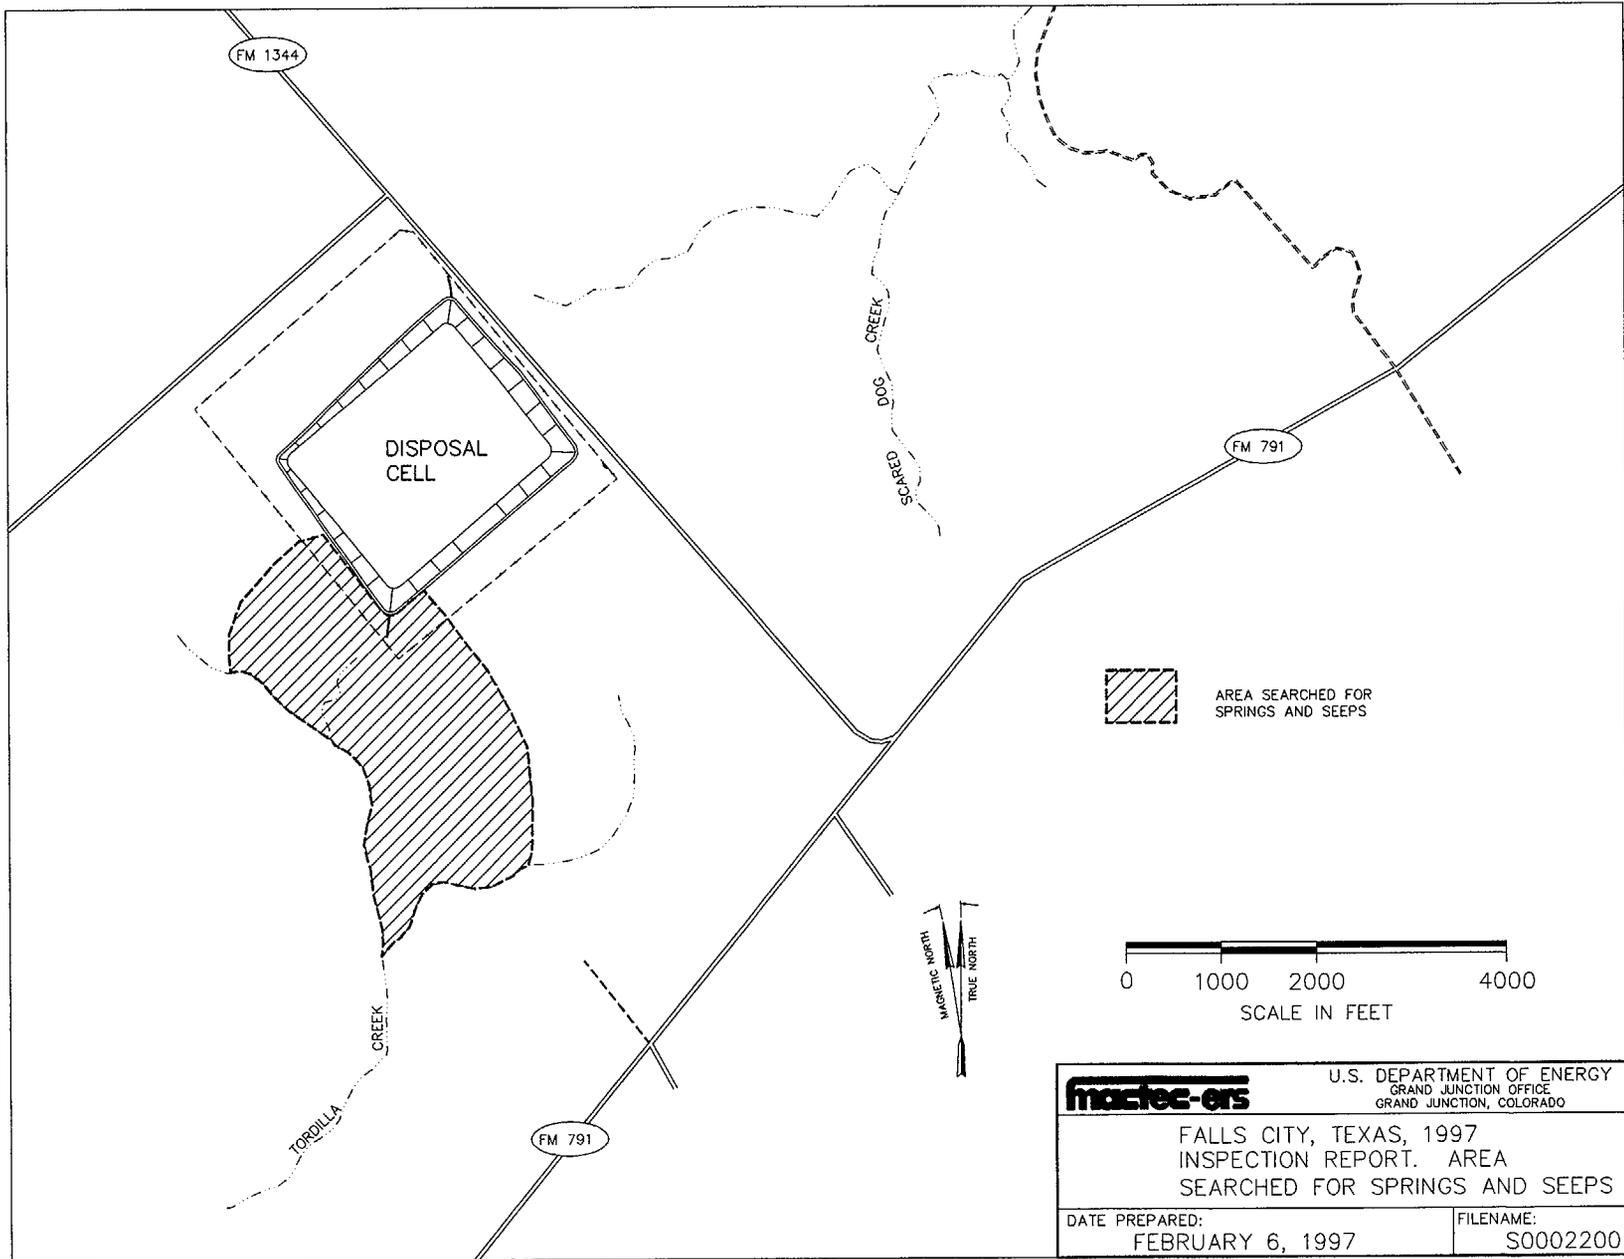
Attachment 2. Falls City, Texas, 1997 Inspection Report. Area Searched for Springs and Seeps.

At the request of ERD-UMTRA, the area south and southwest of the site, between the site boundary and Tordilla Creek, was inspected for springs and seeps (Attachment 2). None were found. There is evidence of minor headcutting in Tordilla Creek, which was dry at the time of this inspection. Gullies leading into Tordilla Creek from the direction of the site were followed headward, but none ended at a spring or seep. All were related to normal surface runoff. Nor did inspectors see anomalies in the vegetation anywhere in this outlying area that would indicate persistent moisture associated with a spring or seep.

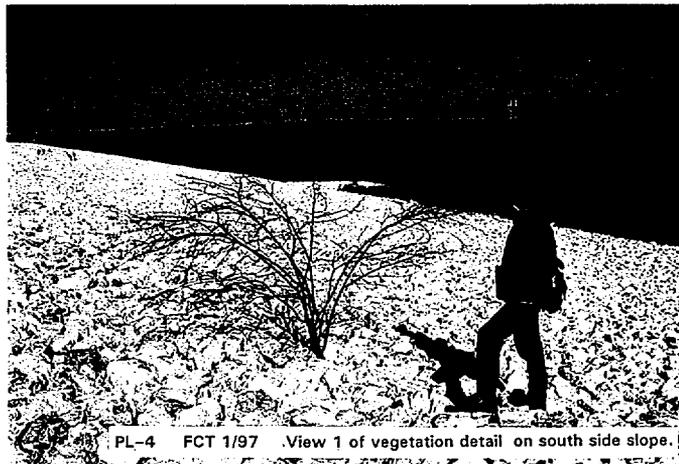
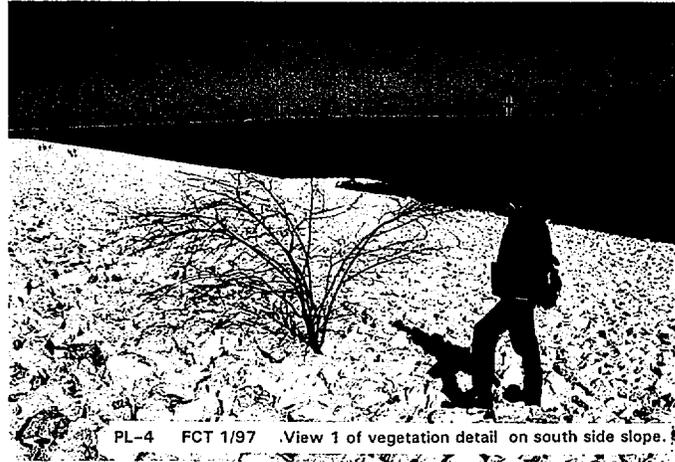
All side slopes are in excellent condition except that small trees, greasewood and an unidentified species, occur at a few places on the northeast and southeast side slopes. (These trees were cut down by the groundwater sampling field party that visited the site the week of January 20.) Henceforth, inspectors will be prepared to cut new trees as they appear.

PL-4 FCT 1/97 View 1 of vegetation detail on south side slope.

Recommendation: Cut down trees as they appear during the next and following site visits.

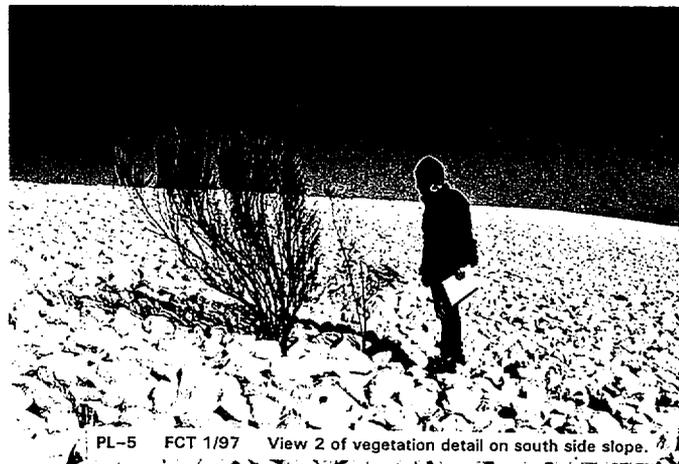
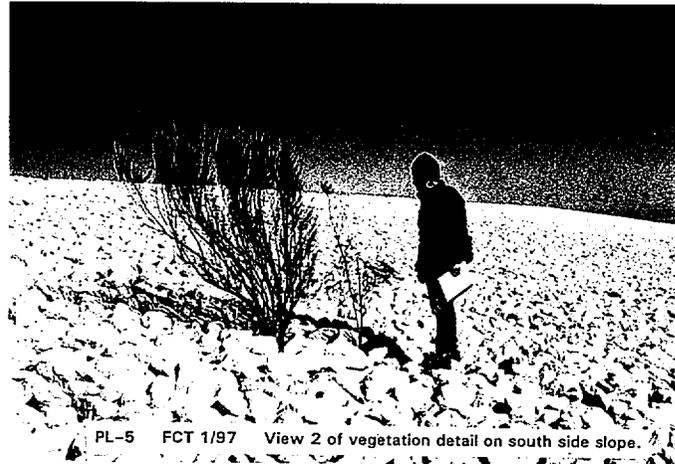
PL-5 FCT 1/97 View 2 of vegetation detail on south side slope.
