Beaver Valley Power Station, Unit No. 2
Docket No. 50-412 License No. NPF-73
LER 99-009-00

LER 99-009-00, 10 CFR 50.73(a)(2)(i), "Missed Performance of Technical Specification Surveillance Requirement 4.8.1.1.1a Following Failure to Re-Establish Auto Bus Transfer Capability of 4KV Bus 2A."

TITLE (4)
Missed Performance of Technical Specification Surveillance Requirement 4.8.1.1.1a Following Failure to Re-Establish Auto Bus Transfer Capability of 4KV Bus 2A

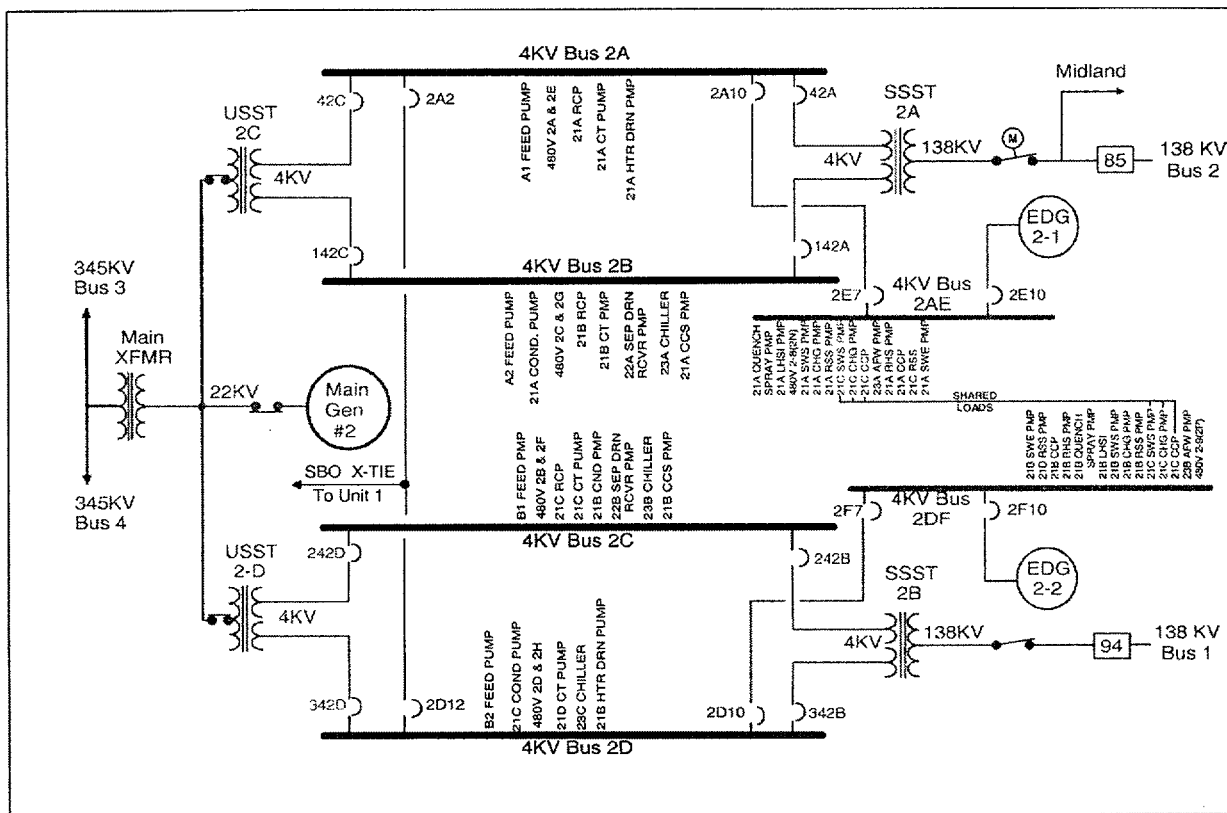
FIGURE 1

On October 12, 1999, at approximately 1730 hours, the power supply input to Unit 2 4KV Bus 2A was transferred from the onsite Unit Station Service Transformer (USST) 2C to the offsite System Station Service (SSST) Transformer 2A (see Figure 1). This was done to support start-up of a cooling tower pump. The pump was started and 4KV Bus 2A was realigned back to USST 2C, at approximately 1741 hours (same day). Subsequently, at approximately 0322 hours on October 13, 1999, it was discovered that the auto bus transfer feature of 4KV Bus 2A to the off-site alternating current (A.C.) power source had not been re-established when 4KV Bus 2A was re-aligned back to USST 2C. This event occurred when the auto-closure circuit for input power supply breaker ACB-42A of SSST 2A to 4KV Bus 2A Bus was not placed in the "after-close position", as required by procedure. This had rendered 4KV automatic offsite A.C. power to Bus 2A inoperable and required entry into ACTION a of Technical Specification (TS) 3.8.1.1 within 1 hour, which was not performed. The TS implications of this event were recognized at approximately 1700 hours on October 13, 1999.

4KV Electrical Distribution - Unit 2
