James A. FitzPatrick  
Nuclear Power Plant  
268 Lake Road  
P.O. Box 41  
Lycoming, New York 13093  
315-342-3840

Subject: **Docket No. 50-333**  
**LICENSEE EVENT REPORT: LER-99-010 (DER-99-02065)**

**Main Turbine Trip and Reactor Scram Due to Degraded Cable in Main  
Generator Anti-Motoring Circuit**

Main Turbine Trip and Reactor Scram Due to Degraded Cable in Main Generator Anti-Motoring Circuit

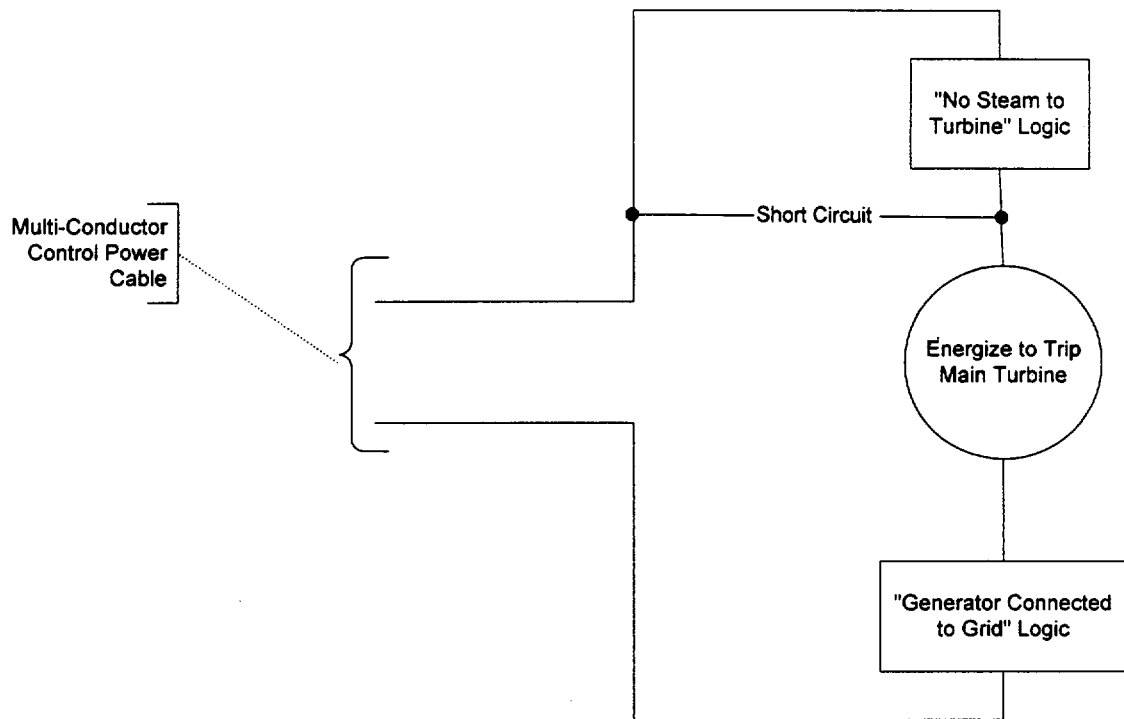
Figure 1

On October 14, 1999 at 17:44, an automatic Main Turbine [TA] trip occurred due to a short circuit between conductors in a control cable in the Main Generator [TB] anti-motoring protective relay circuit. (Figure 1). A Reactor scram occurred as a consequence of the Main Turbine trip based on Turbine Control Valve Fast Closure signals.

The cause of this event was damaged insulation on a control power cable to the Main Generator anti-motoring circuit. The mechanism that caused the damaged insulation has not been identified (Cause Code X). Analysis to determine the cause of the insulation degradation is scheduled for the cycle 15 refuel outage (Fall 2000).

The extent of this condition is limited to this single cable. The insulation resistance of all the conductors in all of the cables run in this common conduit was checked using testing appropriate to the conductor's application (resistance checks or megger checks). These checks verified adequate insulation resistance for all conductors.

1. The Main Generator anti-motoring circuit was repaired. The repair used spare conductors in the control power cable with the degraded insulation. These spare conductors were verified to have adequate insulation integrity by meg-ohm testing prior to conducting the repair. **(Complete)**
2. The HPCI System piping was analyzed to determine if the overpressure condition had an adverse effect on the integrity of the pipe. This analysis concluded the piping was not adversely effected and remained operable. **(Complete)**
3. Perform analysis to determine the cause of the degraded cable. **(Scheduled to be complete prior to restart from R014)**
4. Replace the degraded cable with a new cable. **(Scheduled to be complete prior to restart from R014)**
