Dresden Nuclear Power Station, Unit 2
Facility Operating License No. DPR-19
NRC Docket No. 50-237

Subject: Licensee Event Report 1999-005-00, "Unanticipated loss of Level in Reactor Cavity/Fuel Pool during Refueling Activities due to Open Electromatic Relief Valve"

TITLE (4)
Unanticipated Loss of Level in Reactor Cavity/Fuel Pool during Refueling Activities due to Open Electromatic Relief Valve

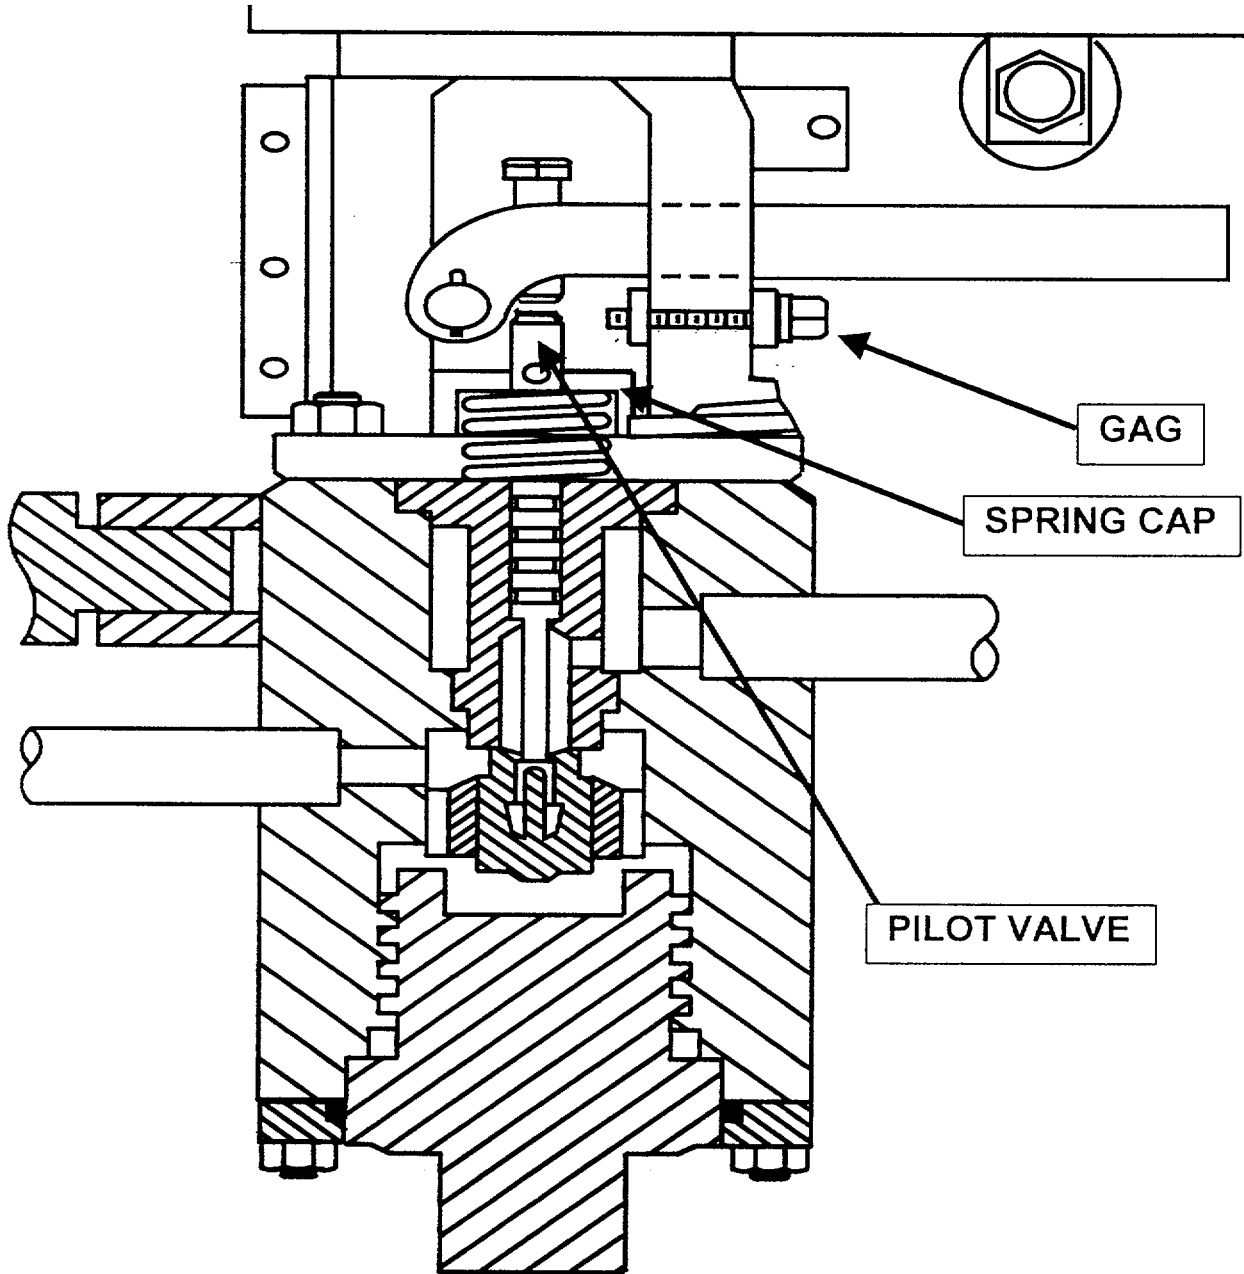
Figure 1
ERV Pilot Valve Diagram

Based upon review of the maintenance work packages, the investigation concluded that the gagging device was in place when the "E" ERV was cycled. When cycled, the downward force of the solenoid plunger against the actuator arm was sufficient to force the gag downward (into its final resting position as found by the Outage Manager on October 19, 1999). This repositioning of the gagging device was sufficient to permit the actuator arm to contact the pilot stem, and permit successful completion of the position indication limit switch checks. When personnel entered the Drywell for troubleshooting during the draindown event, the "E" ERV was found to be open, and the ERV was subsequently closed. The Outage Manager did not reposition the gagging-device until after the "E" ERV was closed. This confirmed his visual observation that the gagging device was not hindering the movement of the pilot stem through contact with the pilot spring cover (see attached drawing).

The inadvertent opening of the ERV was caused by failure of the ERV pilot valve to reseal after being cycled for a post maintenance testing. The probable cause for the "E" ERV Pilot valve's failure to close appears to be either a mechanical defect or the intrusion of foreign material during pilot valve assembly. Following performance of a component failure analysis, a supplemental LER will be issued, incorporating any additional corrective actions.

- The "E" ERV pilot assembly was replaced. The station has quarantined the removed component for performance of a component failure analysis. (Complete)
- Following performance of a formal component failure analysis, a supplemental LER will be submitted including a review of the Post Maintenance Testing (PMT) process, system readiness and work request package control, incorporating any additional corrective actions.
- (ATI# 18034)
