VIRGINIA ELECTRIC AND POWER COMPANY
SURRY POWER STATION UNITS 1 AND 2
ASME SECTION XI RELIEF REQUEST
NOTICE OF CHANGE TO TEMPORARY REPAIR AND
EXTENDED USE OF A TEMPORARY NON-CODE PIPE REPAIR

Notice of Change to Temporary Repair and
Request for Extended Use of Temporary Repair on "D" Component Cooling Heat
Exchanger Service Water Discharge Piping

System: Service Water
Class: ASME Class 3
Drawing: 11448-FM-071A Sh. 4
Component: 30"-WS-41-10

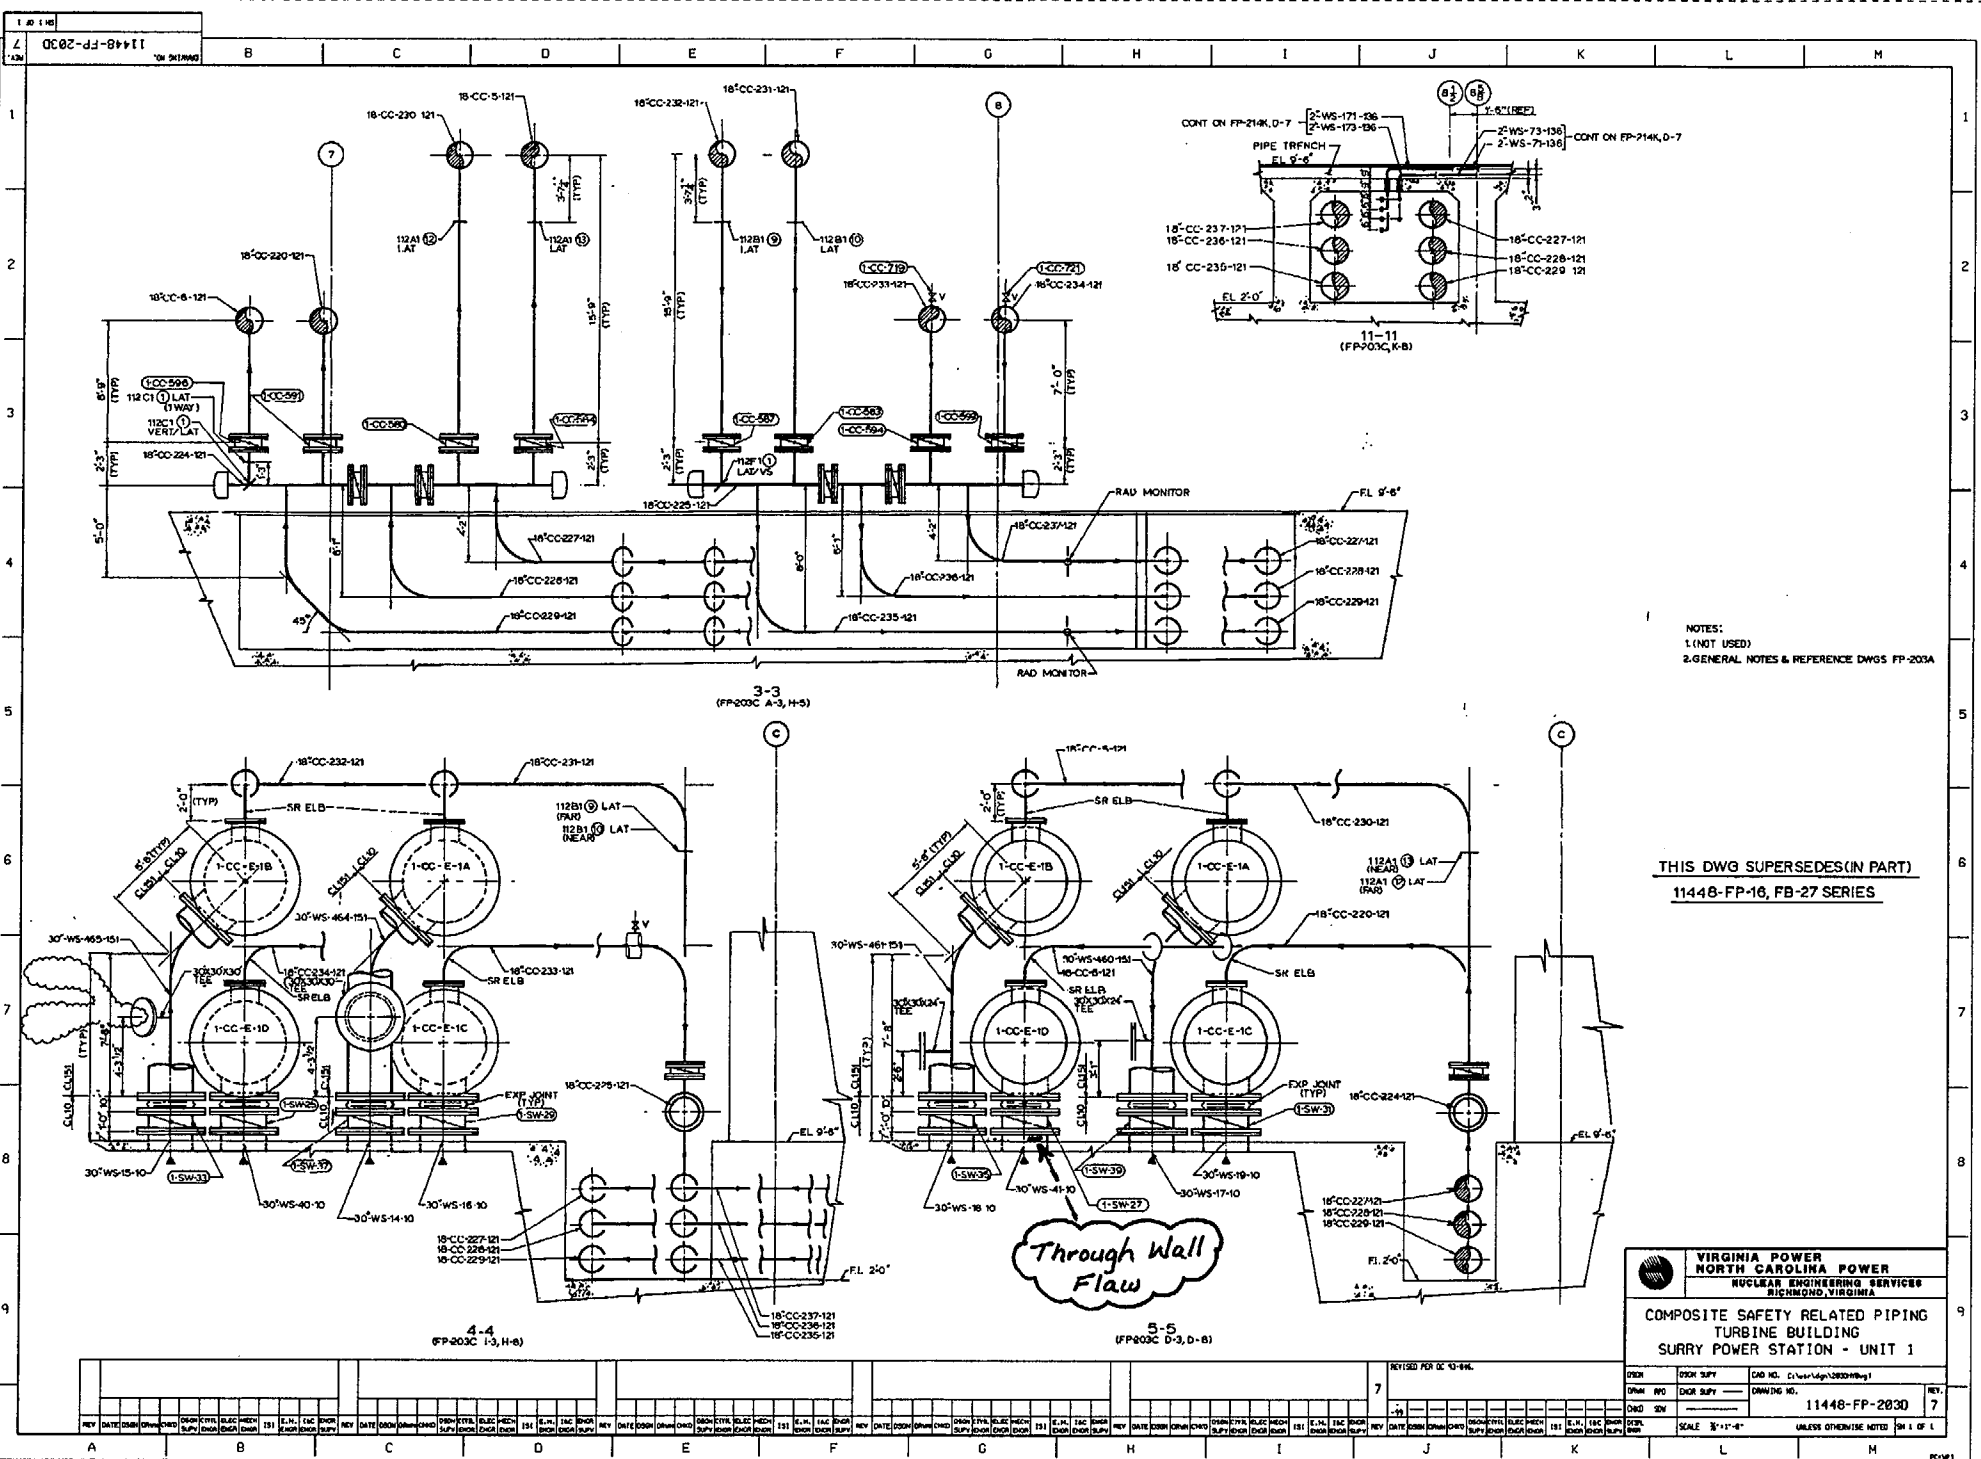
COMPOSITE SAFETY RELATED PIPING
 TURBINE BUILDING
 SURRY POWER STATION - UNIT 1

A through wall leak exists on the moderate energy service water (SW) system downstream of the "D" CCHX (1-CC-E-1D) discharge isolation valve 1-SW-27. (See attached drawing 11448-FP-203D.) The flaw was evaluated by the "through wall" flaw method and determined to be within Generic Letter 90-05 guidelines. Virginia Electric and Power Company (Virginia Power) previously submitted a relief request dated October 20, 1999 (Serial No. 99-495) that requested the use of a temporary non-Code repair in accordance with Generic Letter 90-05. A temporary patch comprised of rubber gasket material and a 1/8 inch thick steel backing plate was placed over the hole and is held in place with stainless steel bands.
