Dresden Nuclear Power Station, Unit 2
Facility Operating License No. DPR-19
NRC Docket No. 50-237

Subject: Licensee Event Report 1999-005-00, "Unanticipated loss of Level in Reactor Cavity/Fuel Pool during Refueling Activities due to Open Electromatic Relief Valve"

TITLE (4)
Unanticipated Loss of Level in Reactor Cavity/Fuel Pool during Refueling Activities due to Open Electromatic Relief Valve

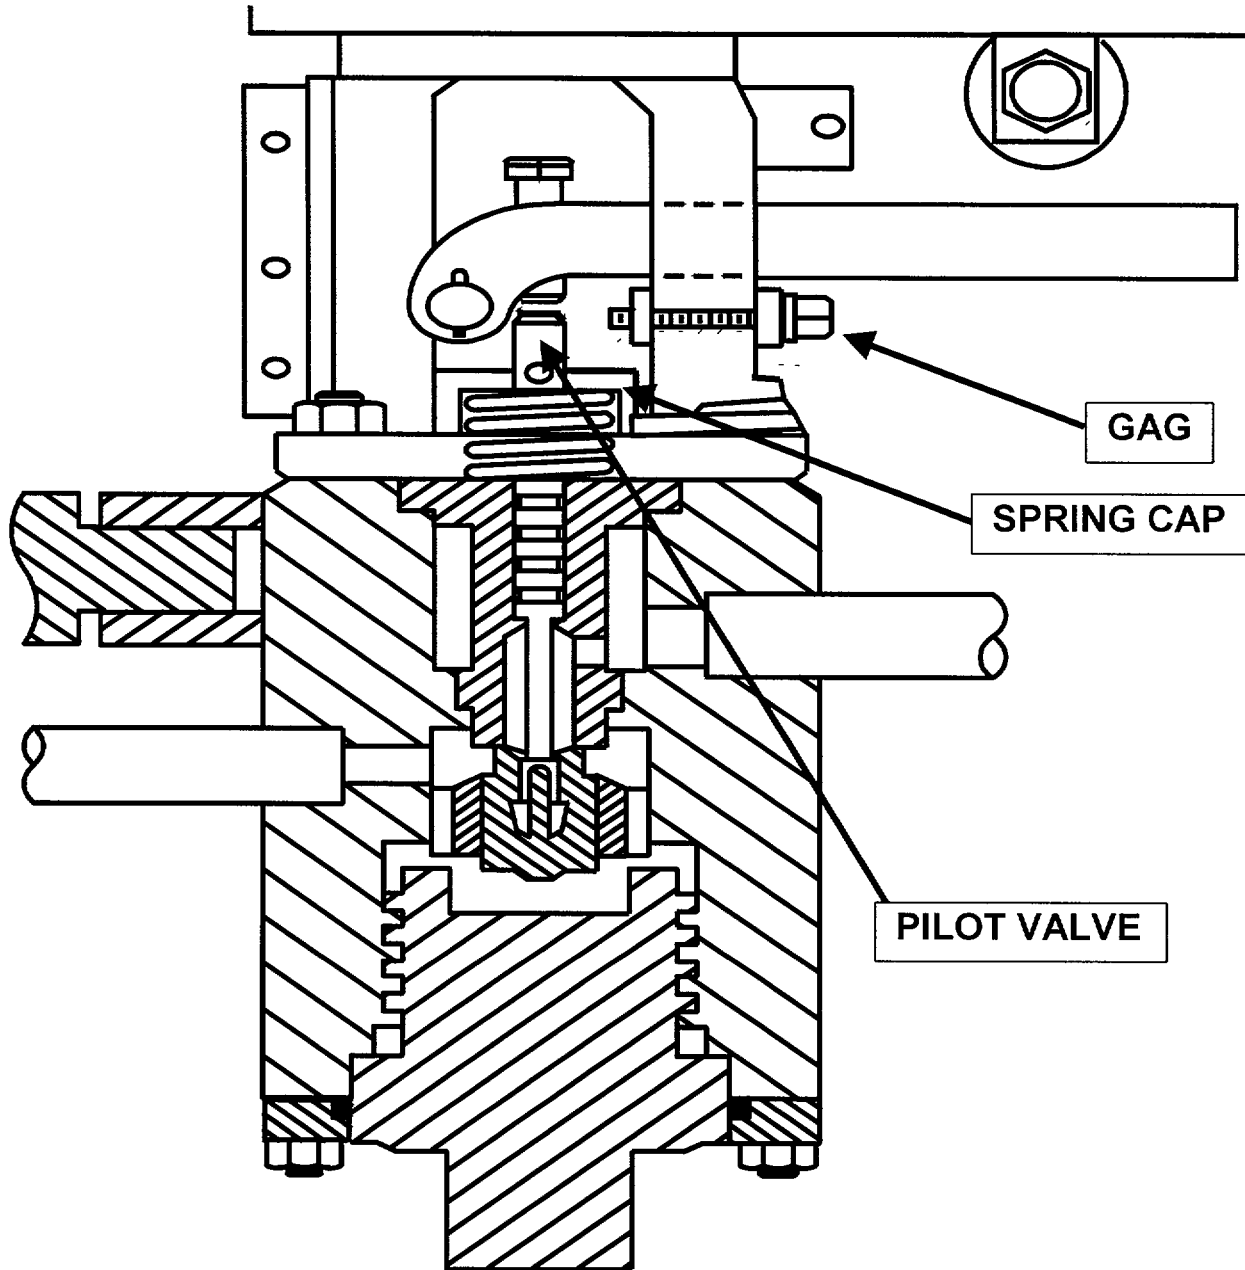
Figure 1
ERV Pilot Valve Diagram

Based upon review of the maintenance work packages, the investigation concluded that the gagging device was in place when the "E" ERV was cycled. When cycled, the downward force of the solenoid plunger against the actuator arm was sufficient to force the gag downward (into its final resting position as found by the Outage Manager on October 19, 1999). This repositioning of the gagging device was sufficient to permit the actuator arm to contact the pilot stem, and permit successful completion of the position indication limit switch checks. When personnel entered the Drywell for troubleshooting during the draindown event, the "E" ERV was found to be open, and the ERV was subsequently closed. The Outage Manager did not reposition the gagging-device until after the "E" ERV was closed. This confirmed his visual observation that the gagging device was not hindering the movement of the pilot stem through contact with the pilot spring cover (see attached drawing).

Before the MSL "B" plug was pulled on October 19, 1999 at 1525 hours, MSL plugs "C" and "D" were pulled. Even though the MSLs are cross-tied just upstream of the inboard MSIVs, the crosstie-piping diameter is small and would preclude a rapid filling of the other MSLs. Once the MSL "B" plug was removed, the approximate 70 feet of cavity water head pressure seen at the ERV established an approximate 30 psi differential pressure across the ERV permitting the main seat to open. Agitation of the pilot valve permitted repositioning of the stem and allowed ERV closure.

The inadvertent opening of the ERV was caused by failure of the ERV pilot valve to reseal after being cycled for a post maintenance testing. The probable cause for the "E" ERV Pilot valve's failure to close appears to be either a mechanical defect or the intrusion of foreign material during pilot valve assembly. Following performance of a component failure analysis, a supplemental LER will be issued, incorporating any additional corrective actions.

- The "E" ERV pilot assembly was replaced. The station has quarantined the removed component for performance of a component failure analysis. (Complete)
- Following performance of a formal component failure analysis, a supplemental LER will be submitted including a review of the Post Maintenance Testing (PMT) process, system readiness and work request package control, incorporating any additional corrective actions.
(ATI# 18034)
