Subject: Three Mile Island Nuclear Station, Unit I (TMI-1)
Operating License No. DPR-50
Docket No. 50-289
LER 99-008-01, "Reactor Building Emergency Cooling System (RBECS) Outside the Design Basis with Reduced Air Flow Due to Inadequate Consideration of the Potential for Reactor Coolant Leakage to Impact RBECS Performance"

LICENSEE EVENT REPORT (LER)

Reactor Building Emergency Cooling System (RBECS) Outside the Design Basis with Reduced Air Flow Due to Inadequate Consideration of the Potential for Reactor Coolant Leakage to Impact RBECS Performance

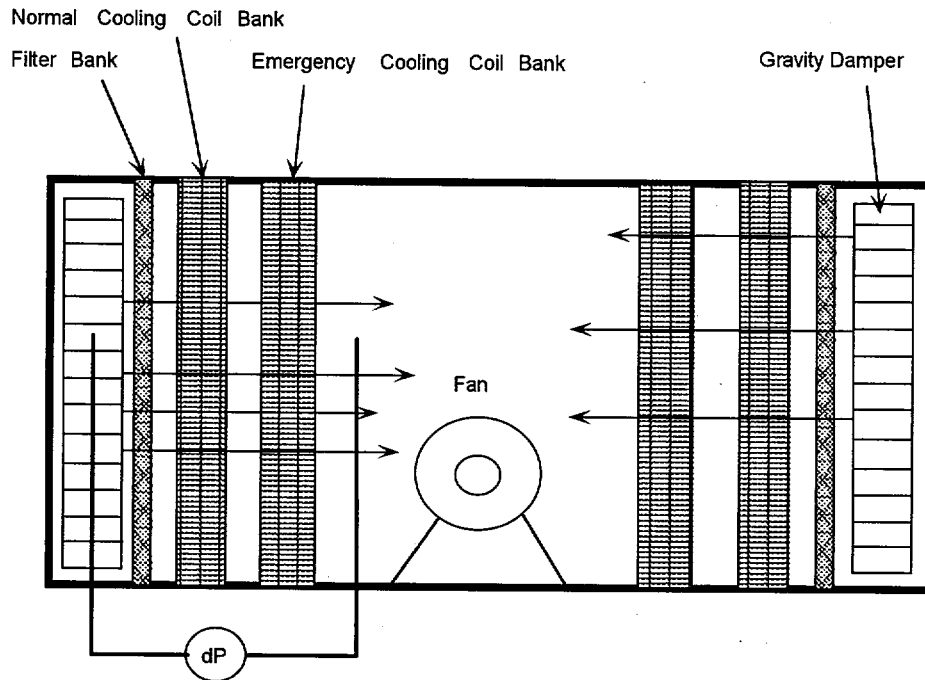
Figure 1
Reactor Building Cooler Cross-sectional View

The Reactor Building (RB) Emergency Fan Cooler units (AH-E-1 A, B, and C) (see Figure 1) provide containment energy removal during both normal and emergency conditions. These units [BK/FCU]* are referred to in the TMI-1 Updated Final Safety Analysis Report (UFSAR) as the Reactor Building Emergency Air Recirculation and Cooling Units and in the TMI-1 Technical Specifications (TS) as the RB Emergency Cooling Fans of the RB Emergency Cooling System (RBECS).

Each of the RBECS fan coolers contains normal cooling coils and emergency cooling coils. A single fan draws air from both ends of the unit. The two speed fans operate in fast speed in the normal cooling mode and in slow speed in the emergency cooling mode. During normal operation, the normal cooling coils condition the air inside containment with cooling water provided from an industrial cooling water system while there is no flow through the emergency coils. In the emergency cooling mode, Reactor Building Emergency Cooling Water (RBE CW) is pumped from the Susquehanna River through the emergency cooling coils to remove moisture and heat following a design basis Loss of Coolant Accident (LOCA). Air is drawn through the filter/demisters and both sets of cooling coils from a series of ducts located throughout the RB and exhaust directly to the RB lower elevation. Thus a reduced air flow condition during normal operation would likewise affect the RBECS. The fan coolers are located on the north side of the RB at the 289 ft elevation, approximately 8 ft above the RB floor.
