**DOCKET 50-255 - LICENSE DPR-20 - PALISADES PLANT
LICENSEE EVENT REPORT 99-004, "CONTROL ROD DRIVE SEAL HOUSING
LEAKS AND CRACK INDICATIONS"**

FACILITY NAME (1)
CONSUMERS ENERGY COMPANY - PALISADES NUCLEAR PLANT

TITLE (4)
CONTROL ROD DRIVE SEAL HOUSING LEAKS AND CRACK INDICATIONS

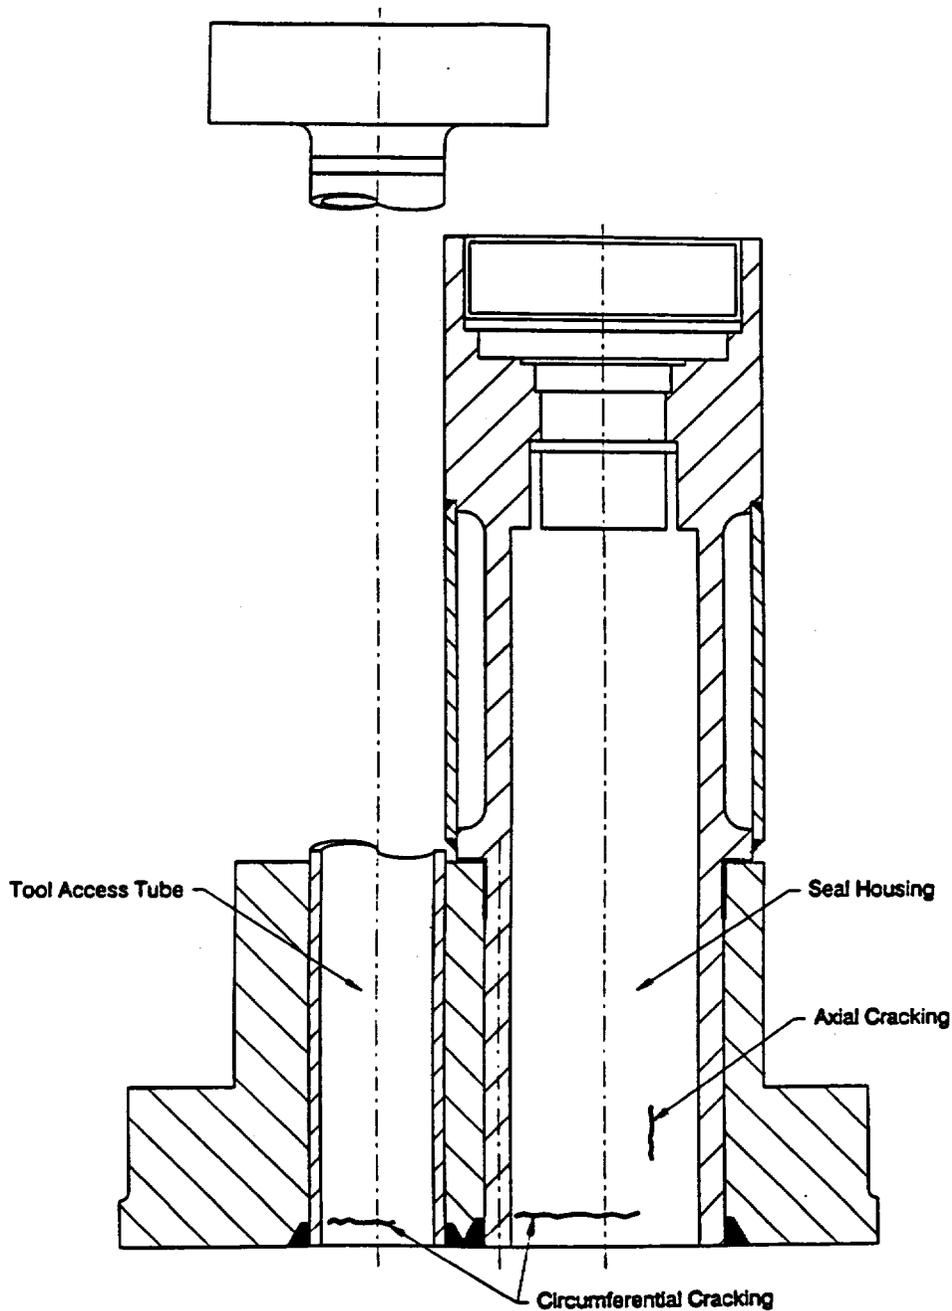
FIGURE 1

Each control rod at Palisades is driven by an electric motor through a drive shaft and bevel gears which engage a rack assembly coupled to the control rod. The drive shaft is offset from and parallel to the axis of its associated control rod. Figure 1 provides a sketch of the CRD seal housing assembly configuration. The primary coolant pressure boundary is provided by a rotating mechanical seal located at the top of the seal housing tube. The lower flange of the seal housing (autoclave flange) is fastened to the support tube with the autoclave nut. The lower region of the seal housing below the mechanical seal provides the primary coolant pressure boundary. The drive motor and clutch assembly mount on the atmospheric side of the mechanical seal at the top of the seal housing. The tool access tube penetrates the autoclave flange directly above the rack assembly. The tool access tube provides access for coupling and uncoupling rods, and is closed with a blank flange when the primary coolant system is filled.

Control Rod Drive Seal Housing
