RE: St. Lucie Unit 1
Docket No. 50-335
In-Service-Inspection Plan
Second Ten-Year Interval
Revised Relief Request 21

**ST. Lucie Unit 1
SECOND INSPECTION INTERVAL
RELIEF REQUEST NUMBER 21**

Drawings Showing Limited Examinations

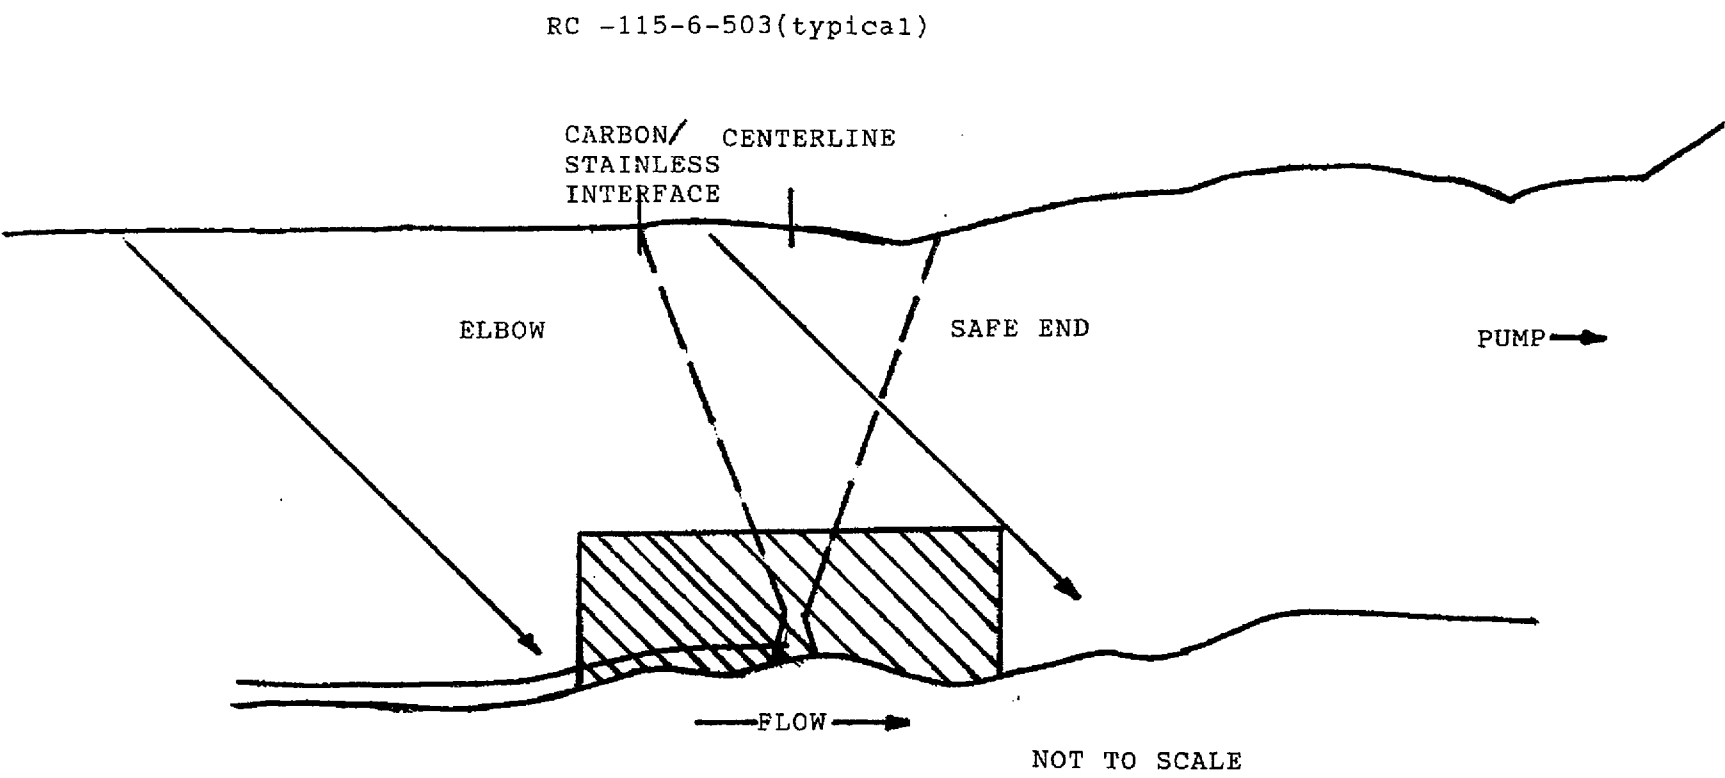
Figure 1

Code Category B-F Table 21-1										
Summary #	Year Item No.	Zone	Component ID	NDE Method	Angle and Technique			Configuration	Fig #	% Coverage Comments
					½ V	Full V	1 ½ V			
025700	91 B5.130	8	RC-115-6-503	UT	45			Elbow to Safe end	1	100% from elbow side 0% from safe end side
028600	96 B5.130	10	RC-121-5-503	UT	45 60			Elbow to Safe end	2	100% from elbow side 25% from safe end side
031800	88 B5.130	12	RC-112-5-503	UT	45L 60	45S		Elbow to Safe end	3	100% from elbow side 25% from safe end side
034700	96 B5.130	14	RC-124-5-503	UT	45 60			Elbow to Safe end	4	100% from elbow side 20% from safe end side
080500	97 B5.130	28	10-509-A	UT	45			Nozzle to Safe end	5	100% from safe end side 40% from nozzle side
083100	90 B5.130	29	10-509-B	UT	45 60			Nozzle to Safe end	6	100% from safe end side 75% from nozzle side

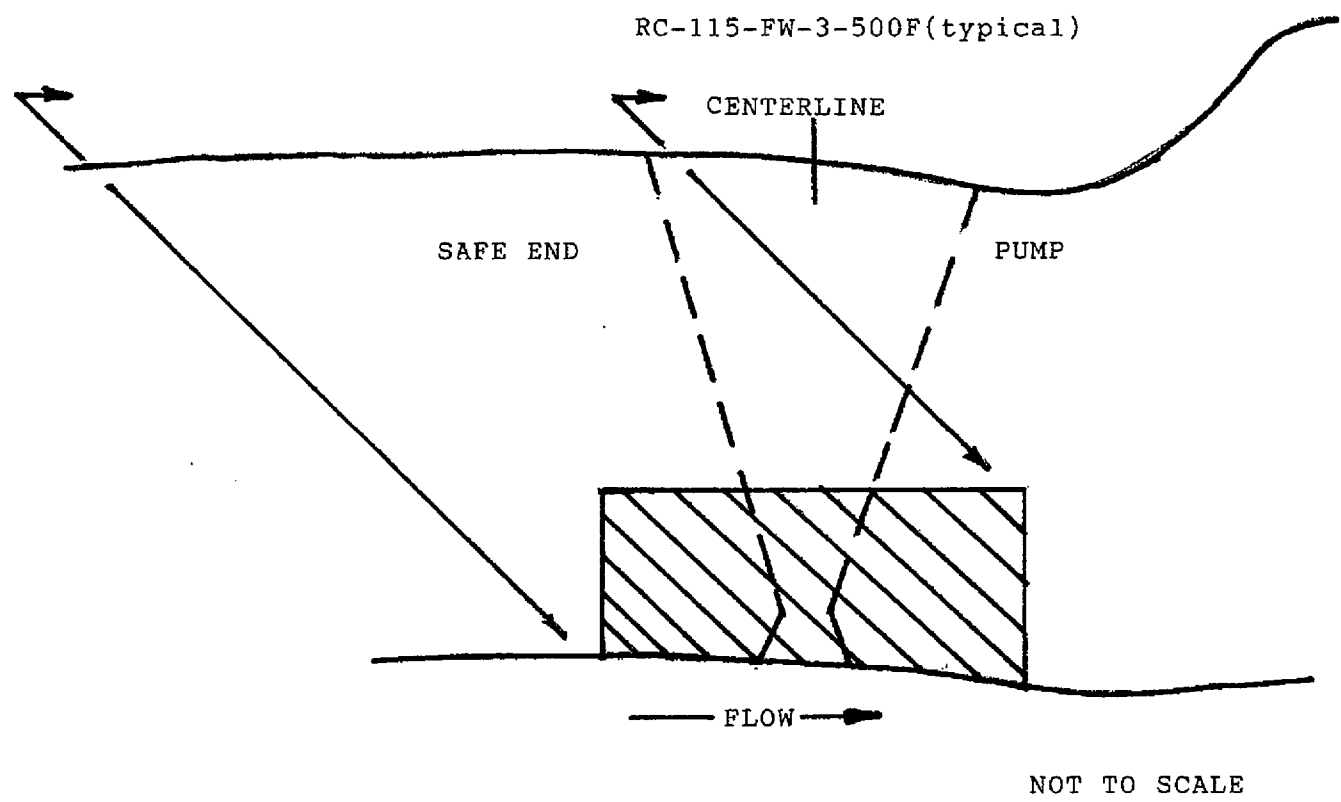
Figure 7

Code Category B-J Table 21-2										
Summary #	Year Item No.	Zone	Component ID	NDE Method	Angle and Technique			Configuration	Fig #	% Coverage Comments
					½ V	Full V	1 ½ V			
025800	91 B9.11	8	RC-115-FW-3-500F	UT	45			Safe end to Pump	7	100% from safe end side 0% from pump side
026000	91 B9.11	9	RC-115-FW-3-500E	UT	45			Pump to Safe end	8	100% from safe end side 0% from pump side
028700	96 B9.11	10	RC-121-FW-3-500B	UT	45			Safe end to Pump	9	20% from safe end side 0% from pump side
028900	96 B9.11	11	RC-121-FW-3-500A	UT	45			Pump to Safe end	10	100% from safe end side 1% from pump side
032000	88 B9.11	12	RC-112-FW-3-500G	UT	45			Safe end to Pump	11	100% from safe end side 0% from pump side
032200	88 B9.11	13	RC-112-FW-3-500H	UT	45			Pump to Safe end	12	100% from safe end side 0% from pump side

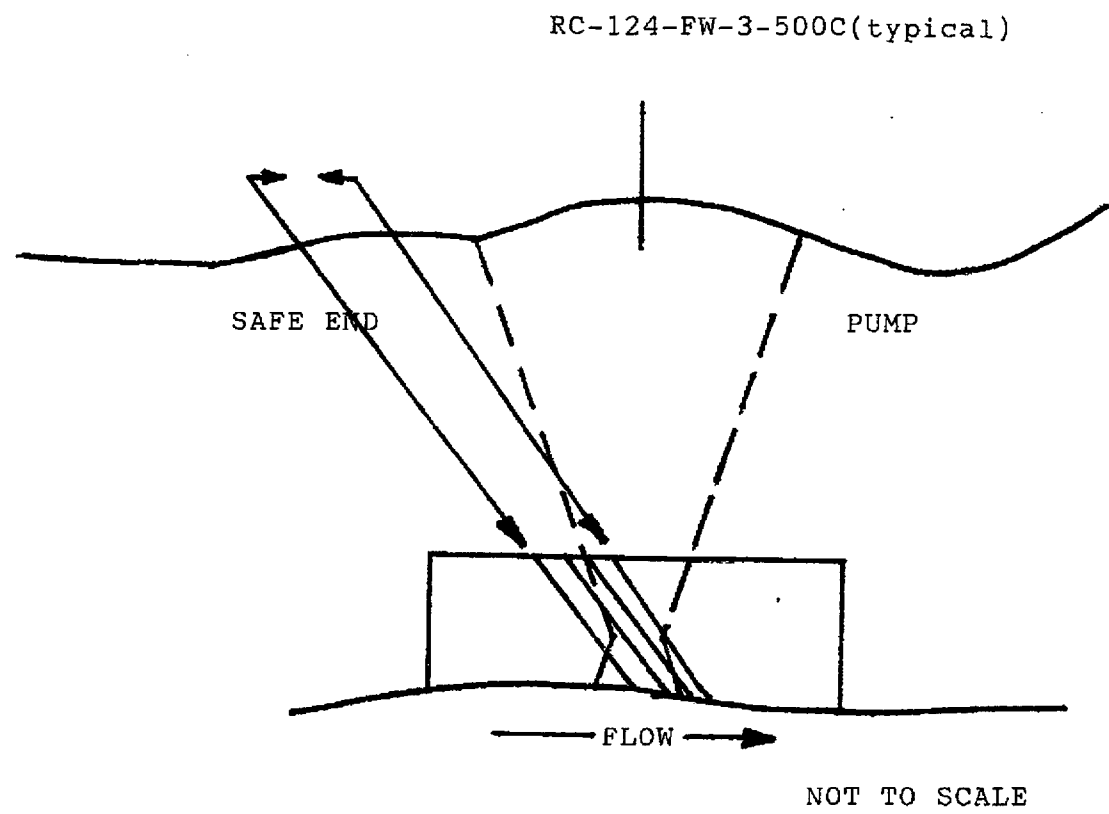
Figure 13

Code Category B-J Table 21-2											
Summary #	Year Item No.	Zone	Component ID	NDE Method	Angle and Technique			Configuration	Fig #	% Coverage	Comments
					½ V	Full V	1 ½ V				
034800	96 B9.11	14	RC-124-FW-3-500C	UT	45			Safe end to Pump	13	19% from safe end side 0% from pump side	
035000	96 B9.11	15	RC-124-FW-3-500D	UT	45			Pump to Safe end	14	100% from safe end side 1% from pump side	
048900	88 B9.11	21	SI-148-FW-5	UT	45 60			Elbow to Valve 3227	15	100% from elbow side 0% from valve side	
047900	90 B9.11	21	SI-148-FW-1	UT	45 60			Valve 3624 to Pipe	16	100% from pipe side 0% from valve side	
049200	88 B9.11	21	RC-151-FW-1	UT	45 60			Valve 3227 to Elbow	17	100% from elbow side 0% from valve side	
055100	91 B9.11	22	SI-113-FW-13	UT	45 60			Pipe to Tee	18	100% from pipe side 0% from tee side	
055400	91 B9.11	22	SI-149-FW-1	UT	45 60			Valve V-3614 to Pipe	19	0% from valve side 100% from pipe side

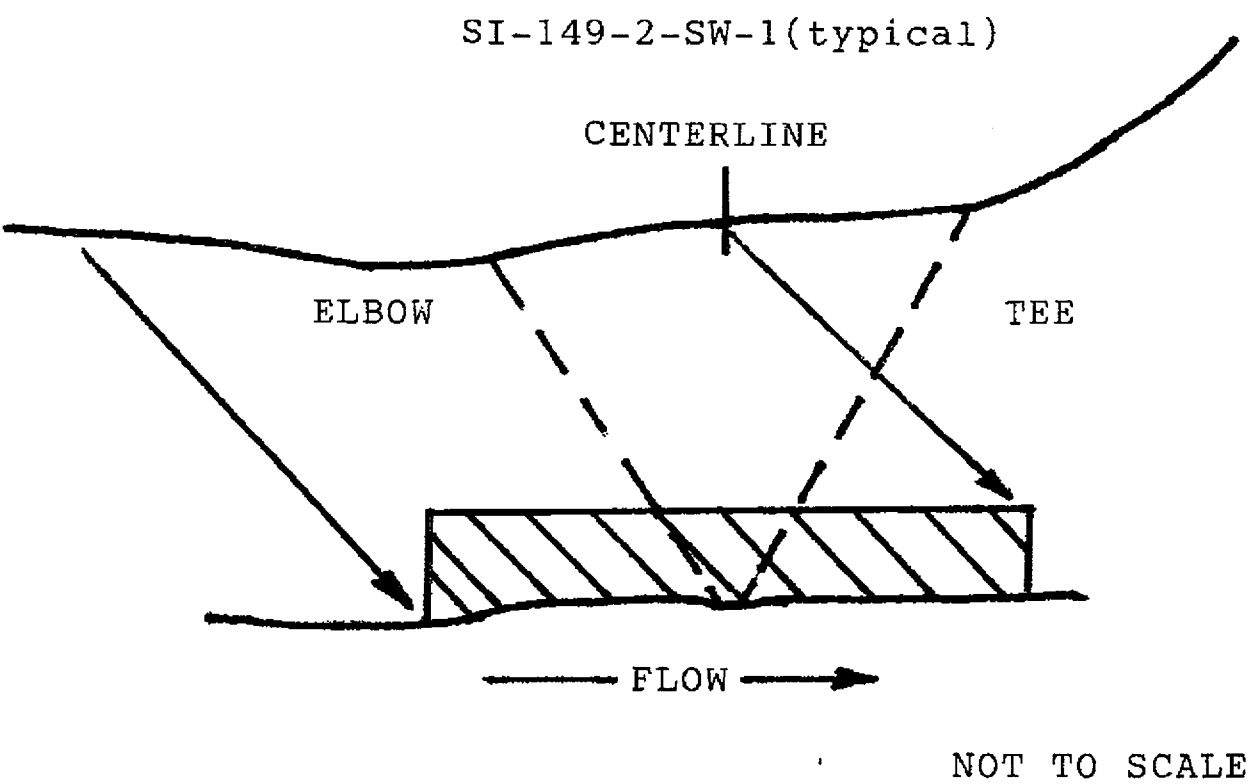
Figure 20

055800	91 B9.11	22	SI-149-2-SW-1	UT	45 60			Elbow to Tee	20	100% from elbow side 0% from tee side	
055900	91 B9.11	22	SI-149-2-SW-2	UT	45 60			Tee to Pipe	21	0% from tee side 100% from pipe side	
056500	91 B9.11	22	SI-149-FW-4	UT	45 60			Pipe to Valve V-3217	22	100% from pipe side 0% from valve side	
056800	91 B9.11	22	RC-154-FW-1	UT	45 60			Elbow to Valve V-3217	23	0% from valve side 100% from elbow side	
060700	96 B9.11	23	SI-150-FW-1	UT	45 60			Valve 3634 to Elbow	24	100% from elbow side 60% from valve side	
062200	96 B9.11	23	RC-152-FW-1	UT	45 60			Valve 3237 to Pipe	25	100% from pipe side 16% from valve side	
065600	91 B9.11	24	SI-151-1-SW-9	UT	45 60			Pipe to Reducer	26	100% from pipe side 0% from reducer side	
065900	91 B9.11	24	SI-151-FW-1	UT	45 60			Valve V-3644 to Pipe	27	55% from valve side 100% from pipe side	
066100	94 B9.11	24	SI-151-1-SW-4	UT	45 60			Pipe to Tee	28	100% from pipe side 55% from tee side

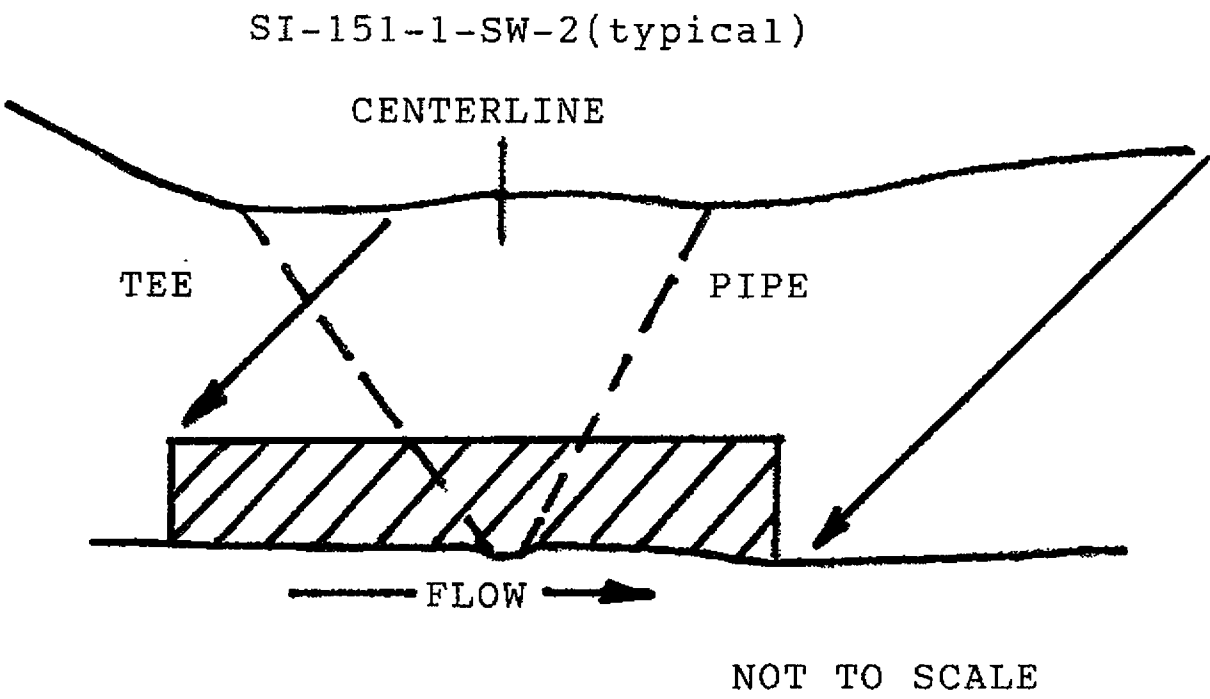
Figure 29

066300	91 B9.11	24	SI-151-1-SW-2	UT	45 60			Tee to Pipe	29	0% from tee side 100% from pipe side

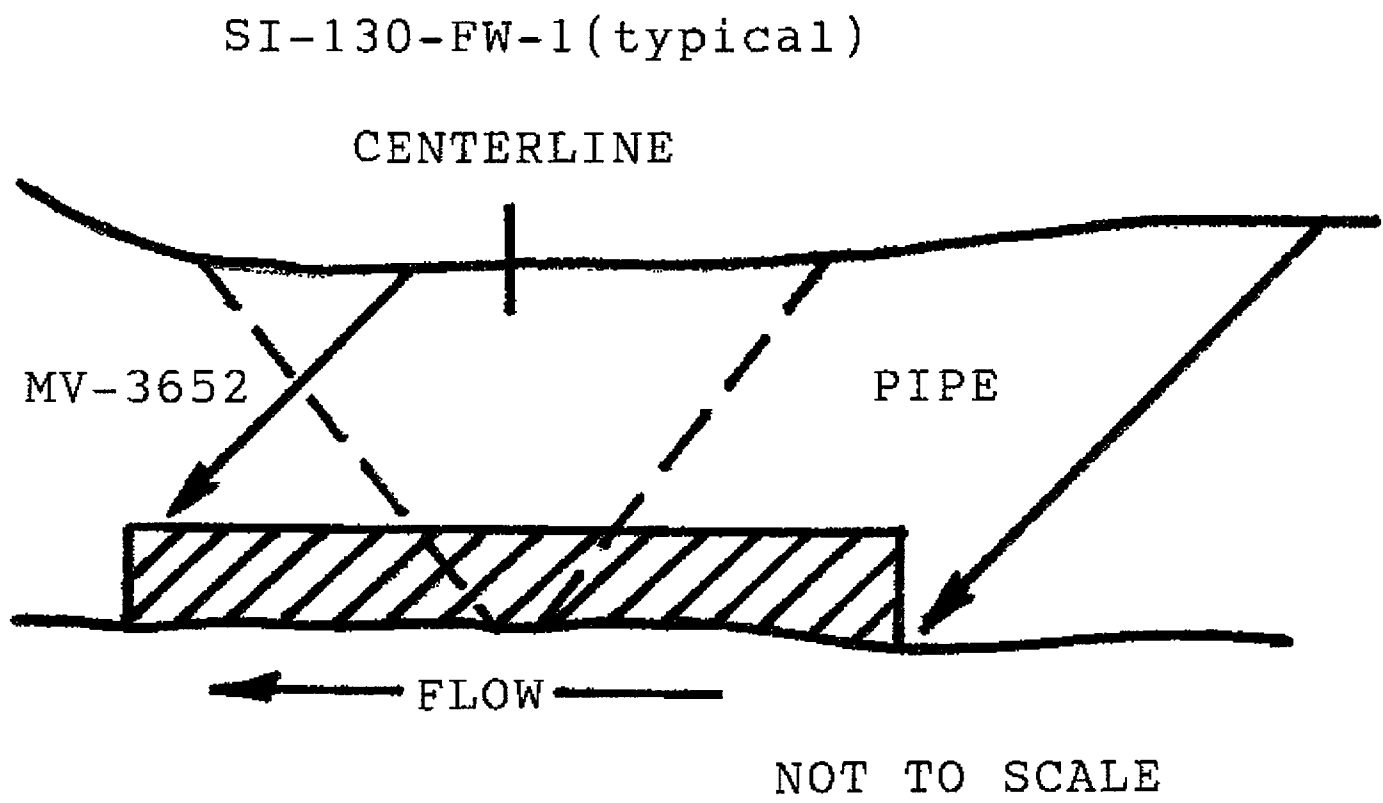
Figure 30

Code Category B-J Table 21-2											
Summary #	Year Item No.	Zone	Component ID	NDE Method	Angle and Technique			Configuration	Fig #	% Coverage	Comments
					½ V	Full V	1 ½ V				
081200	91 B9.11	28	SI-130-FW-1	UT	45 60			Pipe to Valve MV-3652	30	100% from pipe side 0% from valve side	
081500	90 B9.11	28	SI-130-FW-2	UT	45 60			Valve MV-3652 to Elbow	31	100% from elbow side 0% from valve side	
082000	91 B9.11	28	SI-130-FW-3	UT	45 60			Pipe to Valve MV-3651	32	100% from pipe side 0% from valve side	
084200	94 B9.11	29	SI-127-FW-600	UT	45 60			Pipe to Valve-3480	33	Baseline examination 100% from pipe side 35% from valve side	
084455	94 B9.11	29	SI-127-FW-601	UT	45 60			Valve-3480 to Elbow	34	Baseline examination 100% from elbow side 10% from valve side	
084600	90 B9.11	29	SI-127-FW-3	UT	45 60			Elbow to Valve 3481	35	100% from elbow side 0% from valve side	
123900	91 B9.11	39	SI-113-1-SW-6	UT	45 60			Reducer to Tee	36	70% from reducer side 0% from tee side

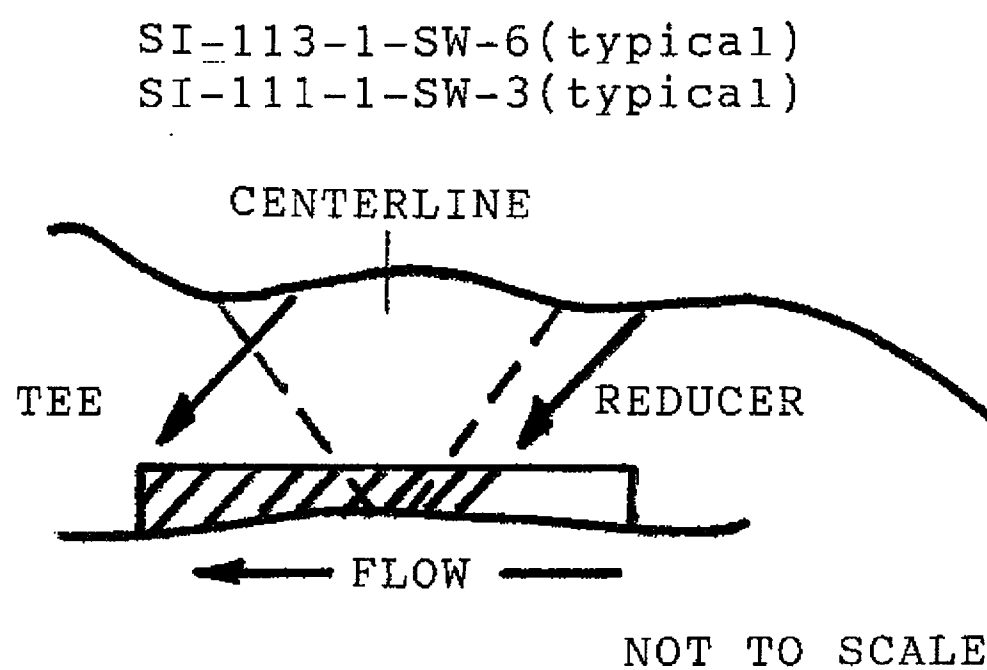
Figure 36

124400	91 B9.11	39	SI-113-1-SW-5	UT	45 60			Tee to Pipe	37	23% from tee side 100% from pipe side	
126300	91 B9.11	39	SI-113-FW-6	UT	45 60			Pipe to Penetration #36	38	100% from pipe side 0% from penetration side	
133600	91 B9.11	40	SI-111-1-SW-3	UT	45 60			Reducer to Tee	36	70% from reducer side 0% from tee side	
134000	91 B9.11	40	SI-111-1-SW-2	UT	45 60			Tee to Pipe	39	0% from tee side 100% from pipe side	
136500	97 B9.11	40	SI-111-FW-8	UT	45 60			Pipe to penetration	40	100% from pipe side 57% from penetration side

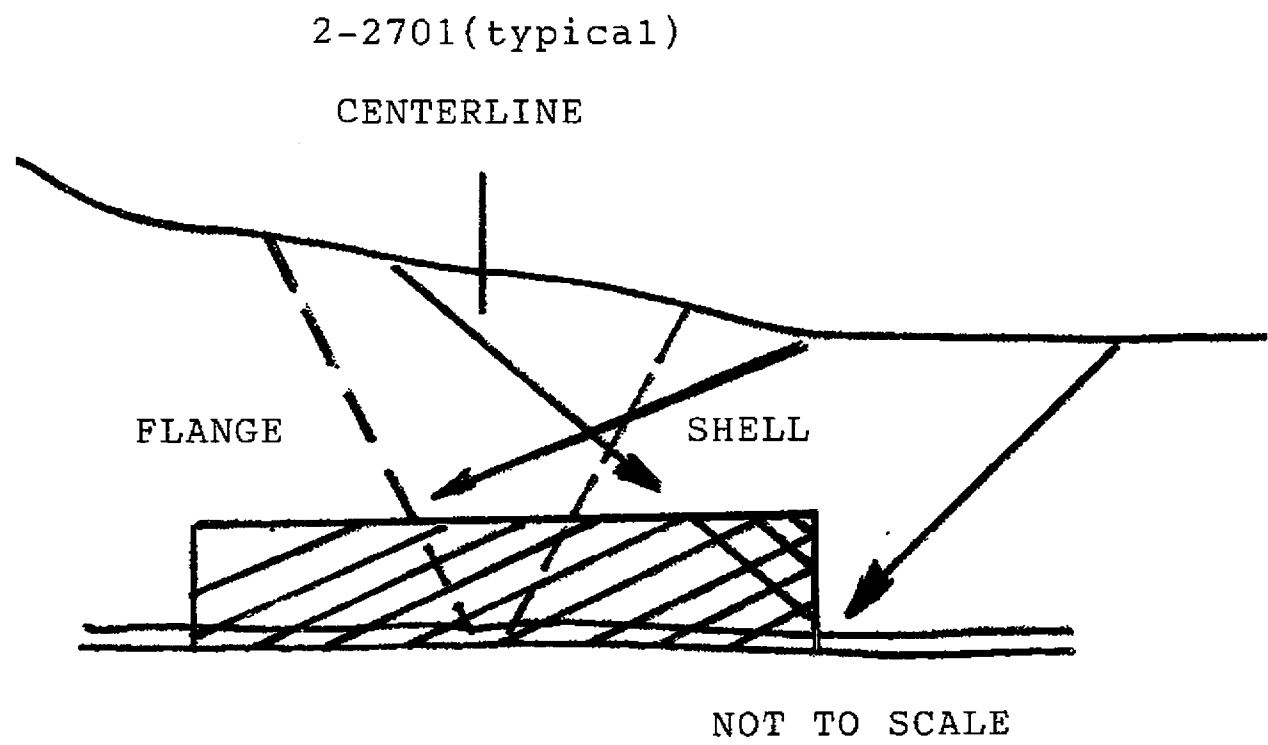
Figure 41

Code Category C-A Table 21-3										
Summary #	Year Item No.	Zone	Component ID	NDE Method	Angle and Technique			Configuration	Fig #	% Coverage Comments
					½ V	Full V	1 ½ V			
211300	97 C1.10	56	2-2701	UT	60 70			Flange to Body	41	85% from the body side 10% from the flange side
211400	93 c1.30	56	2-2702	UT	45 60			Body to tube sheet	42	100% from body side 10% from tube sheet side

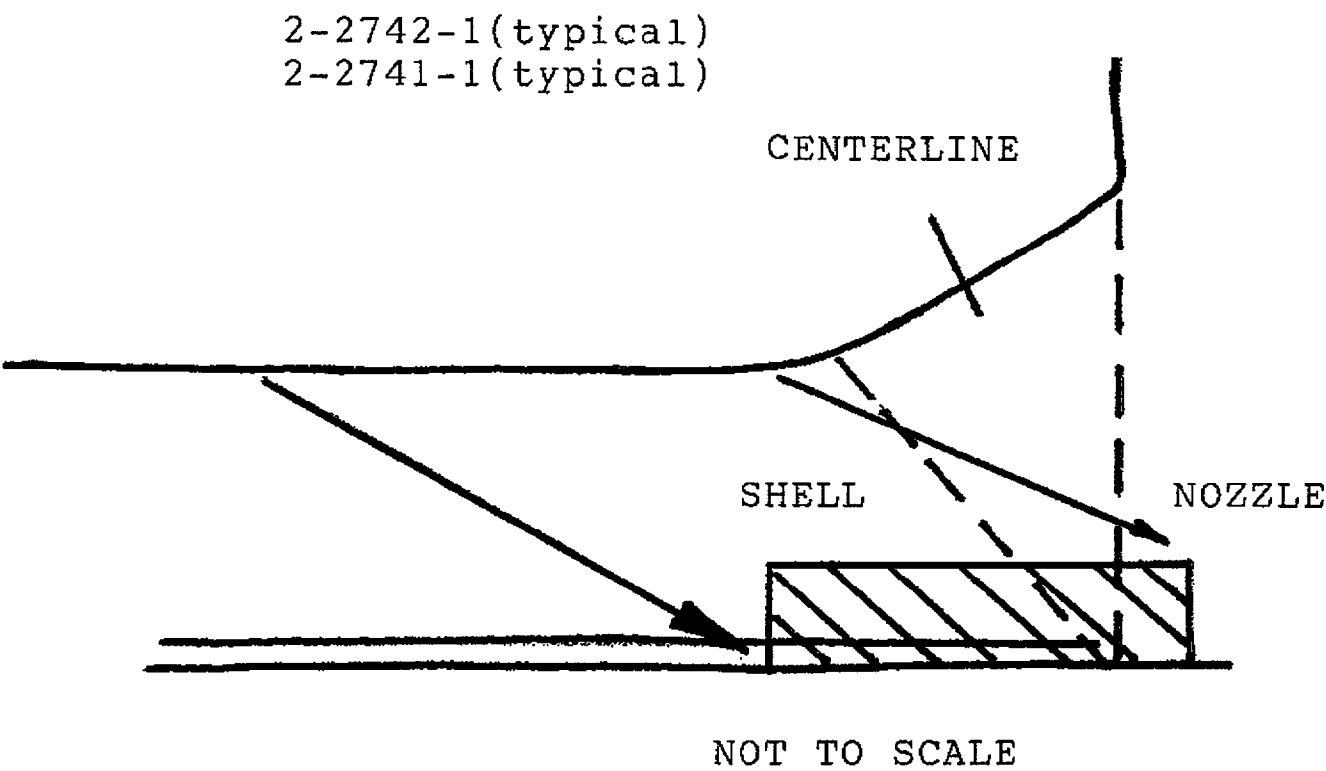
Figure 43

Code Category C-B Table 21-4										
Summary #	Year Item No.	Zone	Component ID	NDE Method	Angle and Technique			Configuration	Fig #	% Coverage Comments
					½ V	Full V	1 ½ V			
211000	93 C2.21	56	2-2742-1	UT	45 60			Nozzle to Shell	43	100% from shell side 0% from nozzle side
211500	97 C2.21	56	2-2741-1	UT	60 70			Shell to Nozzle	43	100% from shell side 0% from nozzle side

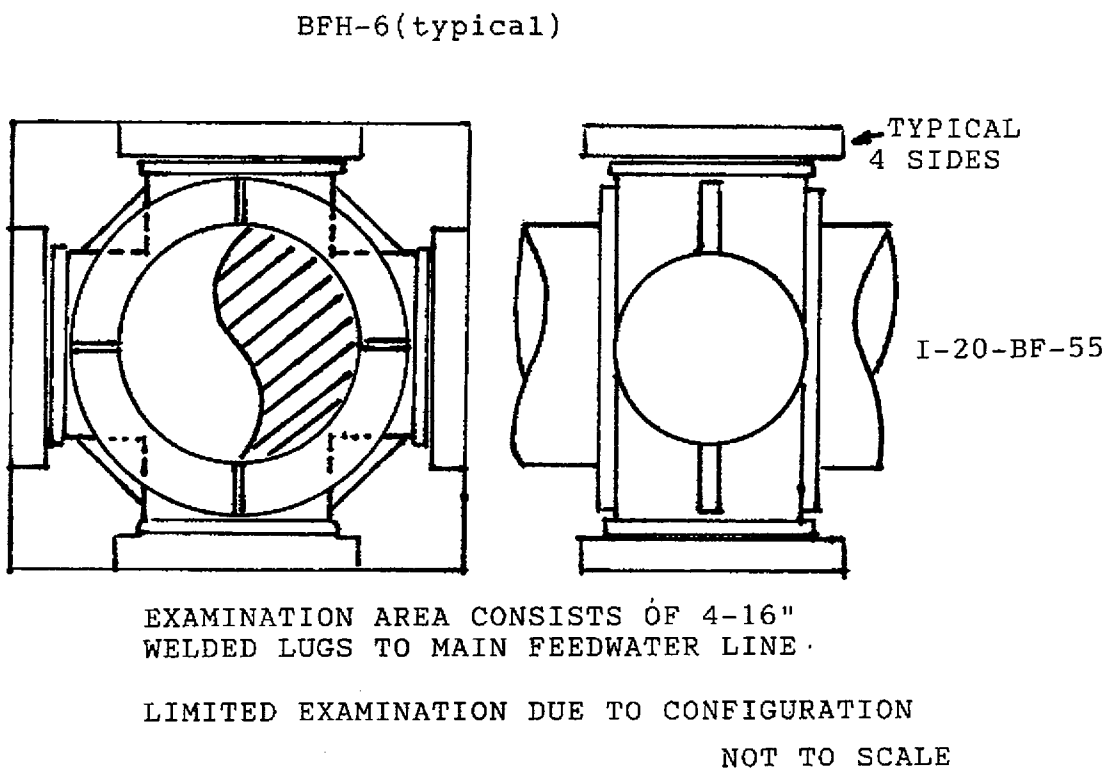
Figure 44

Code Category C-C Table 21-5										
Summary #	Year Item No.	Zone	Component ID	NDE Method	Angle and Technique			Configuration	Fig #	% Coverage Comments
					½ V	Full V	1 ½ V			
272700	90 C3.20	71	BFH-6 1A	MT				Welded Lugs	44	44% CRS Achieved

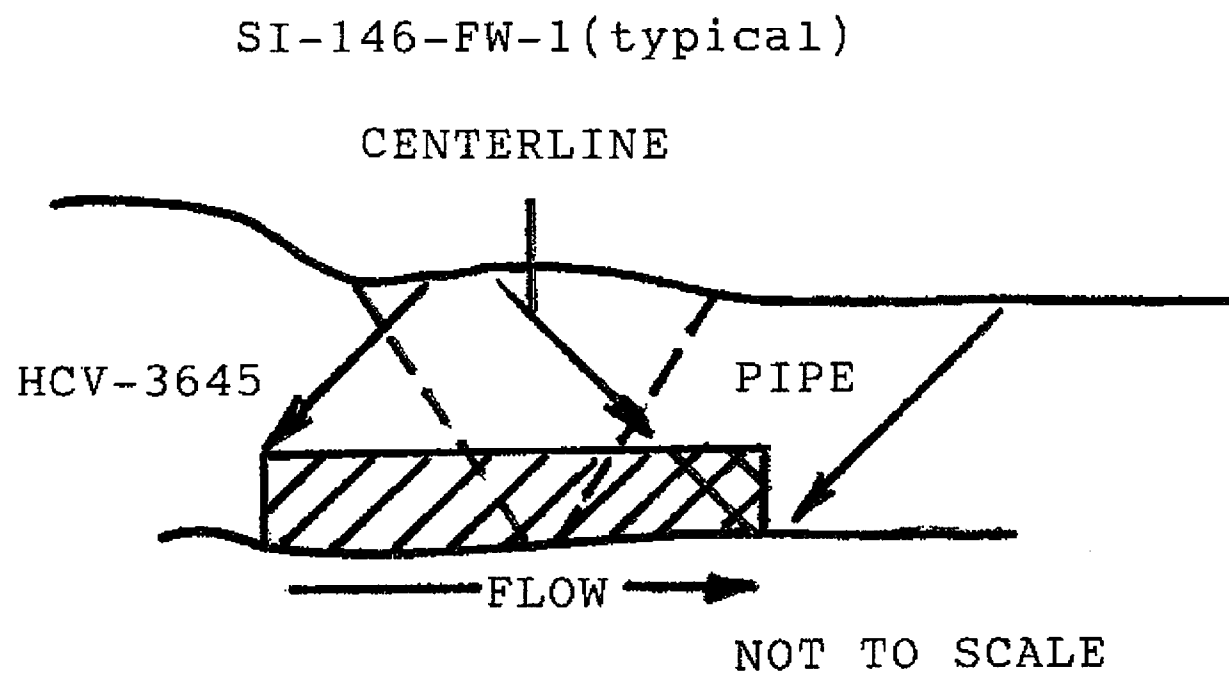
Figure 45

Code Category C-F-1 Table 21-6										
Summary #	Year Item No.	Zone	Component ID	NDE Method	Angle and Technique			Configuration	Fig #	% Coverage Comments
					½ V	Full V	1 ½ V			
159200	97 C5.11	44	SI-146-FW-1	UT	45 60			Valve HCV-3645 to Pipe	45	100% from pipe side 13% from valve side
159300	97 C5.11	44	SI-110-FW-9	UT	45 60			Pipe to Valve V-3144	46	100% from pipe side 25% from valve side
161200	97 C5.11	44	SI-113-FW-9	UT	45 60			Pipe to Valve V-3114	47	100% from pipe side 32% from valve side
164900	90 C5.11	44	SI-142-FW-1	UT			45 60	Valve HCV-3625 to Pipe	48	13% from valve side 100% from pipe side
165000	90 C5.11	44	SI-112-FW-9A	UT			45 60	Pipe to Valve 3124	49	100% from pipe side 13% from valve side
219000	97 C5.21	61	SI-208-1-SW-1	UT	45 60 70			Flange to Tee	50	81% from flange side 66% from tee side
220000	91 C5.11	61	SI-212-FW-1A	UT	45 60			Tee to Pipe	51	0% from tee side 100% from pipe side

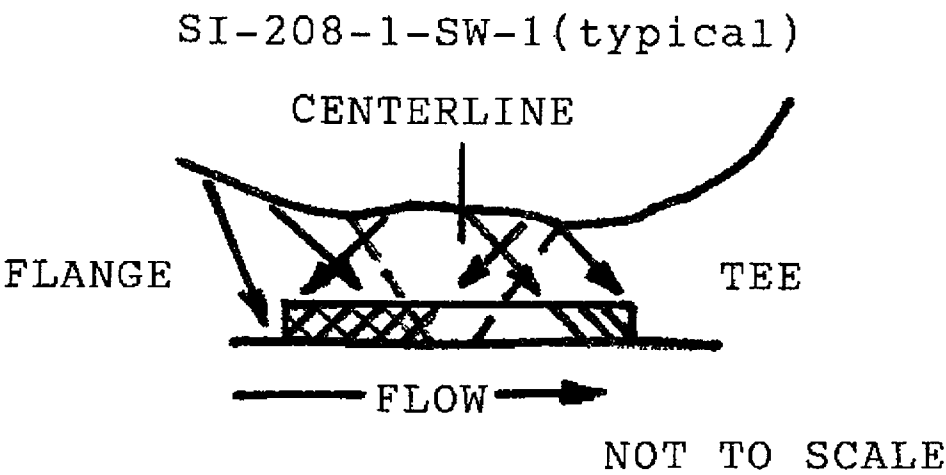
Figure 50

Area of incomplete coverage
2" either side of 0 reference.
4" length of 11" total weld
length limited.

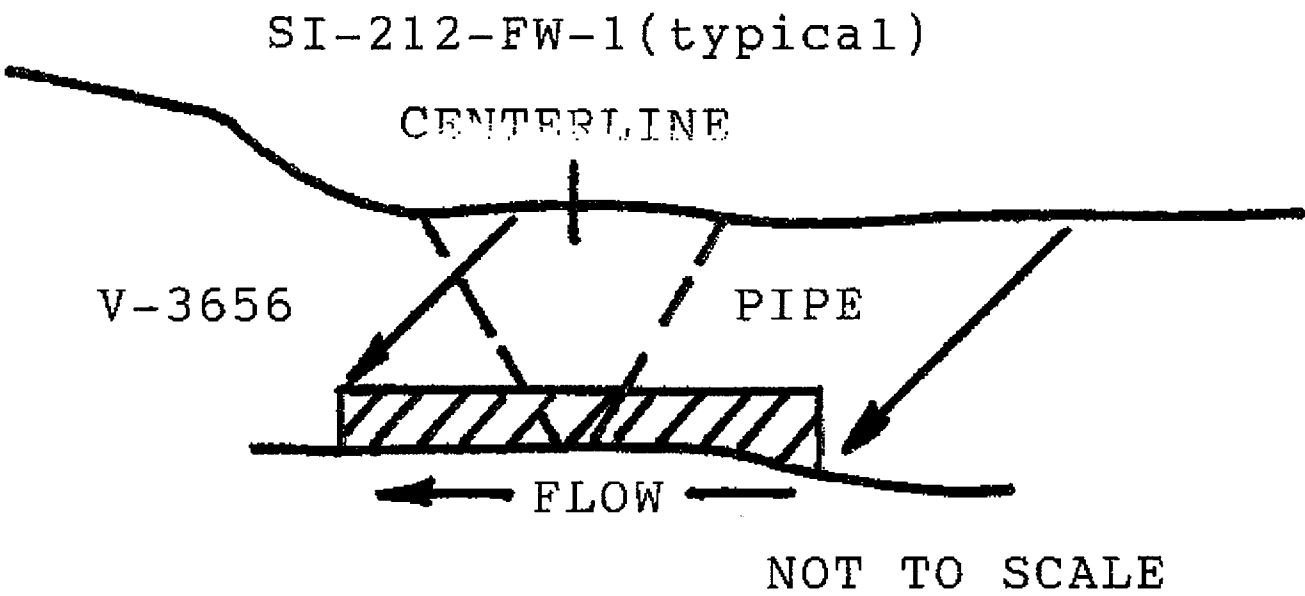
Figure 52

220100	91 C5.11	61	SI-212-FW-1	UT	45 60			Pipe to Valve V-3656	52	100% from pipe side 0% from valve side
220200	91 C5.11	61	SI-105-FW-1	UT	45 60			Valve V-3656 to Pipe	53	0% from valve side 100% from pipe side
228400	97 C5.21	62	SI-209-FW-2	UT	45 60			Valve V-3405 to Pipe	54	80% from valve side 70% from pipe side
229900	91 C5.11	62	SI-213-FW-2	UT	45 60			Valve 3654 to Pipe	55	0% from valve side 100% from pipe side

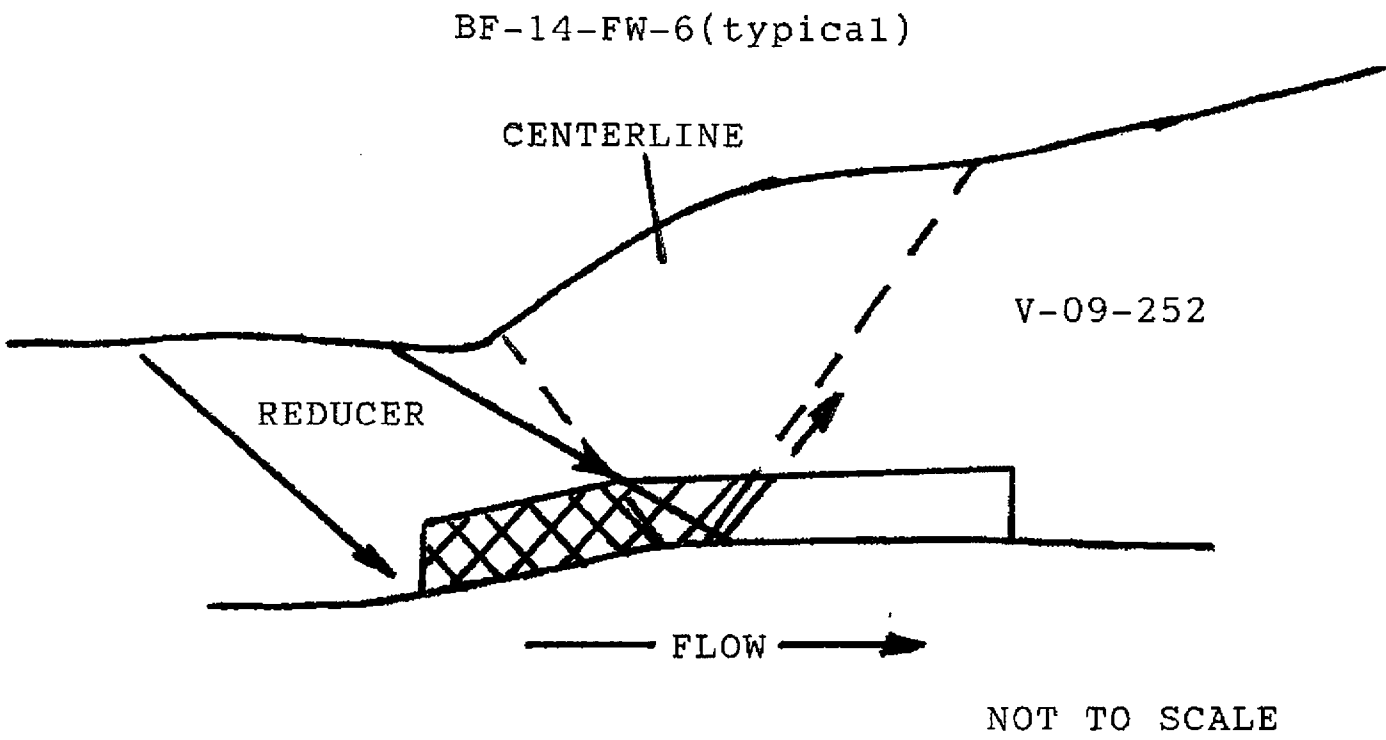
Figure 56

Code Category C-F-2 Table 21-7										
Summary #	Catgy/Item No.	Zone	Component ID	NDE Method	Angle and Technique			Configuration	Fig #	% Coverage Comments
					½ V	Full V	1 ½ V			
259000	91 C5.51	67	BF-14-FW-6	UT		60	45	Reducer to Valve V-09-252	56	50% from reducer side 55% from valve side
272600	88 C5.51	71	BF-55-FW-1	UT	60		45	Valve V-09-248 to Pipe	57	81% from valve side 68% from pipe side
273500	90 C5.51	72	BF-56-FW-1	UT	60		45	Valve V-09-280 to Pipe	57	81% from valve side 68% from pipe side
