NOTE TO: FILE
FROM: Harold Lefevre, NMSS/DWM/URB
SUBJECT: REVIEW OF 1995 AND 1996 PRE-LICENSING INSPECTION REPORTS FOR MEXICAN
HAT, UTAH UMTRA SITE

Evaluation of HAT/MON LTSP dated June 11, 1997 for water resource protection

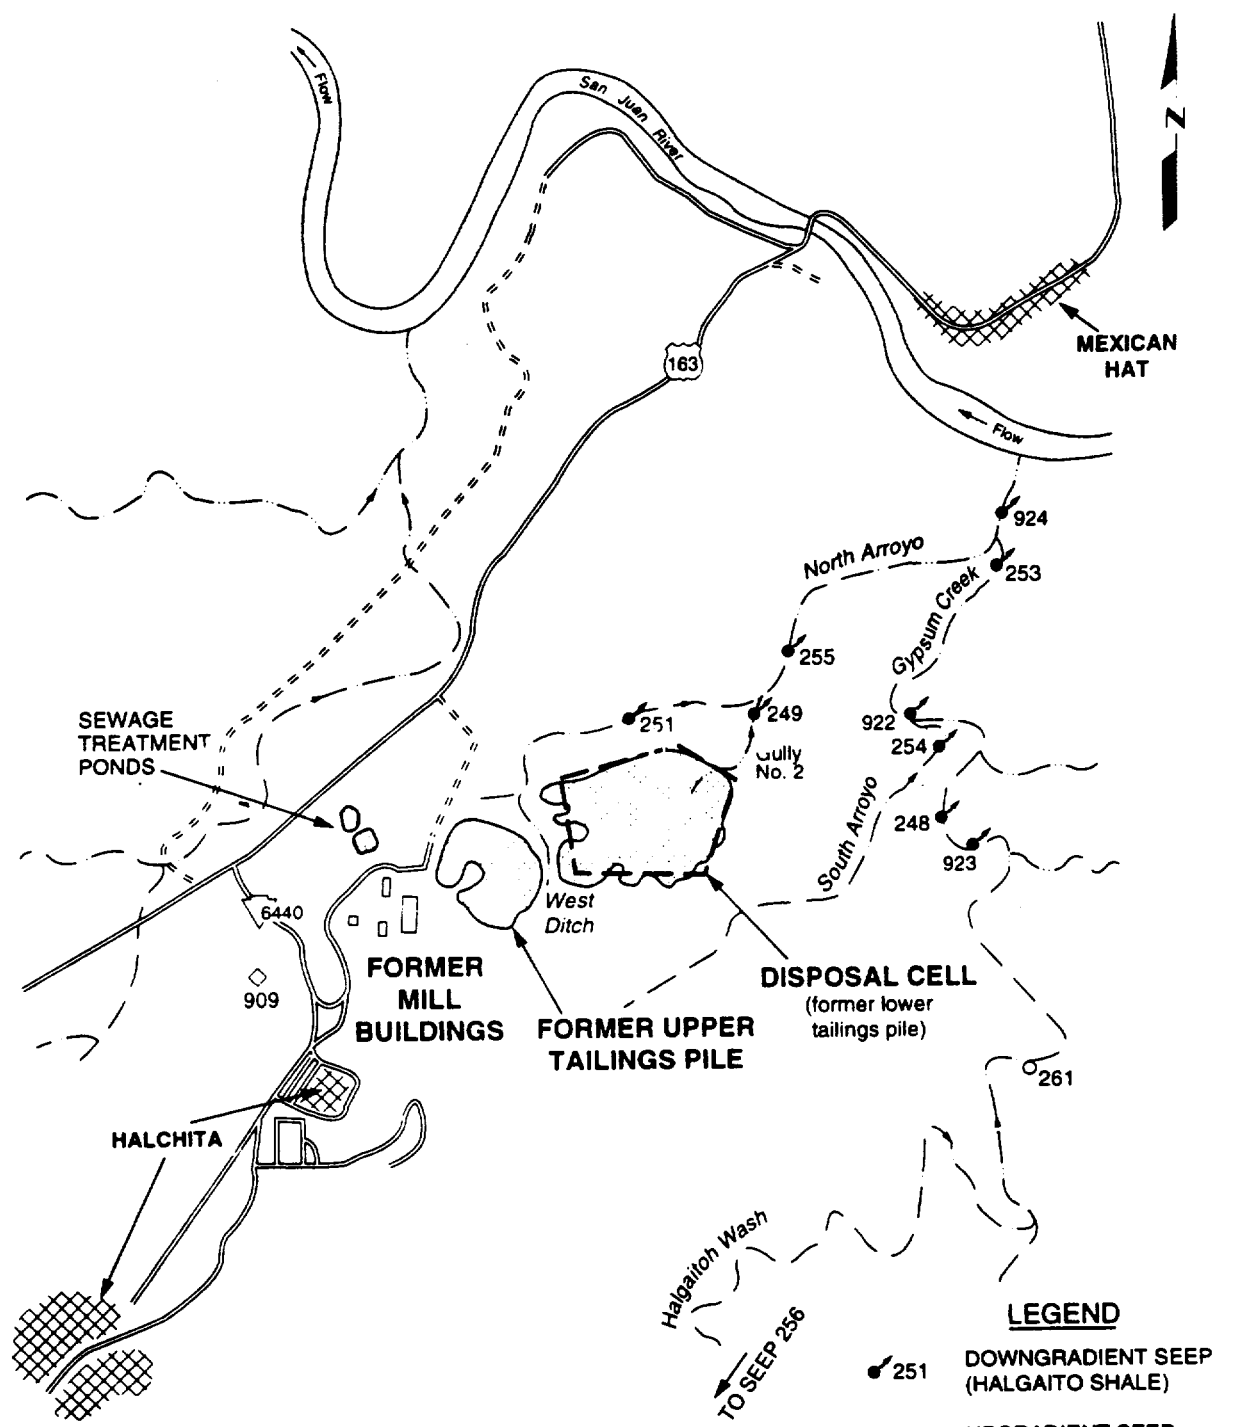
FIGURE 4.2
SEEP LOCATIONS AT THE MEXICAN HAT, UTAH, DISPOSAL SITE

Three seeps (251, 249, and 255) have been identified in or near the North Arroyo in the vicinity of the Mexican Hat disposal site (Figure 4.2). Seep 251 was first noticed in December 1989 during the relocation of the upper tailings pile to the lower tailings pile; however, dense green vegetation in aerial photographs taken as early as 1974 show evidence of the earlier occurrence of near surface water at this location. The flow rate at seep 251 was measured in February 1990 at 4 gallons (gal) (15 liters [L]) per hour, but the flow decreased until it stopped in May 1990. The seep was observed to flow again during remedial action in May 1994. It is not possible to predict when the intermittent flow from seep 251 will stop (DOE, 1995; 1993).

Flow rates at seep 249 (Figure 4.2) were 0.5 gal (1.9 L) per hour in March 1990 and 0.35 gal (1.3 L) per hour in July 1990 (DOE, 1995; 1993). A spring in this area was documented in 1968 (Snelling, 1971), and there is no record that the seep has stopped flowing since the relocation of the upper tailings pile to the lower tailings pile. The seep was observed to flow during remedial action in May 1994. Insufficient information is available to accurately predict the continuation of seepage at this location (DOE, 1995; 1993).

Flowing water has been observed at seep 255 as far back as March 1976 (DOE, 1990), and the seep was observed from 1988 through 1990 by UMTRA Project personnel. The seep was observed to flow during remedial action in May 1994. No flow rates have been measured at seep 255, and it is not possible to predict when the seep will stop flowing (DOE, 1995; 1993).

Seven seeps (261, 923, 248, 254, 922, 253, and 924) have been identified in the Gypsum Creek drainage in the vicinity of the Mexican Hat disposal site (Figure 4.2). Flow rates from these seeps have not been determined, however, the seeps do not have continuous flows of water (DOE, 1995; 1994; 1993).

DOE should, at a minimum, propose monitoring program that includes sampling and analysis of a limited number of indicator parameters in addition to the flow volume estimates. If analysis of the indicator parameters indicates a degradation of seepage water quality, then additional sampling of the full suite of constituents listed in the LTSP should be performed and an evaluation of whether degradation is the result of disposal cell failure. If the seep conditions change to the point of no flow, as is expected for some seeps, then the monitoring provisions of the LTSP can be amended to reflect those changes.
