Prairie Island Nuclear Generating Plant

**LER 1-99-08: Engineered Safety Features Actuation Following
Bus Lockout Caused by an Accidental Actuation of a Lock Out Relay**

LICENSEE EVENT REPORT (LER)

Engineered Safety Features Actuation Following Bus Lockout Caused by an Accidental Actuation of a Lock Out Relay

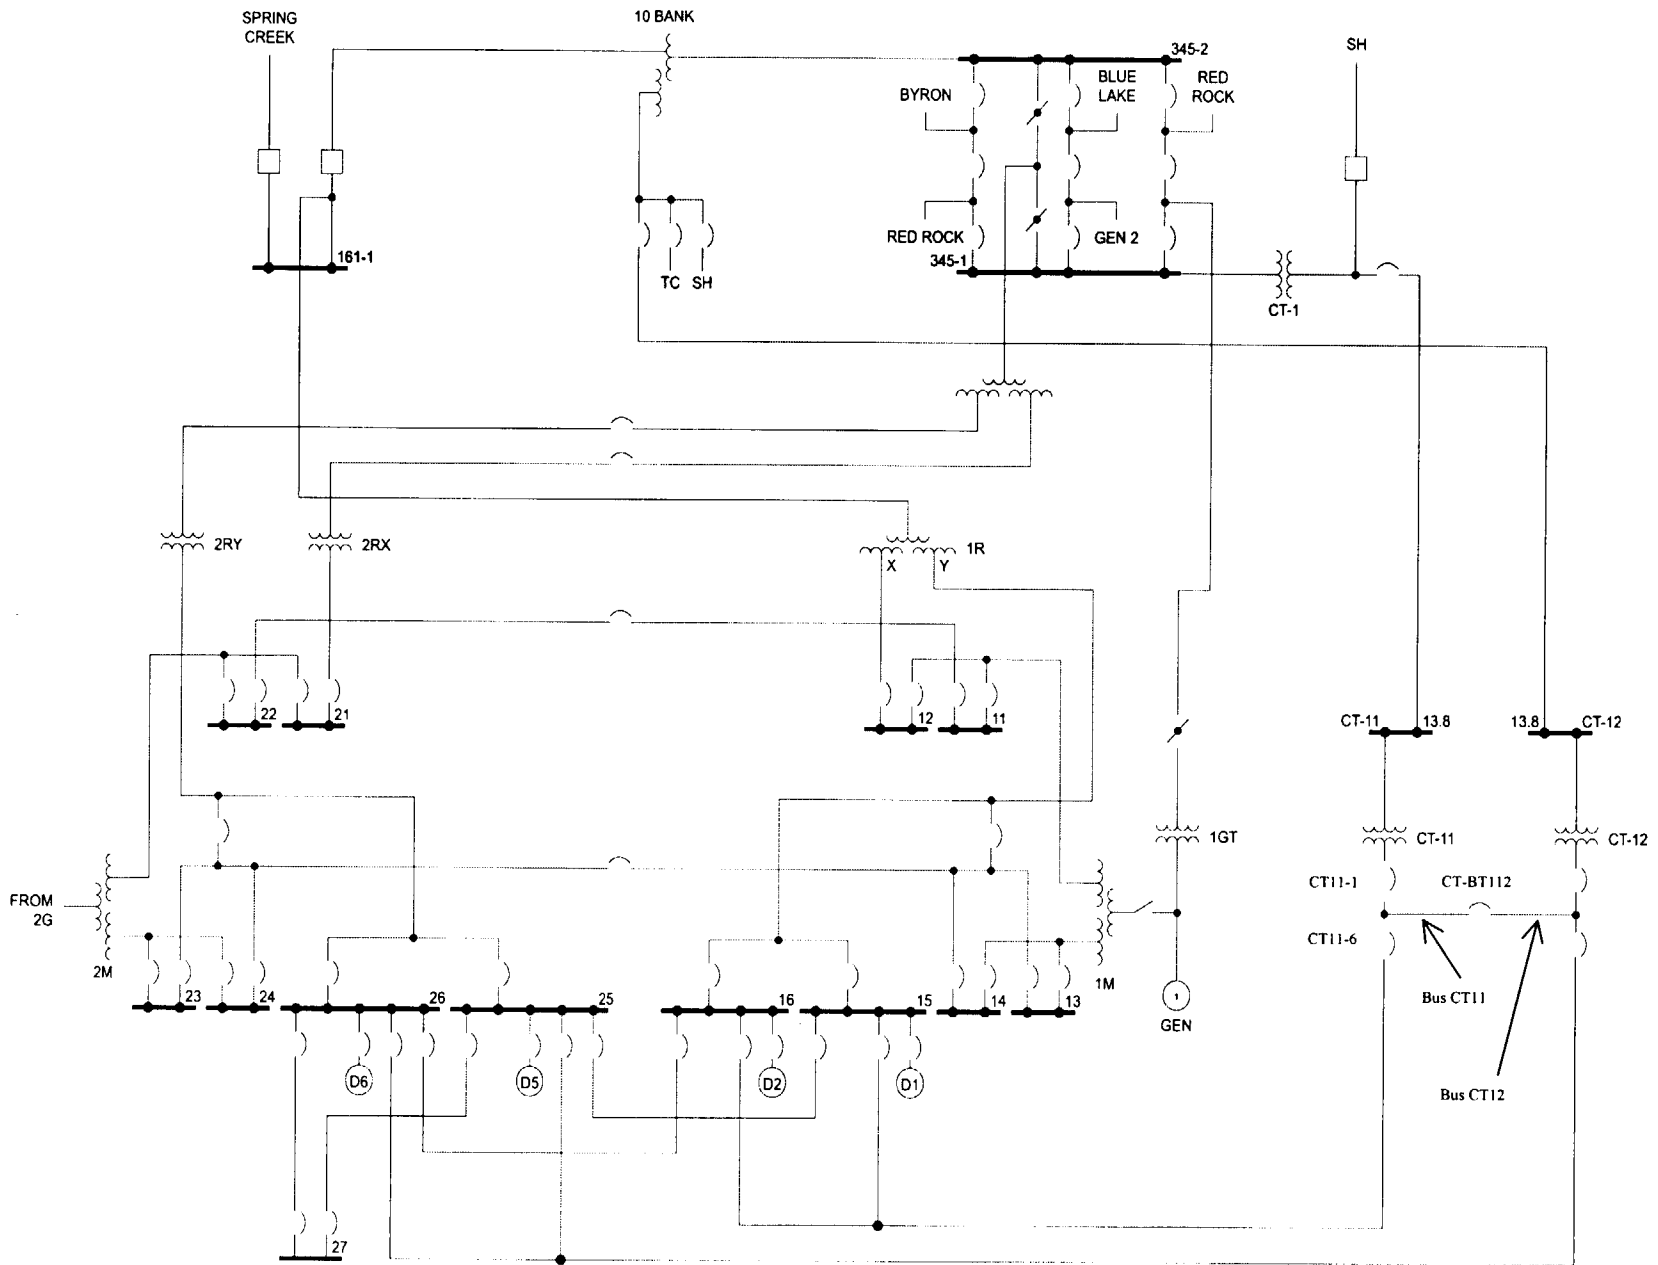
Figure 1 - Electrical Distribution

As a result of the loss of Bus CT-11 the load sequencer automatically repowered safeguards Bus 16 from the 1R source (see Figure 1). This momentary interruption of Bus 16 caused some equipment to trip. Most notably, the 11 Component Cooling Water Pump automatically started on low system pressure (caused by the loss of the 12 Component Cooling Water Pump, which tripped when power to Bus 16 was interrupted).
