DEPARTMENT OF MECHANICAL ENGINEERING  
THE UNIVERSITY OF TEXAS AT AUSTIN

Subject: Report on Technical Specification violation at The University of Texas

Reference: The University of Texas Reactor License, Docket 50-602

The Nuclear Engineering Teaching Laboratory (NETL) at The University of Texas at Austin reported a violation of the facility license Technical Specifications on December 2, 1999.

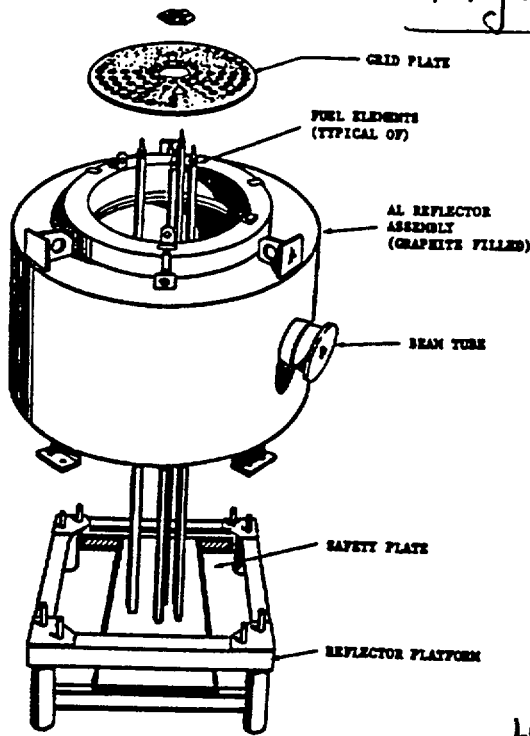
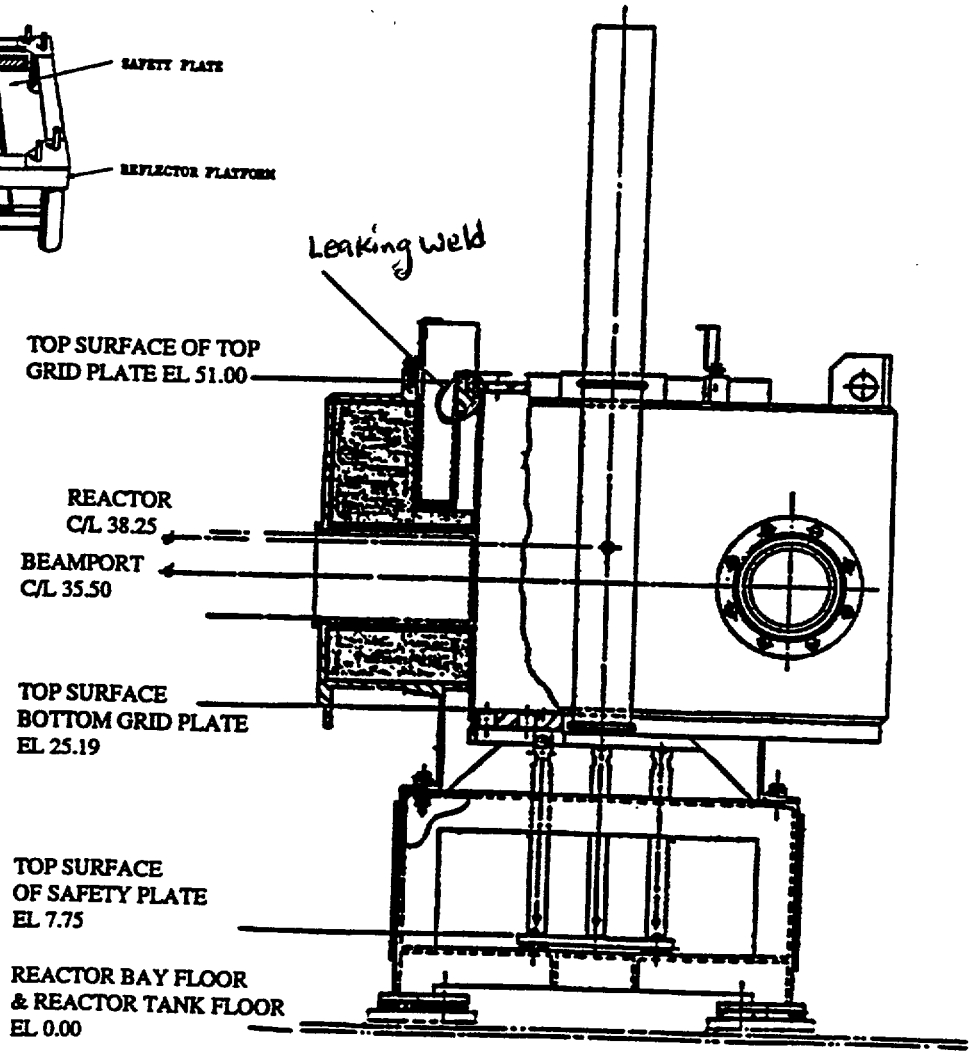
Figure 1

The ultimate cause is believed to be an extremely small leak that developed or was present from the date of manufacture in a weld of the NETL TRIGA Reactor Reflector. The Reflector is an annular, machined block of graphite canned or encapsulated in 0.25 to 0.5 inch welded Alloy 6061 aluminum. The welds are tested using dye penetrant and helium leak tests during manufacturing. The weld and approximate leak location is shown in Figure 1.

A Pneumatic Transfer Tube was found stuck in the outer ring of the reactor grid plate, but was eventually removed. Visual inspections indicated a bulging of the inner wall of the Reactor Reflector had caused binding of the experimental device. Further inspection revealed obvious bulges or swelling of the large plates forming the inner wall of the Reflector. Four non-fuel graphite elements were also found to be binding. The locations of the graphite elements, pneumatic tube and approximate bulges locations are shown in Figure 2. The NRC and General Atomics (GA) were notified of the unusual circumstances and the continuing investigation.

Repeatable (in size and location but spread in time) bubbles were eventually noticed while unloading the fuel from the reactor at a rate of one per 1.5 hours. At this point it became clear there had been a failure of the Reflector outer boundary producing a leakage into the system and gas venting. Plans were made for draining the reactor pool and installing a continuous vent or purge system to compensate for the leak. It was hoped that the Reflector could remain dry and not compromise the Reflector characteristics or several experiment locations.

The NETL has been consulting with various experts in hydrogen, gaseous fuels and explosives to determine the best method of venting the flammable gases. At this time, it is believed that a controlled venting of the internal gases by slowly drilling or piercing the aluminum container is the most likely means of correcting the present conditions.

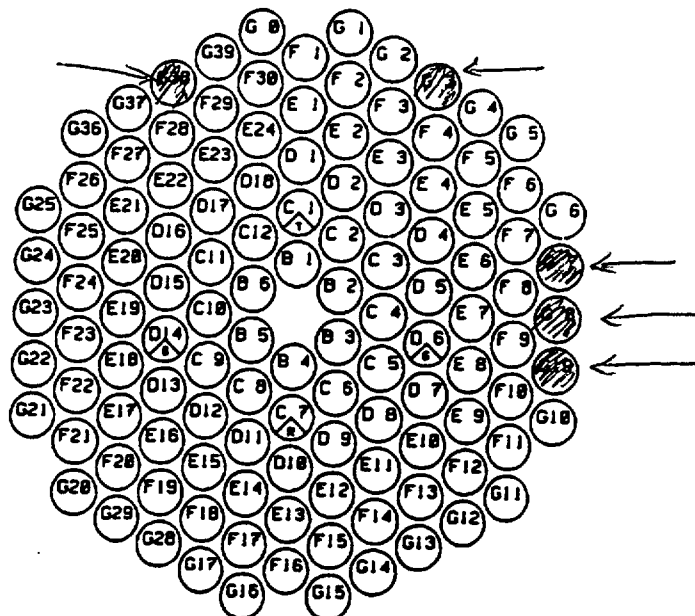
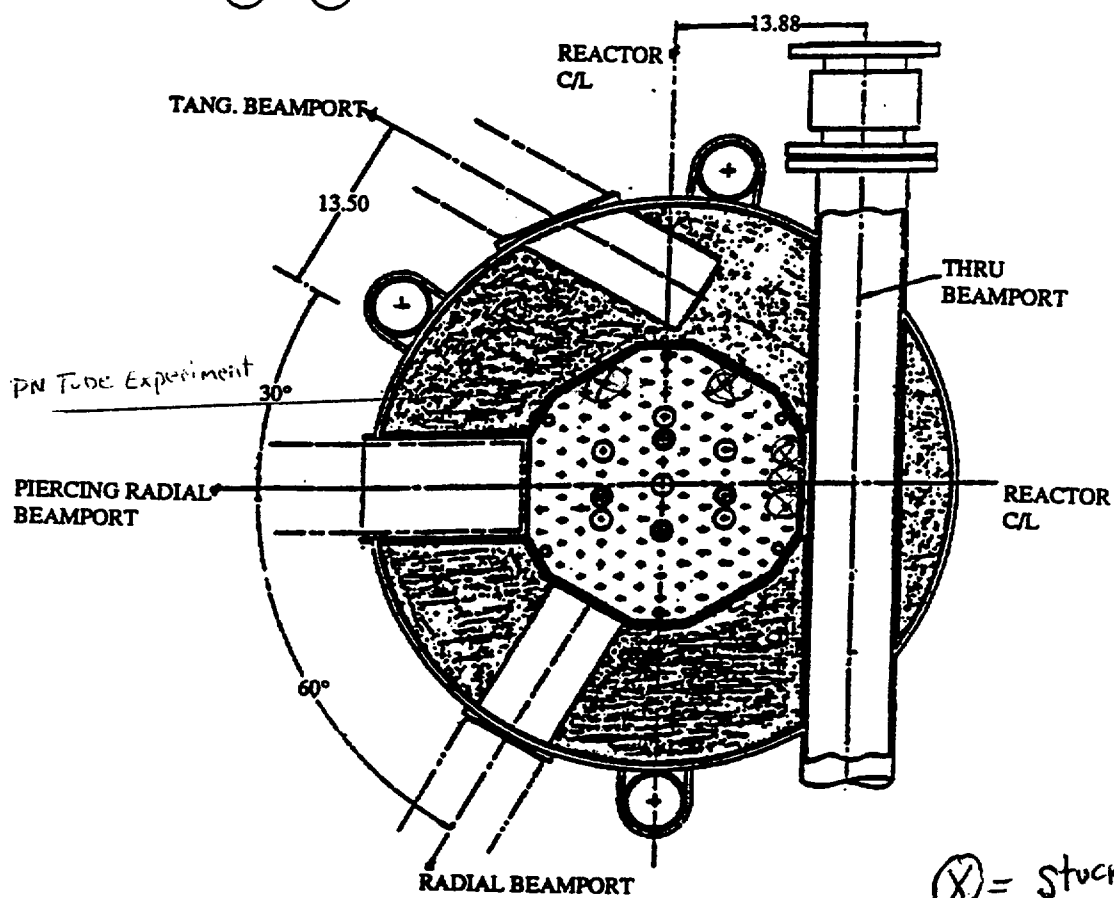
Figure 4-27

⊗ = stuck element or device
