DEPARTMENT OF MECHANICAL ENGINEERING
THE UNIVERSITY OF TEXAS AT AUSTIN

Nuclear Engineering Teaching Laboratory • (512) 471-5787 • FAX (512) 471-4589

Subject: Report on Technical Specification violation at The University of Texas

Reference: The University of Texas Reactor License, Docket 50-602

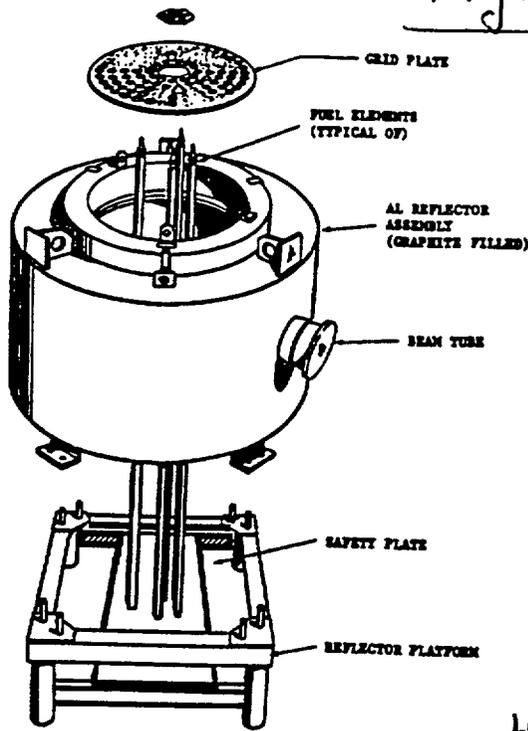
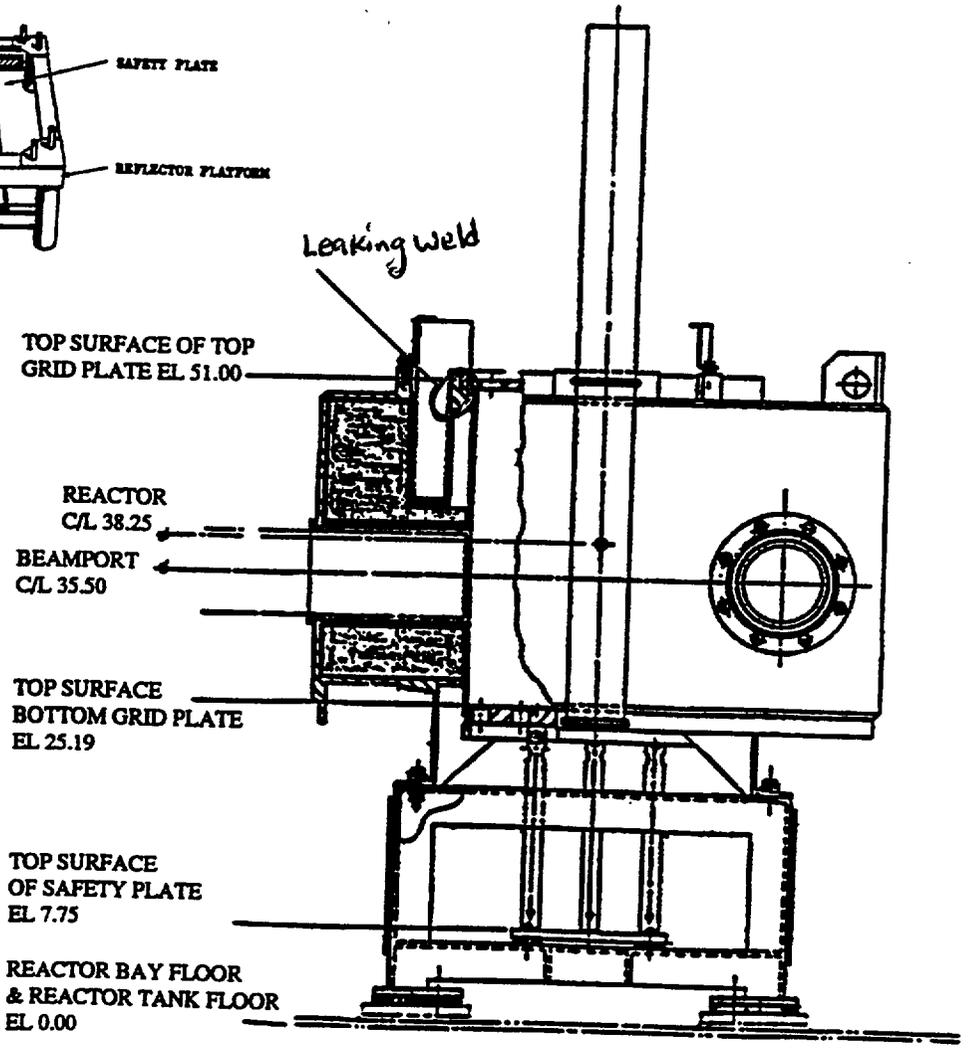
Figure 1

The ultimate cause is believed to be an extremely small leak that developed or was present from the date of manufacture in a weld of the NETL TRIGA Reactor Reflector. The Reflector is an annular, machined block of graphite canned or encapsulated in 0.25 to 0.5 inch welded Alloy 6061 aluminum. The welds are tested using dye penetrant and helium leak tests during manufacturing. The weld and approximate leak location is shown in Figure 1.

The NETL has been consulting with various experts in hydrogen, gaseous fuels and explosives to determine the best method of venting the flammable gases. At this time, it is believed that a controlled venting of the internal gases by slowly drilling or piercing the aluminum container is the most likely means of correcting the present conditions.
