**Subject: Beaver Valley Power Station, Unit No. 2
Docket No. 50-412, License No. NPF-73
Response to Request for Additional Information
Unit 2 SG Tube Inspection Surveillance Interval Extension,
License Amendment Request No. 142**

Document Identifier 51- 5002381-01

Title Beaver Valley-2 Condition Monitoring and Operational Assessment: 08/98 Forced Outage

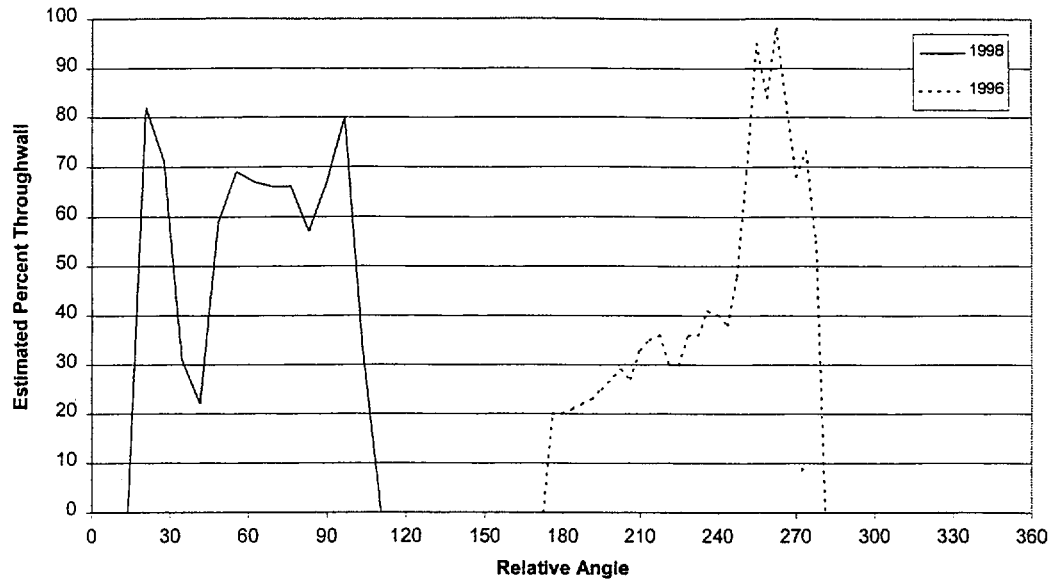
Figure 3-1

**Depth Profile For SG C R8 C46
Beaver Valley-2 08/98 Forced Outage**

SG	Row	Col	1998			1996		
			Volts	Length	PDA	Volts	Length	PDA
C	8	46	0.50	0.74"	13.8	0.14	0.83"	12.7
B	8	50	0.21	0.23"	3.0	0.15	0.36"	8.2
A	13	88	0.11	0.85"	22.3	0.12	0.91"	22.4
A	8	48	0.23	0.22"	2.6	NDD	NDD	NDD
A	33	31	0.14	0.16"	3.8	NDD	NDD	NDD

SG	Row	Col	Volts	Length	PDA
C	8	46	0.36	-0.09	1.1
B	8	50	0.06	-0.13	-5.2
A	13	88	-0.01	-0.06	-0.1
A	8	48	0.23	0.22	2.6
A	33	31	0.14	0.16	3.8
Average¹			0.16	0.08	1.50
STD DEV¹			0.14	0.11	1.67

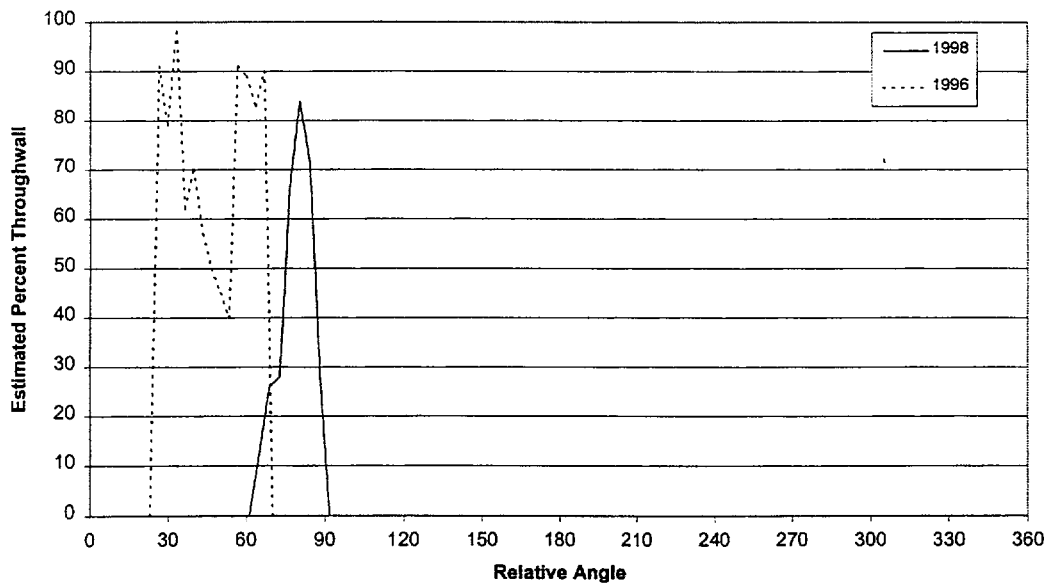
Figure 3-2

**Depth Profile For SG B R8 C50
Beaver Valley-2 08/98 Forced Outage**

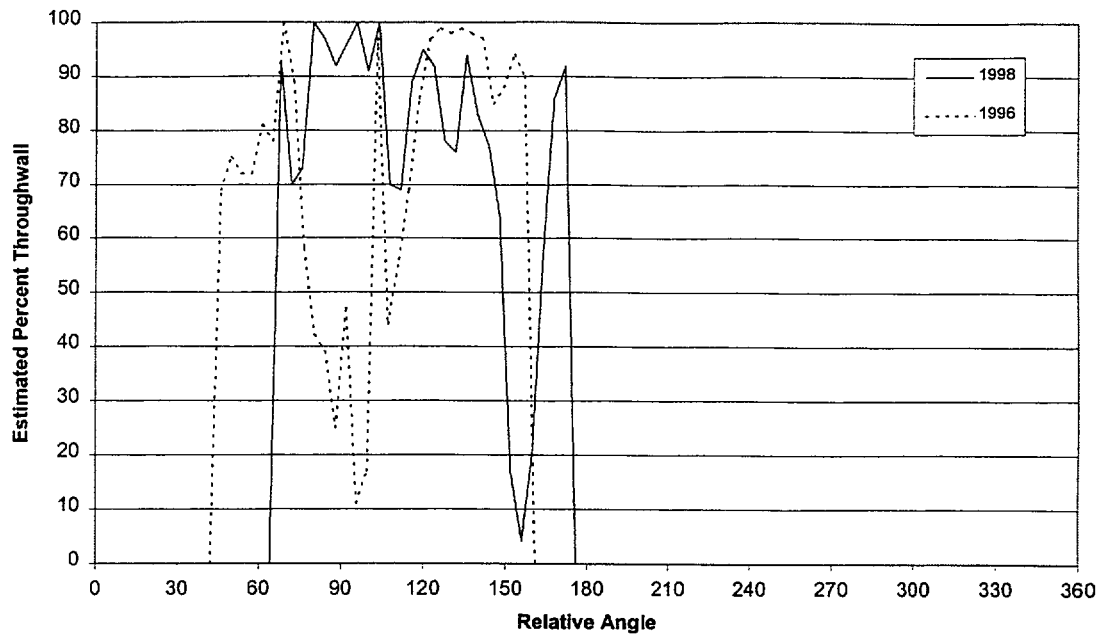
Figure 3-3

**Depth Profile For SG A R13 C88
Beaver Valley-2 08/98 Forced Outage**

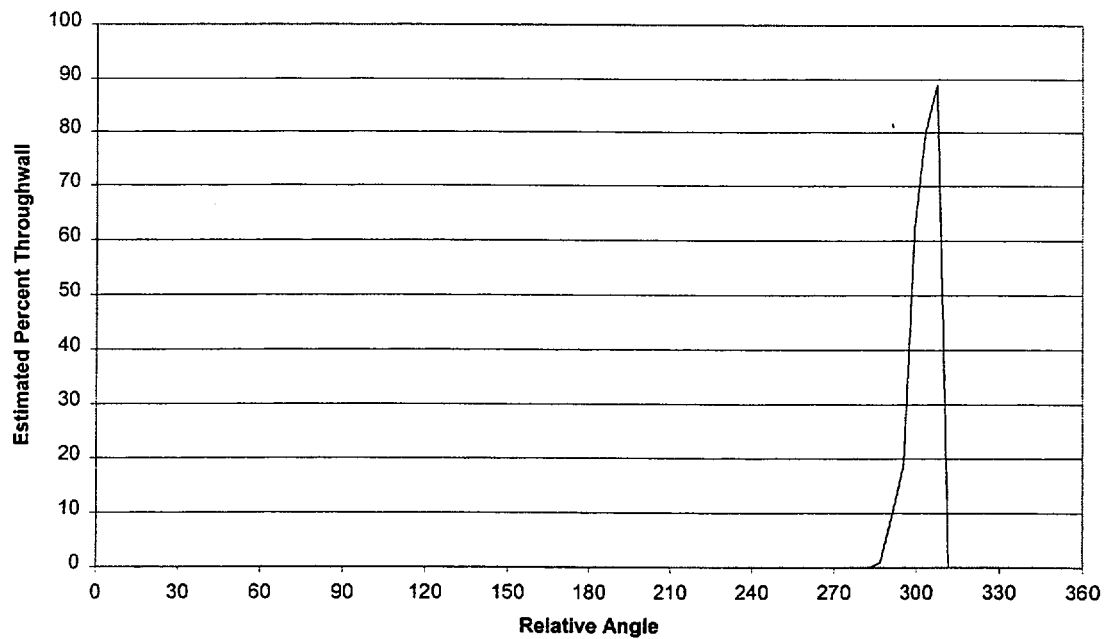
Figure 3-4

**Depth Profile For SG A R8 C48
Beaver Valley-2 08/98 Forced Outage**

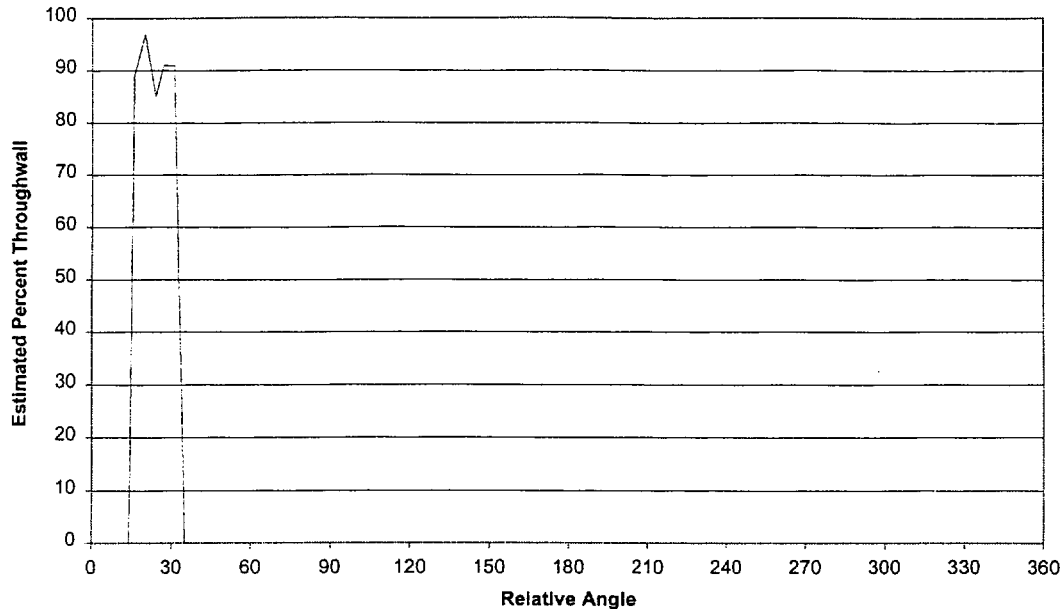
Figure 3-5

**Depth Profile For SG A R33 C31
Beaver Valley-2 08/98 Forced Outage**

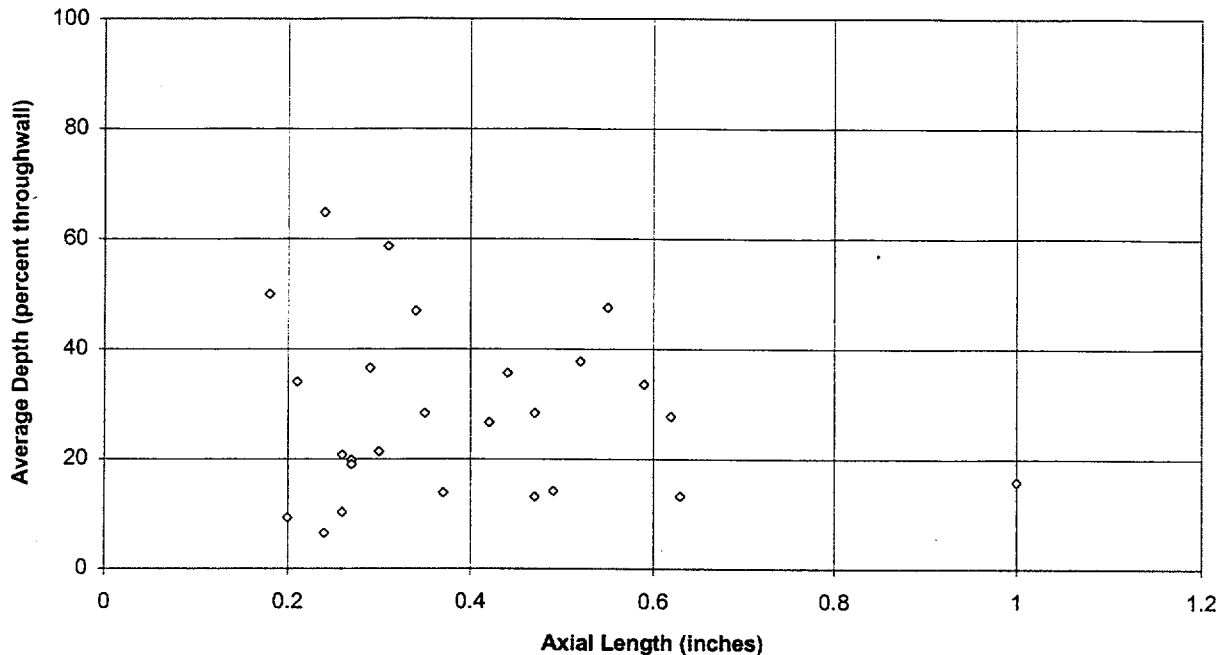
For the purposes of this report, the detection threshold will be 0.45" and 25%TW average depth. Figure 4-1 shows that for the last two inspections at BVPS-2, 7 out of the 25 indications which had depth profiles done were below this threshold. This gives assurance that indications below this threshold are detectable.

**Average Depths vs. Axial Lengths for TSH Indications
Beaver Valley-2 1996 2R6 and 08/98 Forced Outage**
