December 22, 1999
NG-99-1798

Subject: Duane Arnold Energy Center
Docket No: 50-331
Op. License No: DPR-49
Licensee Event Report #1999-007
File: A-120

LICENSEE EVENT REPORT (LER)

TITLE (4)
Safety Relief Valve Opened During 125VDC Ground Troubleshooting Due to Two Faults in the Solenoid Valve DC Circuit.

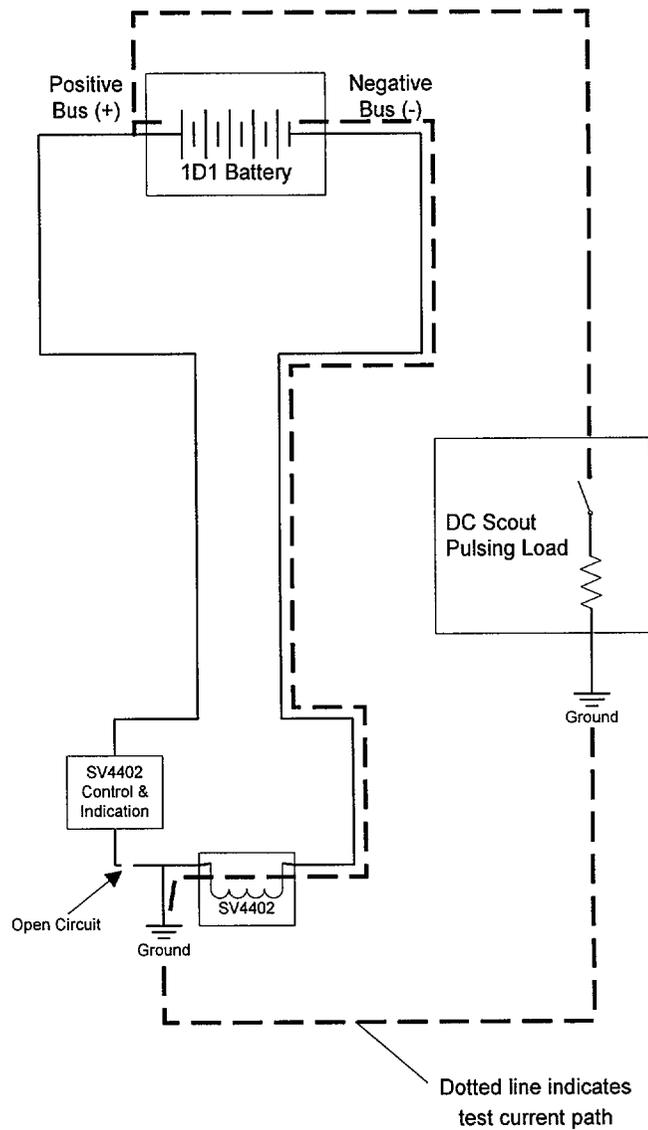
Figure 1: Location of Open and Ground in SV-4402 Circuit

Solenoid Valve (SV) 4402 is a normally de-energized, DC solenoid operated valve that, when energized by the ADS logic, opens and provides nitrogen pressure to open PSV-4402. Inspection of the electrical connections to SV-4402 revealed an open circuit at the field side of the positive Grayboot pin and a ground (to the conduit) on the positive side of SV-4402. The location of these two faults explains why a negative ground had been indicated.

With the D.C. Scout connected to the positive 125 VDC bus (looking for the negative ground), a current path was established through SV-4402 (see Figure 1). Given this current path, once the 50 milliamp output of the D.C. Scout was applied, the current was high enough to energize (open) the normally de-energized SV-4402. Evaluation of the circuit's resistance verified that 50 milliamps was a large enough current to pick up the solenoid.

The cause of the event was the damage to the Grayboot connection that created the open circuit and the grounded wire (two separate faults) inside the conduit. The wiring that runs between the junction box and SV-4402 is contained inside a flexible conduit (Sealtite), which is located inside the plant's drywell at a level and location susceptible for personnel to step on. Due to nearby weld repairs inside the drywell during the outage, there was considerable foot traffic over the top of this conduit. Based on these factors and work history from previous outages, it is concluded that the root cause of the damaged connection/wiring is from personnel stepping on the flexible conduit for SV-4402.

The damaged Grayboot connection and wiring was repaired, post maintenance testing completed and the valve declared operable at 2250 hours on November 29, 1999. Upon reaching 150 psig during the subsequent plant startup, PSV-4402 successfully passed STP 3.4.3-03 at 0315 on November 30, 1999.

A rigid support will be installed to protect the flexible conduit for SV-4402. This action will be completed by the end of RFO-17 and will be tracked by AR #18176. A search indicated there are 6 installed Grayboot connections inside the drywell, all of them on the SRVs. The remaining SRVs are not located in a vulnerable foot traffic area like PSV-4402. Maintenance history reviews did not identify a trend of similar problems in the other SRVs. Therefore, generic actions to protect the conduit on all of the SRVs are not warranted at this time.
