**UNITED STATES
NUCLEAR REGULATORY COMMISSION**

SUBJECT: INSPECTION NO. 99990001/99-013 AND NOTICE OF VIOLATION

INSPECTION REPORT

Rowe International, Inc.
NRC Inspection Report No. 99990001/99-013

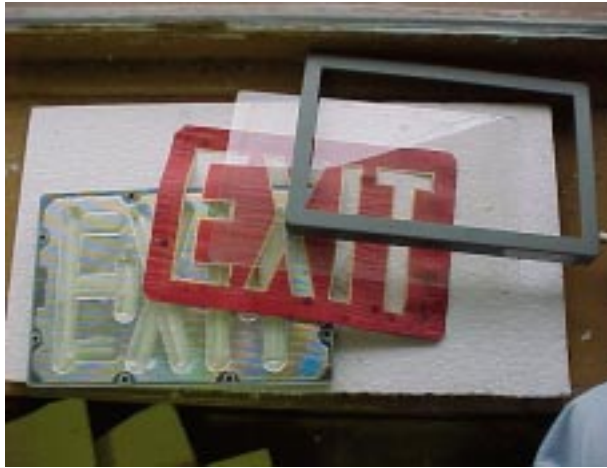
Figure 5 - Pieces of Disassembled Exit Sign

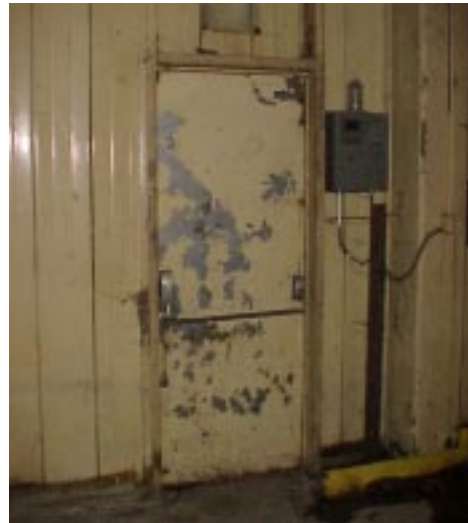
In preparation for demolition of the facility, a Sovereign employee was to remove all the signs. On December 6, 1999, the employee was removing a sign from above an exit door at the northeast side of the "high bay" building with a crow bar. The sign fell to the concrete floor and the glass cover of the sign was broken. The employee noticed that a glass tube in the "X" of the sign was cracked and that the cracked tube did not glow as brightly as the rest of the sign. The employee placed the sign in a cardboard box and transported it back to the training building.

Figure 6 - Door where Broken Sign was Installed

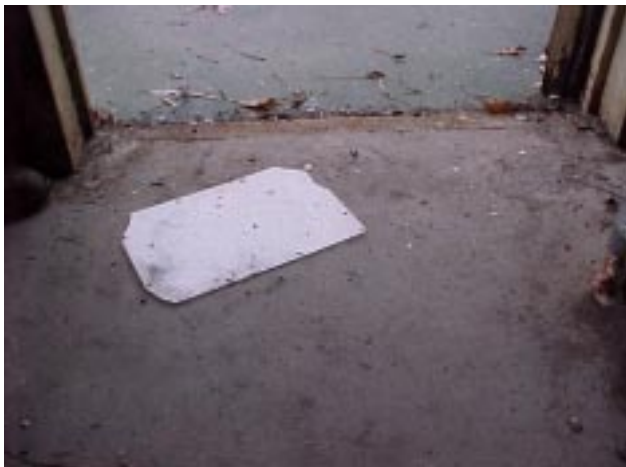
Removable contamination levels of up to 105 dpm/100 cm² were measured at Sovereign's Robbinsville, NJ, office. Removable contamination levels of up to 16,300 dpm/100 cm² were measured on the glass cover from the broken sign and up to 9,960 dpm/100 cm² in the area where the sign broke at the Rowe facility. These tritium contamination levels were at least 700 times less than the undetermined removable contamination screening value from Table 1. Therefore, the dose and resultant risk to a member of the public that would result from the free release of these facilities would be negligible. Therefore, no remediation of these facilities is necessary.

Figure 7 - Cover of Broken Sign (in location where sign was damaged)

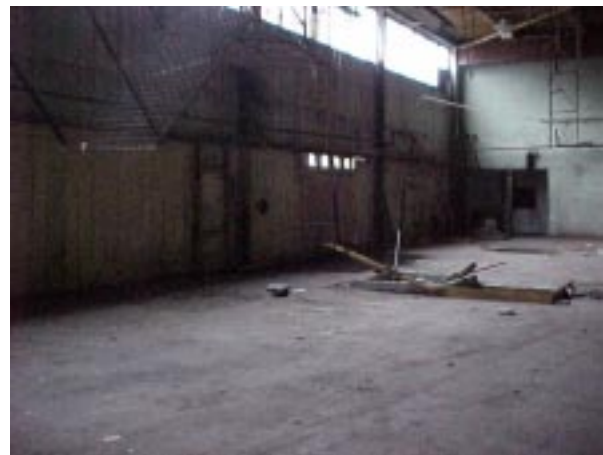
19	Floor where sign broke in "high bay" building	381 ± 11
20	Floor where sign broke in "high bay" building	181 ± 9
21	Intact signs in storage	821 ± 13
22	Intact signs in storage	147 ± 8

Figure 8 - Area of Building Where Sign Was Damaged
