Dresden Nuclear Power Station, Unit 2  
Facility Operating License No. DPR-19  
NRC Docket No. 50-237

Subject: Licensee Event Report 1999-005-01, "Inadvertent Reactor Vessel Drain Down Through an Electromatic Relief Valve Caused by Procedure Non-Adherence Due to Inadequate Supervision and Ownership of Work"

## LICENSEE EVENT REPORT (LER)

Inadvertent Reactor Vessel Drain Down Through an Electromatic Relief Valve Caused by Procedure Non-Adherence Due to Inadequate Supervision and Ownership of Work

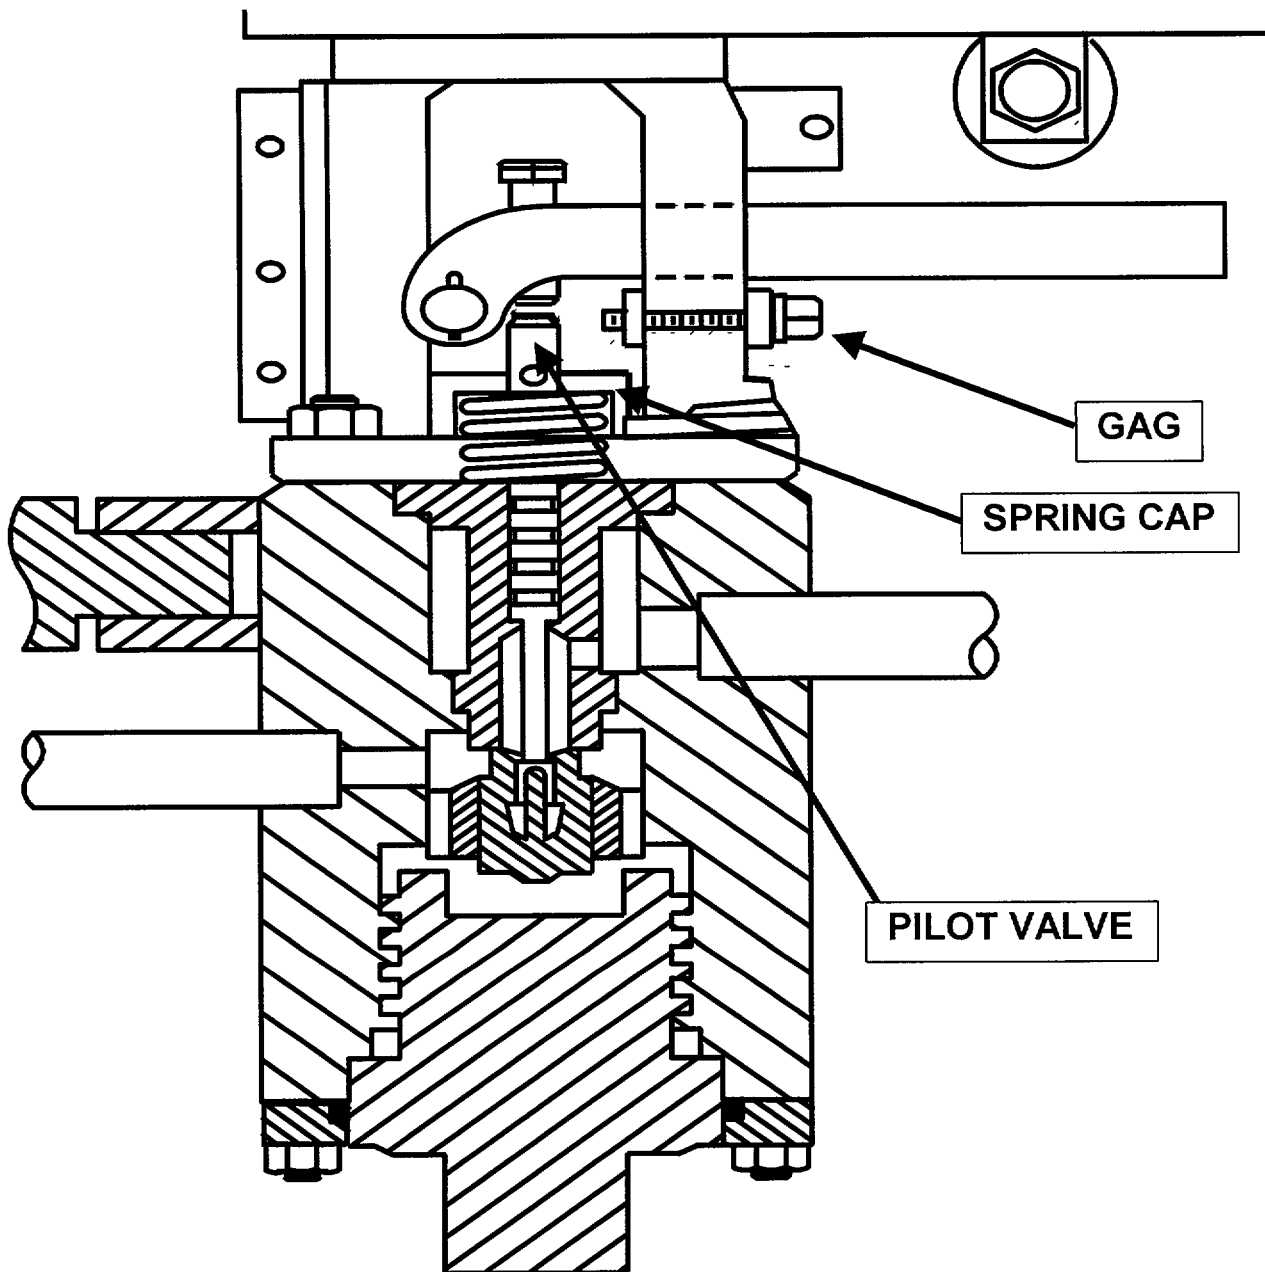
Figure 1  
ERV Pilot Valve Diagram

- Each stroke of the valve was smooth and no binding of the pilot valve during operation was observed.
- A general inspection of the pilot valve assembly found that no foreign material was present and the general appearance of the valve was clean. The seating surfaces were in good condition and showed no indication of foreign material induced damage.
- The pilot valve stem had slight galling marks on an otherwise smooth surface.
- The pilot valve seat bushing's outer surface revealed an indication of where a compressed spring had been pressed against the side of the bushing.

- Physical inspection of the ERV pilot valve stem and bushing revealed that the ERV pilot valve spring cap was skewed believed to be due to inappropriate maintenance. Potential causes include contact with the ERV gag, mechanics wrench, or mechanics hands during ERV gag repositioning. The most likely cause is contact with the ERV gag. The ERV gag should have been removed and was not. This was due to failure to follow station procedure as written. The procedure was not followed as written due to inadequate supervision and ownership of the work.
