**Subject:** Response to the Staff's Requests for Additional Information (RAI) Regarding the Steam Generator Tube Examinations conducted during Spring of 2000 Outage, and the Root Cause Evaluation of the Steam Generator Tube Rupture Event of February 15, 2000 (TAC No. MA8219)

**Response to Questions Regarding Steam Generator Tube Examinations  
Performed During Spring 2000 Outage**

**Consolidated Edison Company of New York, Inc.  
Indian Point Unit No. 2  
Docket No. 50-247  
June 2000**

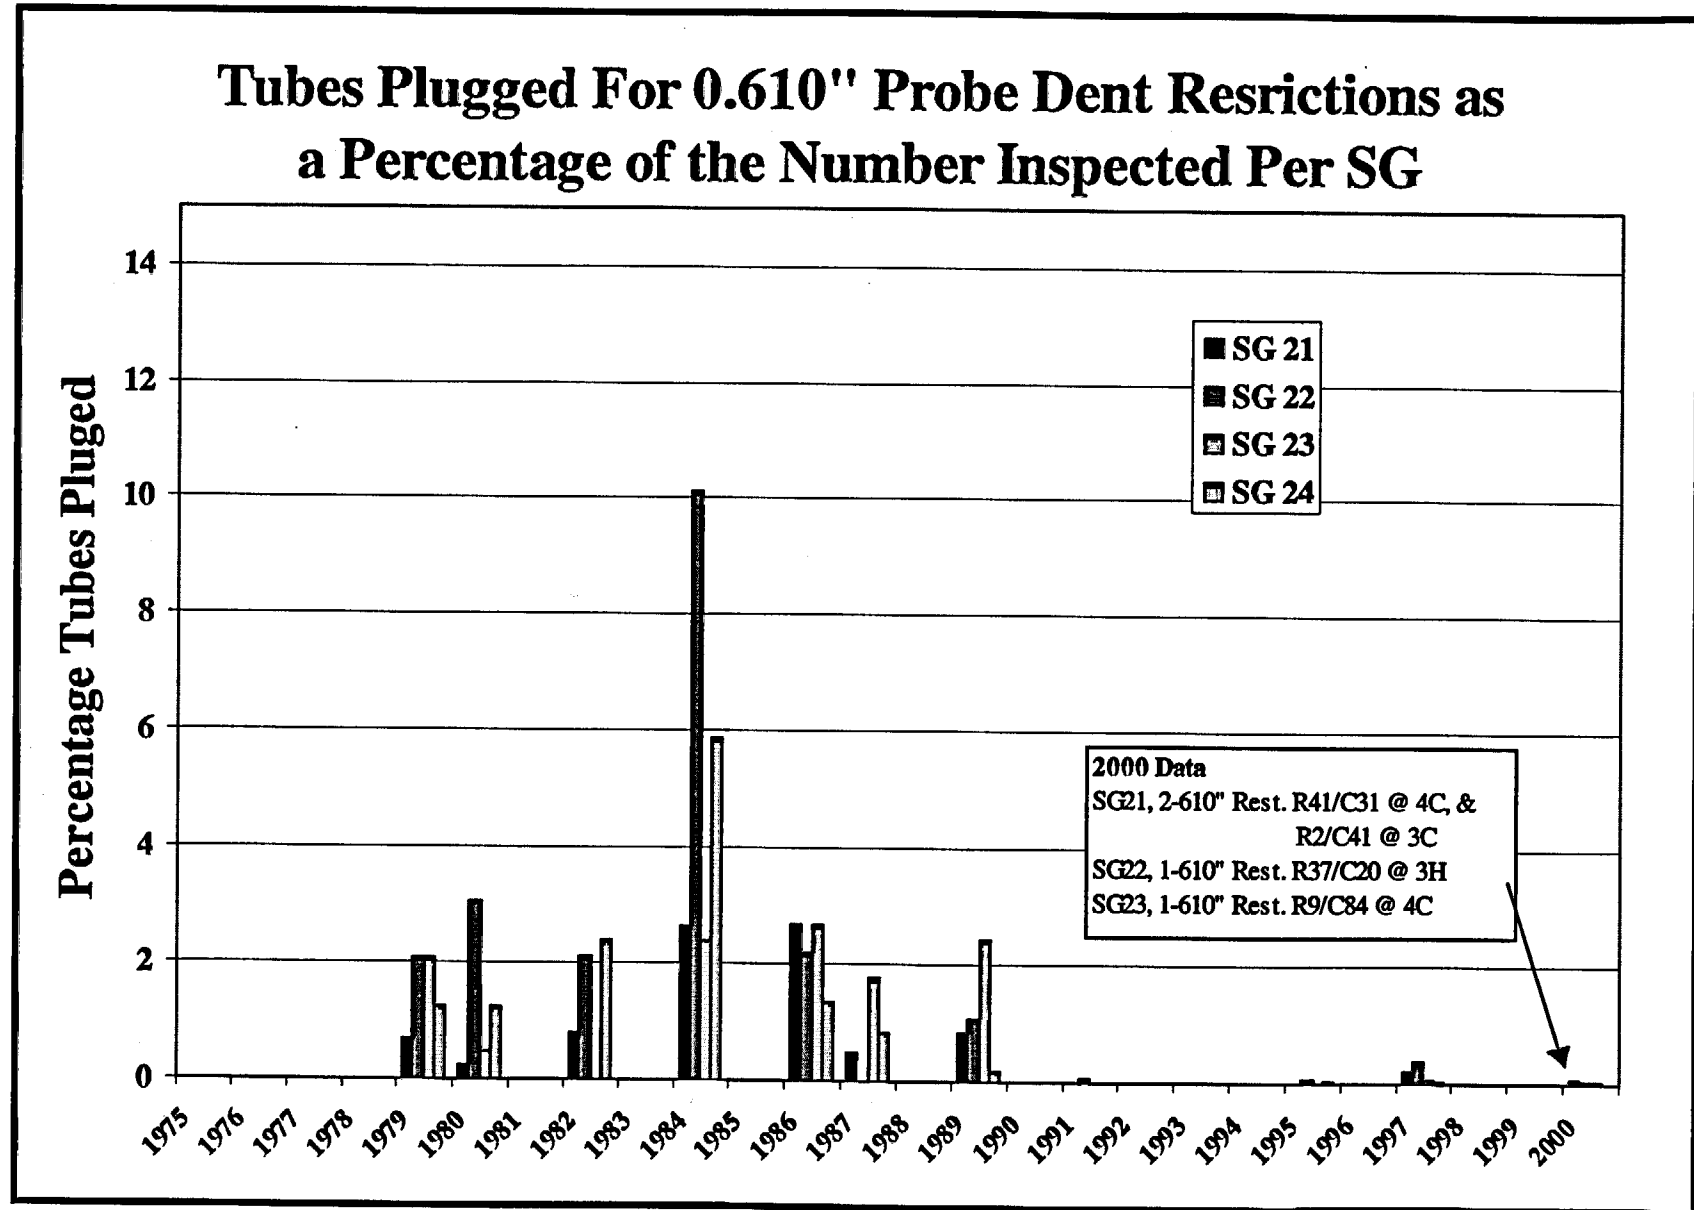
Figure 1

The number of tubes plugged for 610 mil probe dent restrictions as a percentage of the total number of tubes inspected each outage since 1979 is shown in Figure 1. This Figure showed that the percentage of tubes plugged for restriction to the 610 mil probe peaked in 1984 and has declined since that time.

Therefore the data does indeed indicate that the increase in the number of tubes identified as being restricted to the 610 mil probe in 1997 was due to an inspection transient for three reason:

- 1) The 1995 inspection focused on AVB ware in rows 16 and higher. Almost all of the 1997 restrictions were in low row U-bend areas.
- 2) The number of tube restrictions decreased from 1997 to 2000, and
- 3) The inspection scope and probes used in 1997 and 2000 were the same.
