**Subject: Beaver Valley Power Station, Unit No. 1  
Docket No. 50-334, License No. DPR-66  
Completion Report for Generic Letter 87-02,  
USI A-46 Program**

### Beaver Valley Power Station Unit 1 (BV-1) Generic Letter 87-02, USI A-46 Completion Report

### **Updated Outlier Completion Tabulation**

JOB NO. 250540 JOB BEAVER VALLEY A-46 OUTLIER RESOLUTION  
 CALC. NO. C-021 SUBJECT OUTLIER RESOLUTION FOR DAMPERS

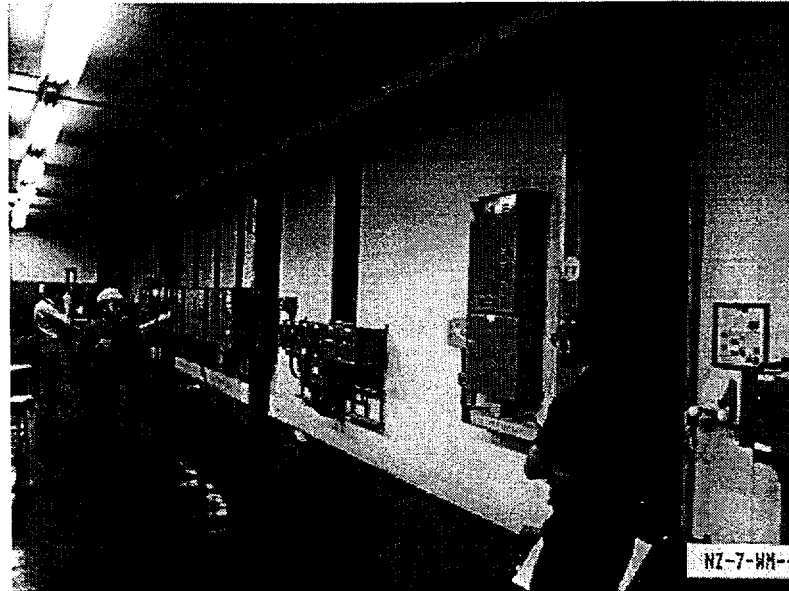
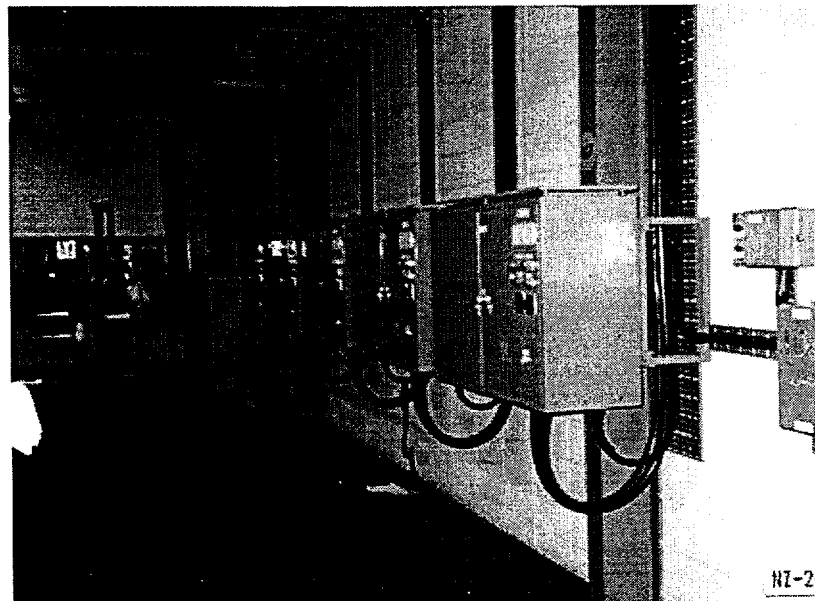
Figure 1: Wall-mounted distribution panelboards exceeding the standard dimensions for depth (dimension normal to the wall) create a question regarding the effect of increased mass moment arm cantilevered from the wall anchorage. Some of the best examples of excessive cantilevered mass in panelboards and similar wall-mounted cabinets are found at sites which withstood the 1987 earthquake in New Zealand. The examples illustrated above are wall-mounted cabinets serving the Whakatane Paper Mill (PGA = 0.3g), where the center of gravity of the cabinets is cantilevered an estimated 18 inches from the bolts anchoring the cabinets to the supporting block wall.

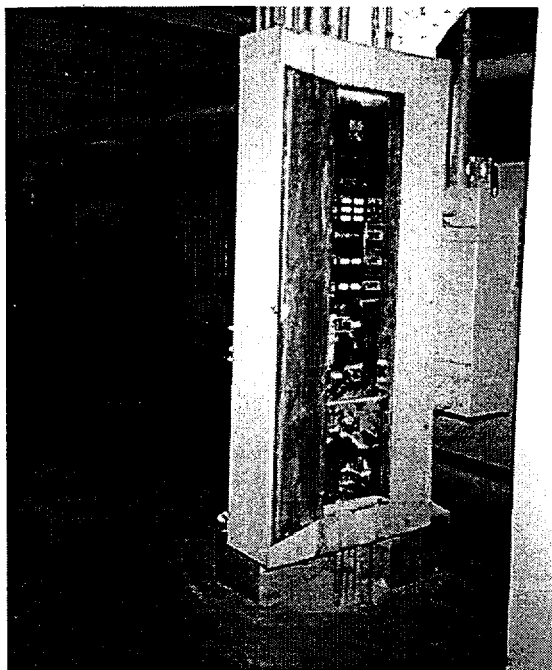
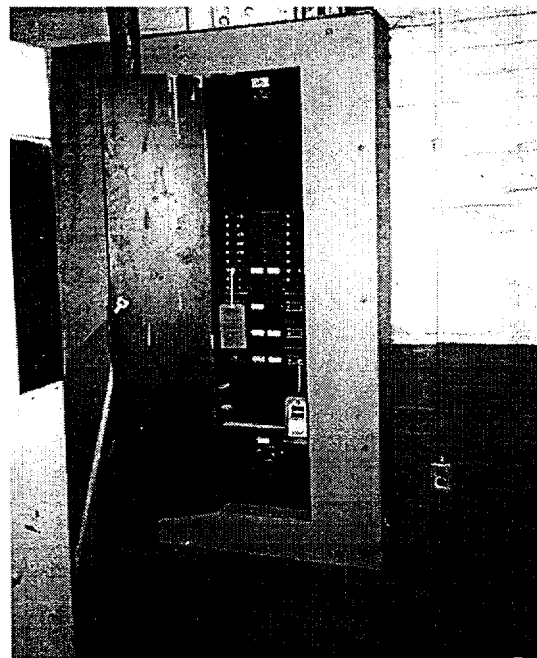
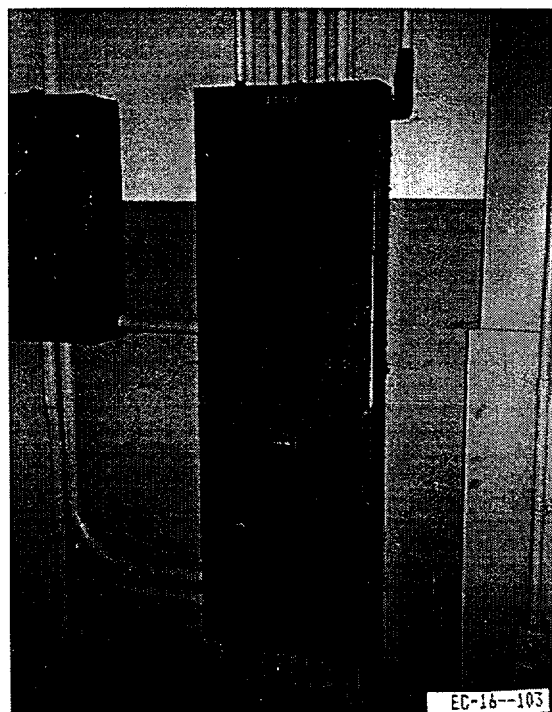
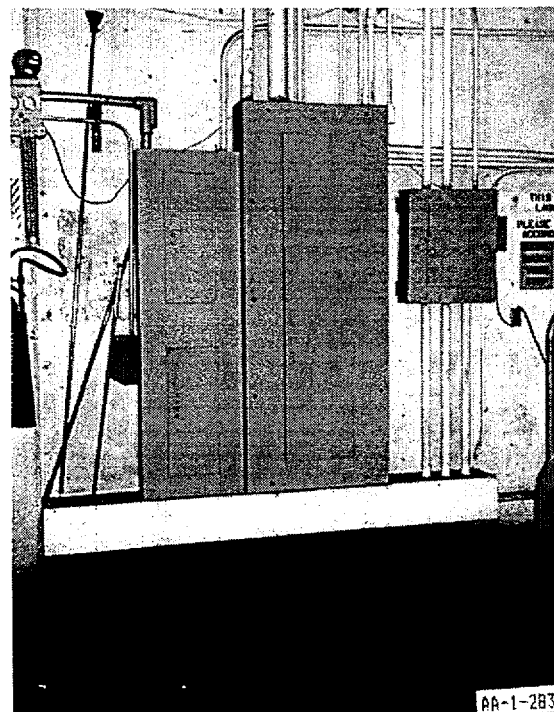
Figure 2: Examples of wall-mounted panelboards ranging from 60 to more than 70 inches in height are found at El Centro Steam Plant (upper and lower left photos, which withstood the earthquakes of 1979 and 1987, with PGA's of 0.42g and 0.25g respectively), and at the Adak Naval Base (lower right photo, which withstood the earthquake of 1986, PGA= 0.25g).

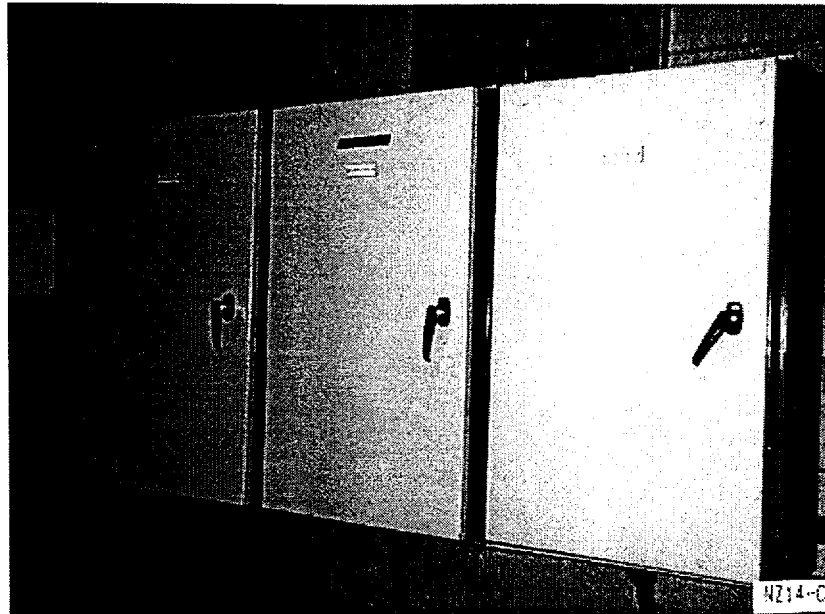
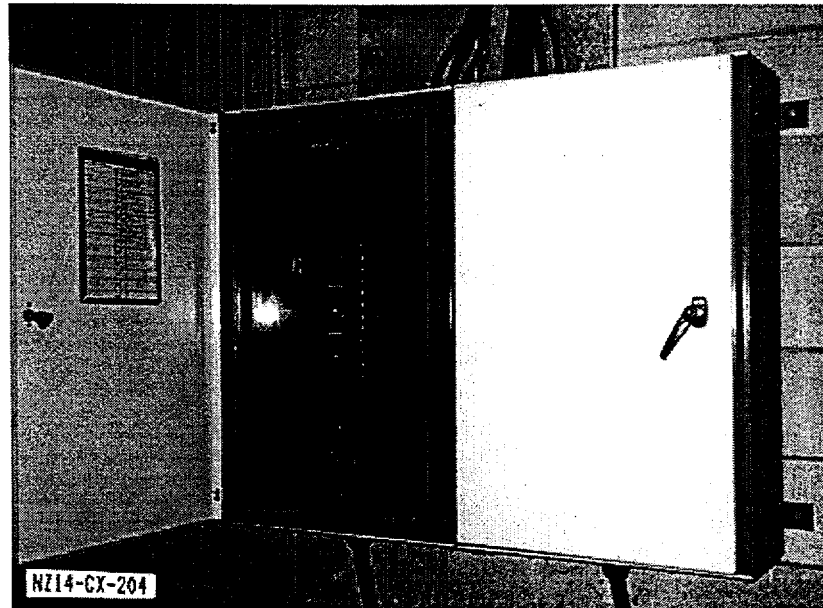
Figure 3: Wall-mounted panelboards exceeding the standard dimensions of width also create a question of excessive mass cantilevered from their supporting wall anchorage. Examples of wall-mounted panelboards exceeding 40 inches in width (~ 72") include double and triple panelboards combined as single wall-mounted cabinets at the Caxton Paper Mill, which withstood by the 1987 earthquake in New Zealand, PGA= 0.40g.

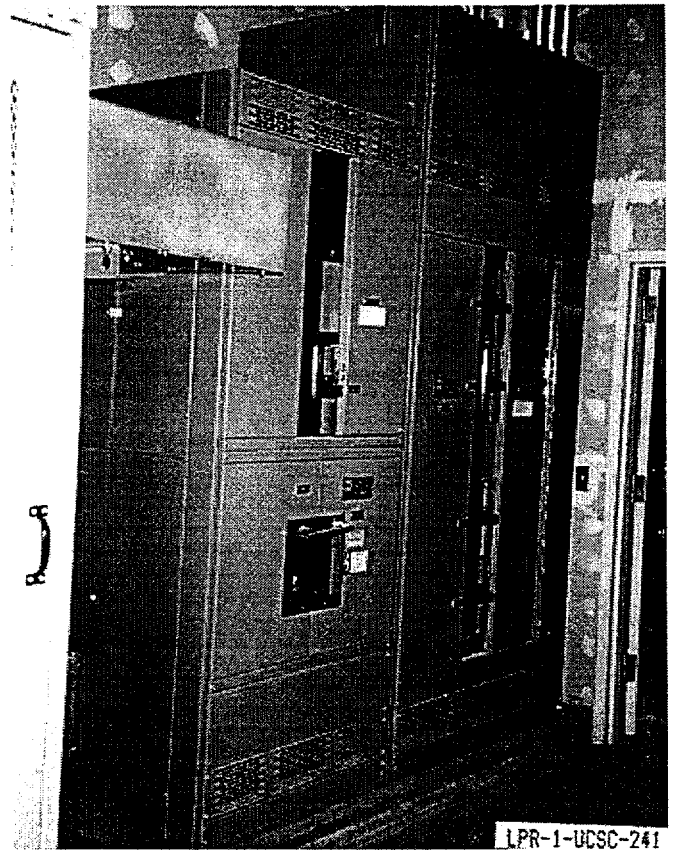
Figure 4: Switchboards exceeding the standard 90 inches in height present a question of excessive mass concentrated at the top of the cabinet, or an excessively high center of gravity. Cabinet height extensions sometimes include cable pullboxes into which overhead conduit connections are made, as in the two examples illustrated in the photos. The switchboards are located in the electrical rooms of the UC Santa Cruz Central Campus, which withstood the 1989 Loma Prieta earthquake ( $PGA = 0.4g$ ).

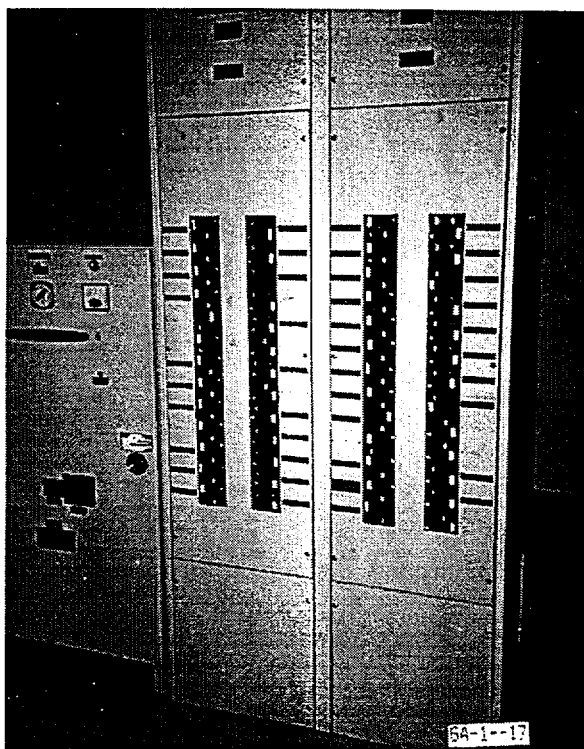
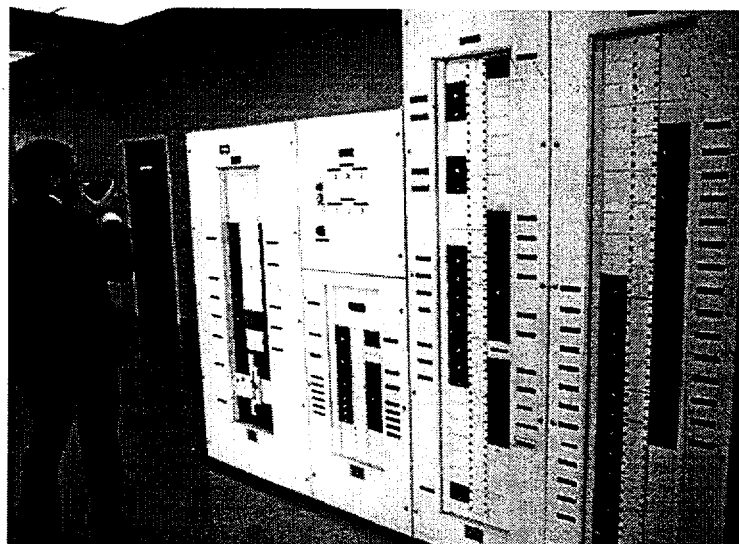
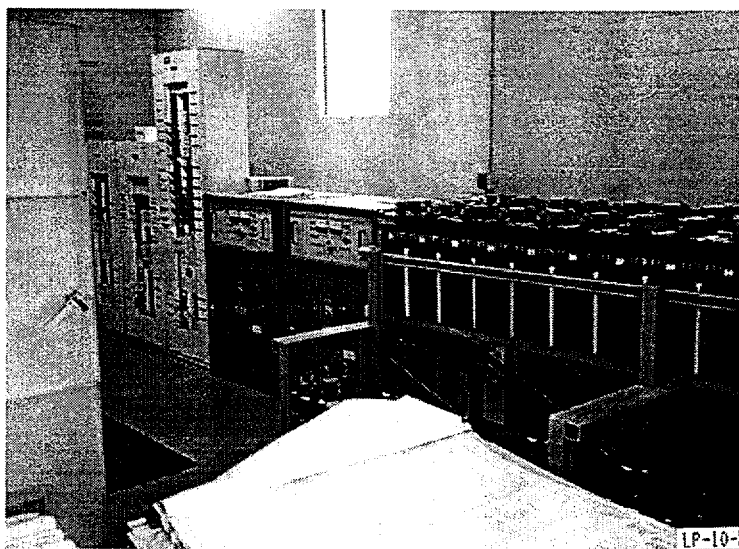
Figure 5: Switchboards with heights estimated from 94 to 98 inches are found at certain electrical substations. Examples of excessively tall switchboards are found at the Gates Substation (left photo, 1983 Coalinga earthquake,  $PGA = 0.25g$ ), at Metcalf Substation (upper right, 1984 Morgan Hill,  $PGA = 0.40g$ , and 1989 Loma Prieta,  $PGA = 0.30g$ , earthquakes), and at Moss Landing Substation (lower right, 1989 Loma Prieta earthquake,  $PGA = 0.30g$ ).

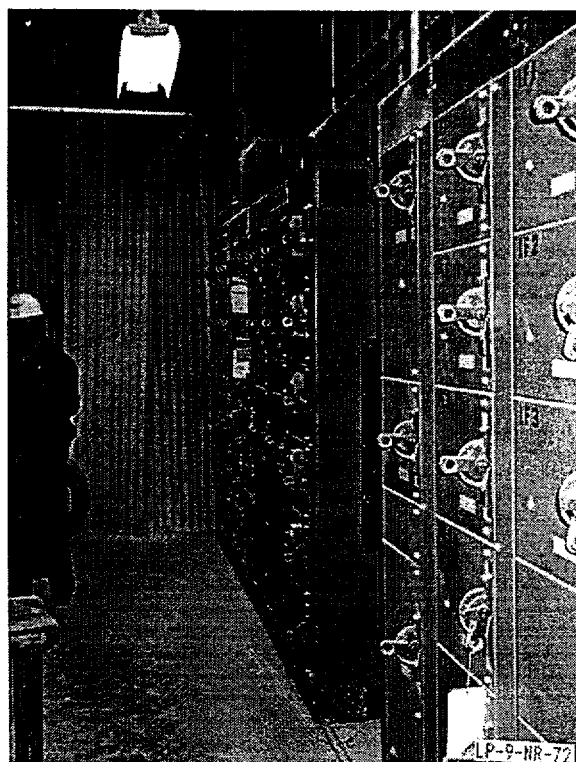
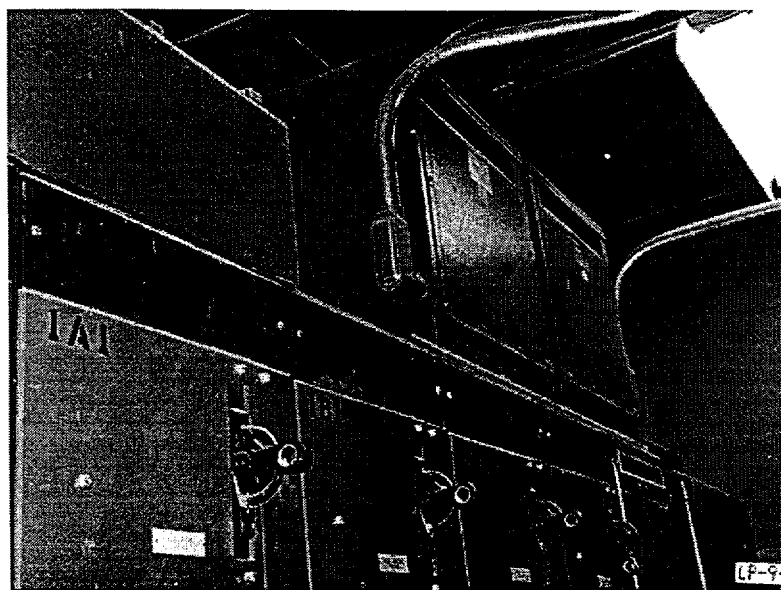
Figure 6: Examples of excessive mass concentrated above the standard cabinet height of 90 inches are best illustrated by the heavy distribution transformers mounted atop motor control centers (with characteristics similar to those of a switchboard) at the National Refractory, which withstood the 1989 Loma Prieta earthquake,  $PGA = 0.30g$ . The two transformers, which comprise concentrated masses of about 100 pounds each, did not overstress the floor anchorage of the MCCs or otherwise damage the cabinets or the switching components housed within.
