**Indian Point 2 Steam Generator Tube Failure
Lessons-Learned Report
(TAC No. MA9163)**

**Final Report
October 23, 2000**

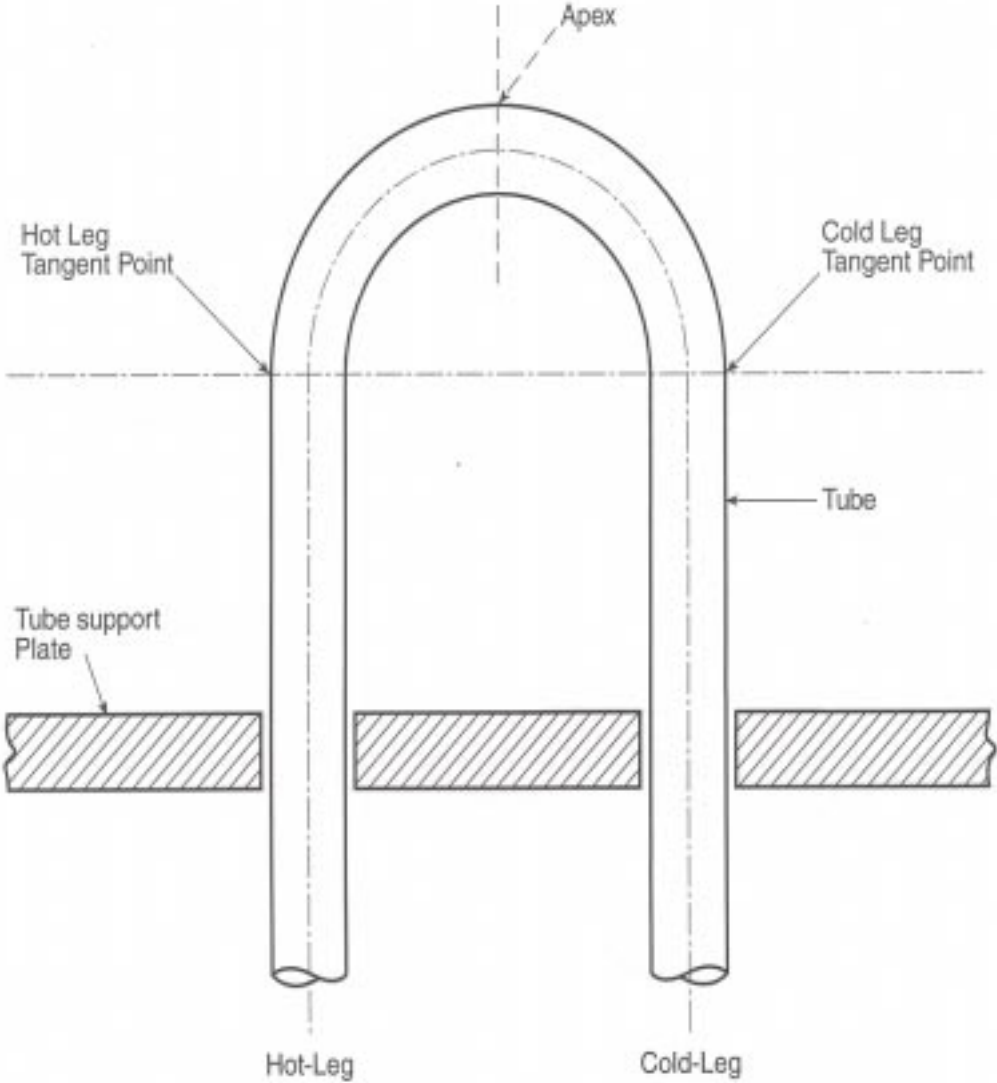
Figure 3-2: Typical Steam Generator Tube U-bend

After placing the unit in the cold shutdown condition, Con Ed inspected SG 24 and found that the row 2, column 5 (R2C5) tube had failed. This small-radius, low-row tube had cracked at the apex of the tube U-bend due to primary water stress corrosion cracking (PWSCC). A typical SG and a typical SG tube U-bend are shown in Figures 3-1 and 3-2. Con Ed's inspection included an eddy current test (ECT) examination of the SG tubes and visual examinations of the secondary side of the SGs. During these ECT inspections, Con Ed found that greater than 1% of the tubes in SGs 21 and 24 contained defects, placing the unit in a condition that required NRC approval before restarting the plant in accordance with the technical specifications (TSs).

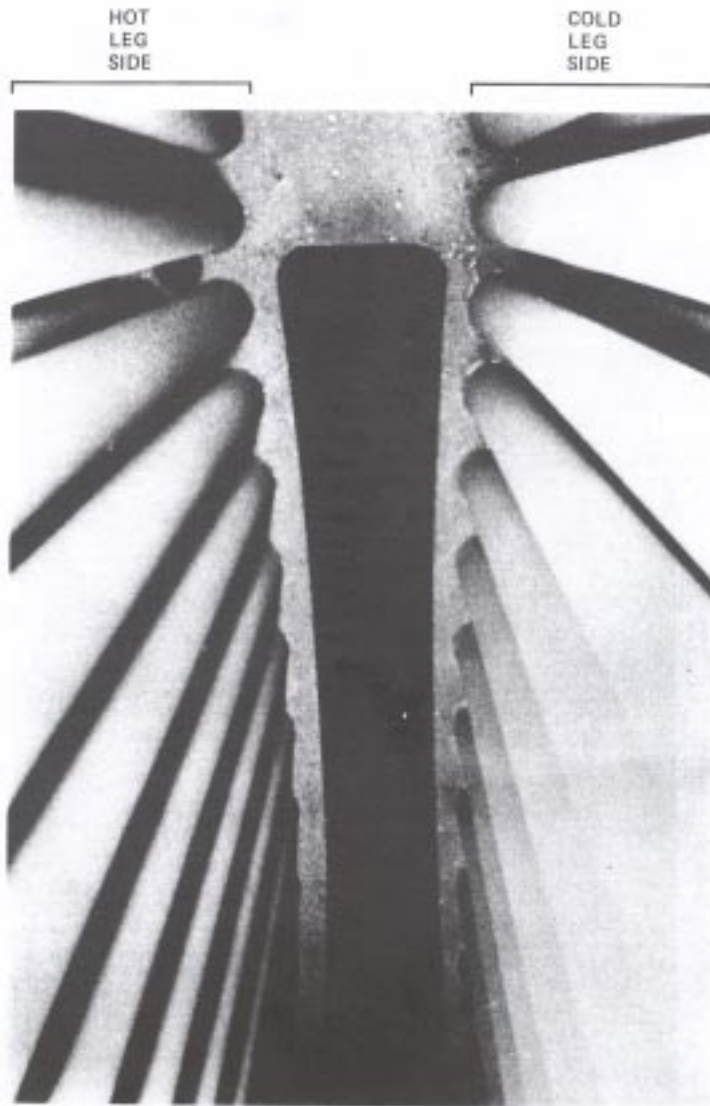
Figure 3-3: Example of Flow Slot Hour-Glassing

The forces causing the denting also act against the TSP. In the area of the flow slots where the structural resistance is low enough, deformation and/or cracking of the TSP can occur. If this happens on both sides of the flow slot, the sides of the flow slot are forced inward at the middle, causing the previously rectangular shaped flow opening to develop the shape of an hour-glass. This is referred to as hour-glassing, with a typical example shown in Figure 3-3. In the low-row U-bends, PWSCC is significantly more likely to occur if hour-glassing forces the tube legs closer together, since a small movement of the tube legs will concentrate sufficient tensile stress at the apex of the U-bend.

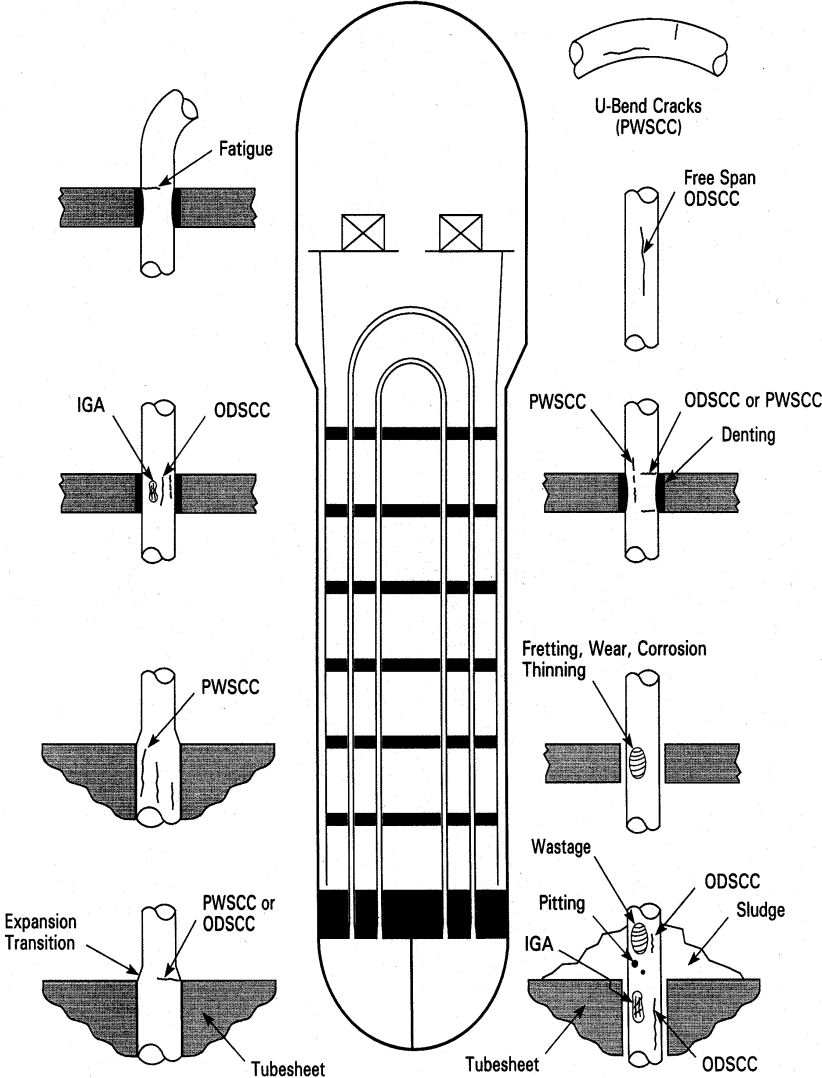
Figure 3-4: Examples of SG Tube Degradation Mechanisms

Throughout the plant's operating history, the IP2 SGs have experienced a broad range of tube degradation modes, requiring plugging of tubes. The causes are common to the industry and include: pitting above the top of the tube sheet, tube sheet roll transition PWSCC, ODSCC in the area between the roll transition and the top of the tube sheet (crevice), ODSCC in the sludge pile area (at the top of the tube sheet), ODSCC and PWSCC and probe restrictions in dented areas, and PWSCC in the low row U-bends. Typical examples of these types of degradation mechanisms are shown in Figure 3-4.
