Commonwealth Edison Company  
Dresden Generating Station  
6500 North Dresden Road  
Morris, IL 60450-9765

Dresden Nuclear Power Station, Unit 3  
Facility Operating License No. DPR-25  
NRC Docket No. 50-249

Subject: Licensee Event Report 1999-003-02, "Reactor Recirculation B Loop, High Pressure Flow Element Venturi Instrument Line Steam Leakage Results in Unit 3 Shutdown Due to Fatigue Failure Of Socket Welded Pipe Joint"

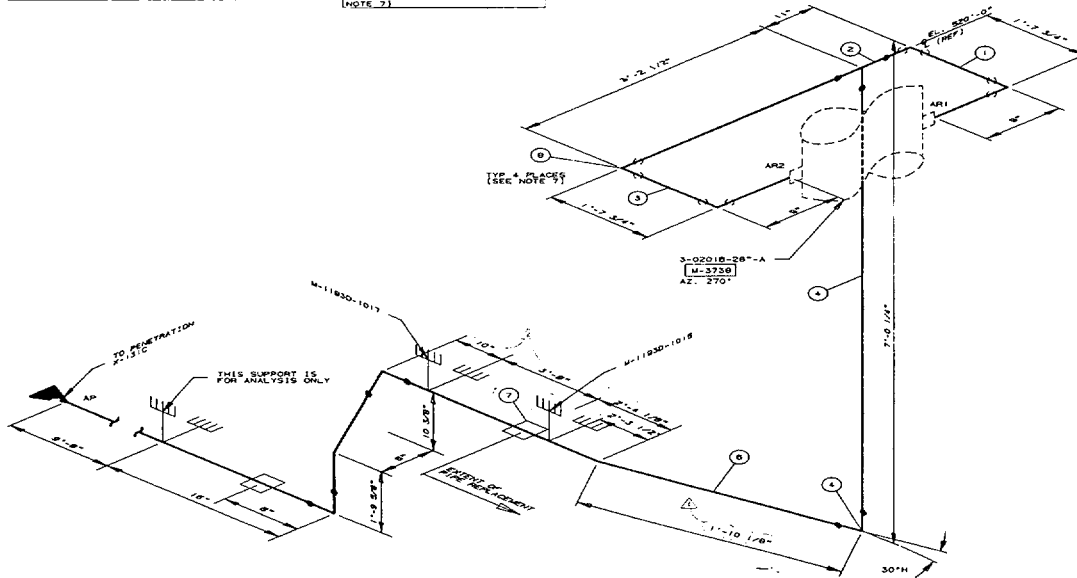
The instrument piping is stainless steel and originates at two locations on the B recirculation loop venturi, high-pressure side. Two branch pipes route around the recirculation piping and join together at the subject tee fitting. The piping is then routed through drywell penetration X-131C to flow transmitters 3-261-6C & 6D (see sketch on page 6).

There are two guide-type supports between the tee and the drywell penetration. The supports are closer to the drywell penetration than to the recirculation loop piping. Those two supports are U-bolts, with gaps, intended to act as two-way restraints.

The steam leak was located in the top portion of the pipe-to-tee socket weld connection. A Management decision was made to replace the piping, two elbows, and the tee with new material. The new socket welds
