Millstone Nuclear Power Station, Unit No. 3  
Licensee Event Report 2000-003-00  
Cable Routing for 3CHS\*P3B Does Not Meet Fire Safe Shutdown Analysis

LER 2000-003-00

**TITLE (4)**  
Cable Routing for 3CHS\*P3B Does Not Meet Fire Safe Shutdown Analysis

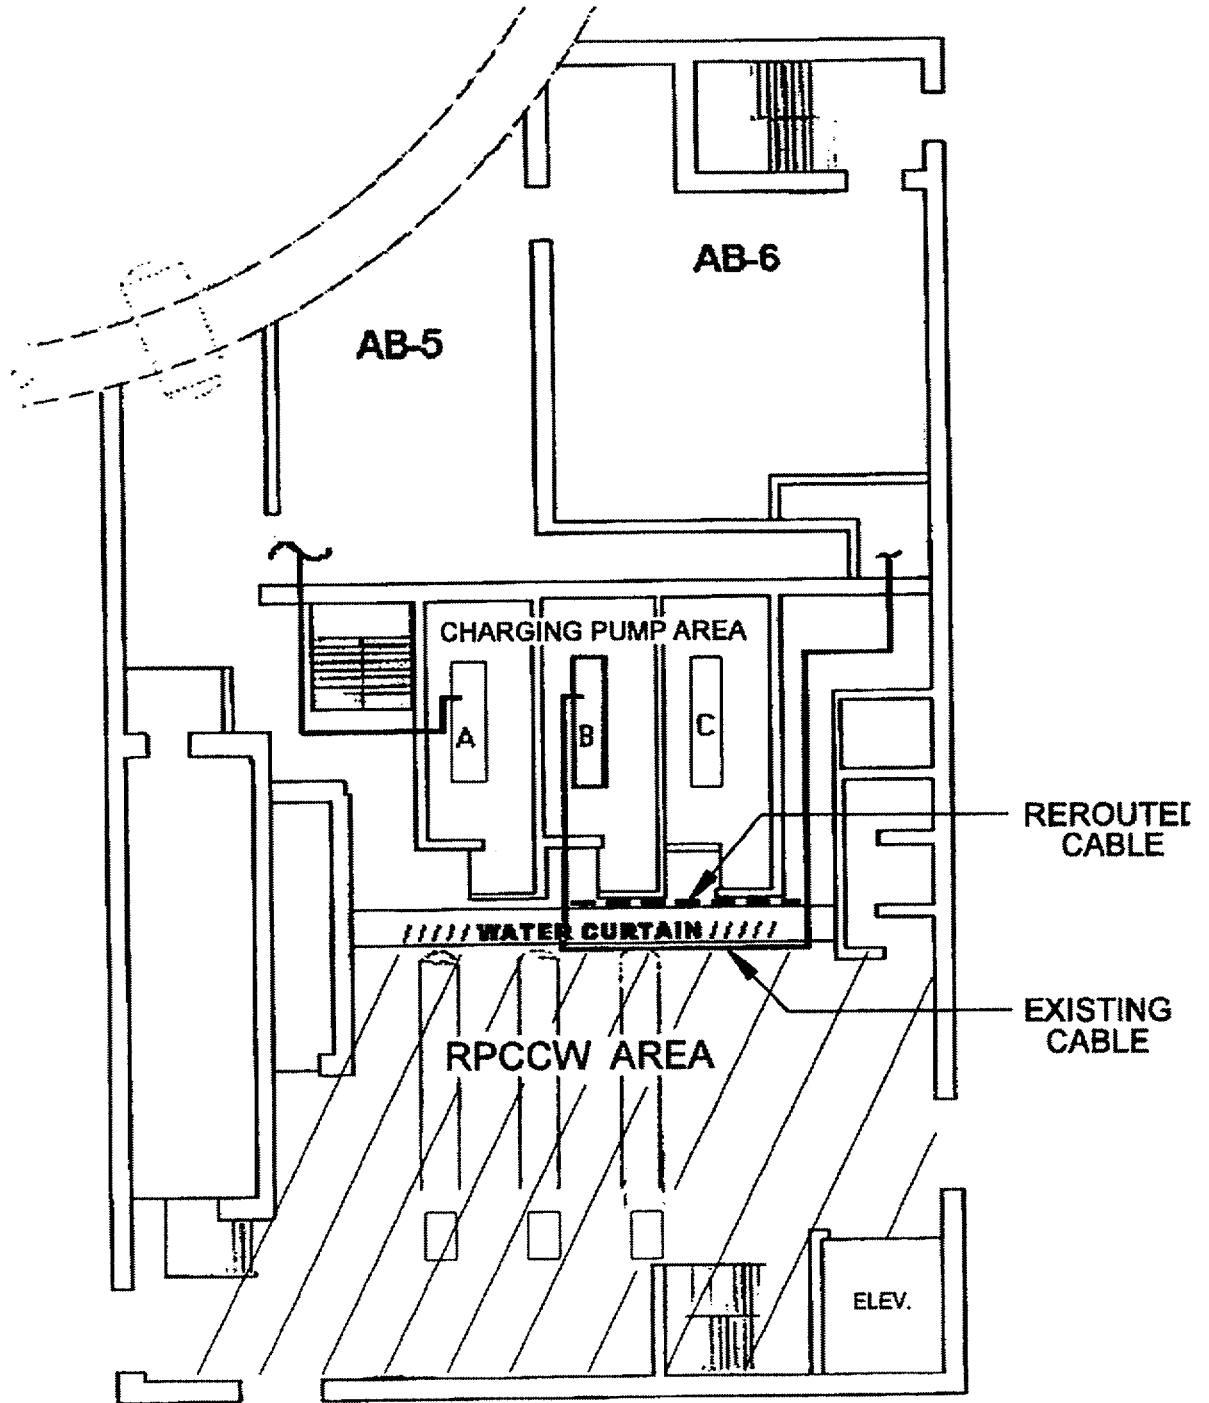
**AUXILIARY BUILDING \* ELEV 24'-6"**

On September 28, 2000, while performing a self-assessment, with the plant in mode 1 at 100% power, it was discovered that the 4160V power cable for charging pump, 3CHS\*P3B [P] was not installed in the Auxiliary Building [NF] as identified by the MP3 BTP 9.5-1 Compliance Report. Contrary to the compliance report cable routing analysis, the cable is routed to the north of the water curtain located on the 24'6" elevation for a short distance such that cable integrity could not be ensured if a fire were to occur in this area. It was determined that this condition could have significantly challenged the ability to achieve and maintain cold shutdown per the requirements of CMEB BTP 9.5-1 if a design basis fire occurred in the area and the pump cable was damaged as a result of this fire. The MP3 BTP 9.5-1 Compliance Report credits this pump to provide Reactor Coolant Pump (RCP) [P] seal cooling, Reactor Coolant System (RCS) [AB] inventory make-up, and RCS boration functions in the event of a postulated fire in an area of the Auxiliary Building [NF] where a fire could potentially damage all Reactor Plant Closed Cooling Water (RPCCW) pumps [P]. The RPCCW pumps [P] provide an alternate means of cooling the seals and are assumed to be lost in such a fire.

The attached diagram depicts the area of concern in the Auxiliary Building, and the cable in question is identified in the diagram.

The cause of this condition is that the reviews performed historically failed to correctly identify the location of the power cable for the charging pump 3CHS\*P3B relative to the water curtain which has been credited as a barrier between two methods of safe shutdown. The cable is part of the original construction of the facility.

1. The power cable for the 3CHS\*P3B Pump has been relocated to place the plant in agreement with the MP3 BTP 9.5-1 Compliance Report. The attached diagram indicates the position of the relocated cable.
2. A limited evaluation was completed to document that this is most probably an isolated condition.
