PG&E Letter DCL-00-153

Docket No. 50-275, OL-DPR-80
Diablo Canyon Unit 1
Licensee Event Report 1-2000-011-00
Manual Reactor Trip Due to Rod Control Failure

LICENSEE EVENT REPORT (LER)

TITLE (4) Manual Reactor Trip Due to Rod Control Failure
--

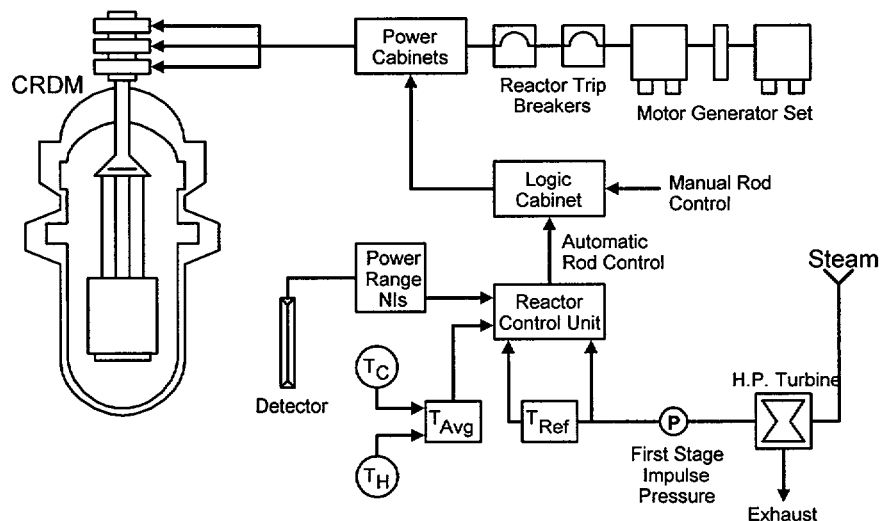
FIGURE 1: Block Diagram of Rod Control System

The urgent failure alarm inhibits further rod motion until the alarm condition is reset. This control feature is provided to stop further rod action that may result in an unintended rod position that could cause an uncontrolled reactivity increase. The rod control system is provided electrical power from the nonsafety-related motor generator set through the safety-related reactor trip breakers. See Figure 1 for graphical detail.
