NUREG/CR-5280
BNL-NUREG-52178
Vol. 2

Age-Related Degradation of Westinghouse 480-Volt Circuit Breakers

Mechanical Cycling of a DS-416 Breaker
Test Results

Brookhaven National Laboratory

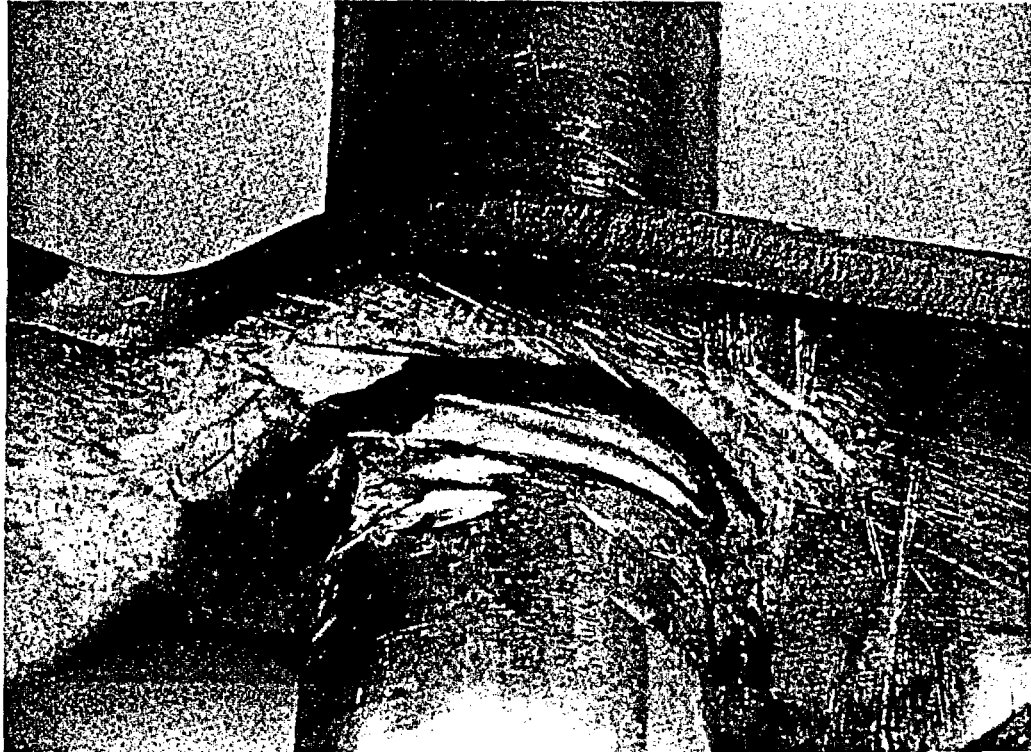
The first shaft with a 60 degree weld at the center pole lever (#3 in Figure 3.1) had a life of 3000 mechanical operating cycles. At the end of the test, the pole lever was completely detached from the shaft, as shown in Figure 4.8. A crack was first noted at one end of the weld where the weld material was taken out for experimental purposes. At that time the breaker had undergone 1000 operating cycles. Up until 2500 cycles, the effect of this crack was not noticed; at this point the pole shaft was bent. From then, until the end of the test, several problems associated with the

Figure 4-8. Complete Detachment of #3 Pole Lever at 3027 Test Cycle.

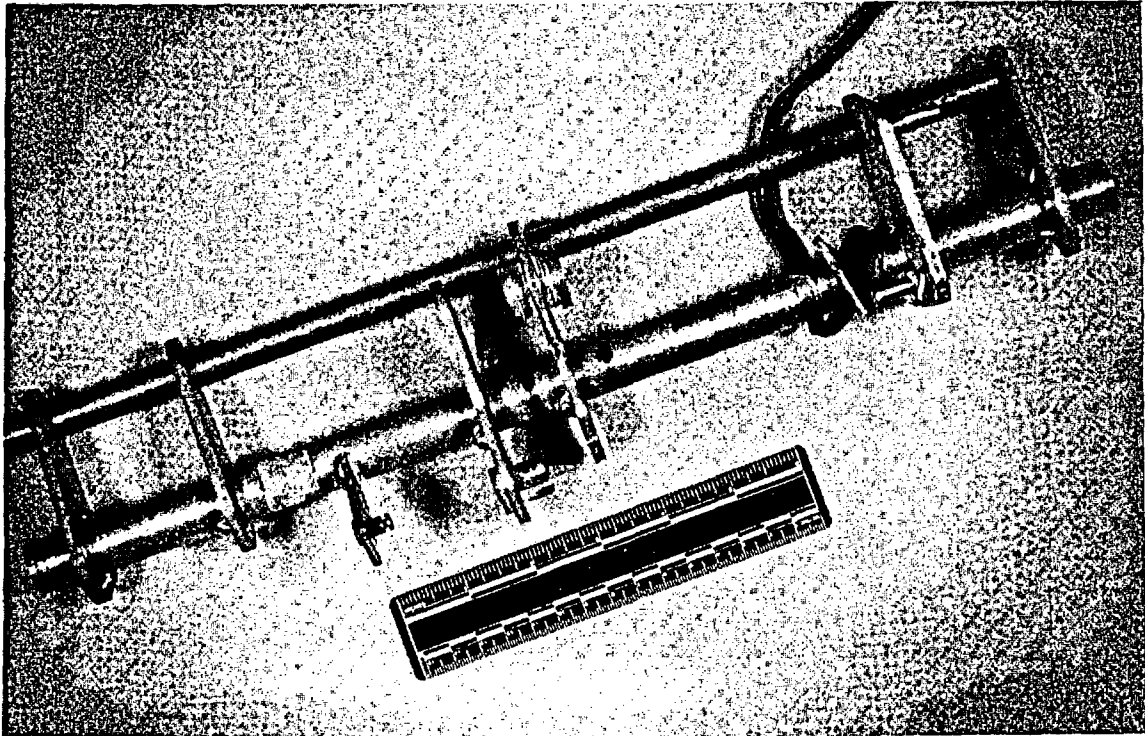
Figure 4-9. Misalignment of Pole Lever #1 from other Levers (#2, #3, #6, and #7).

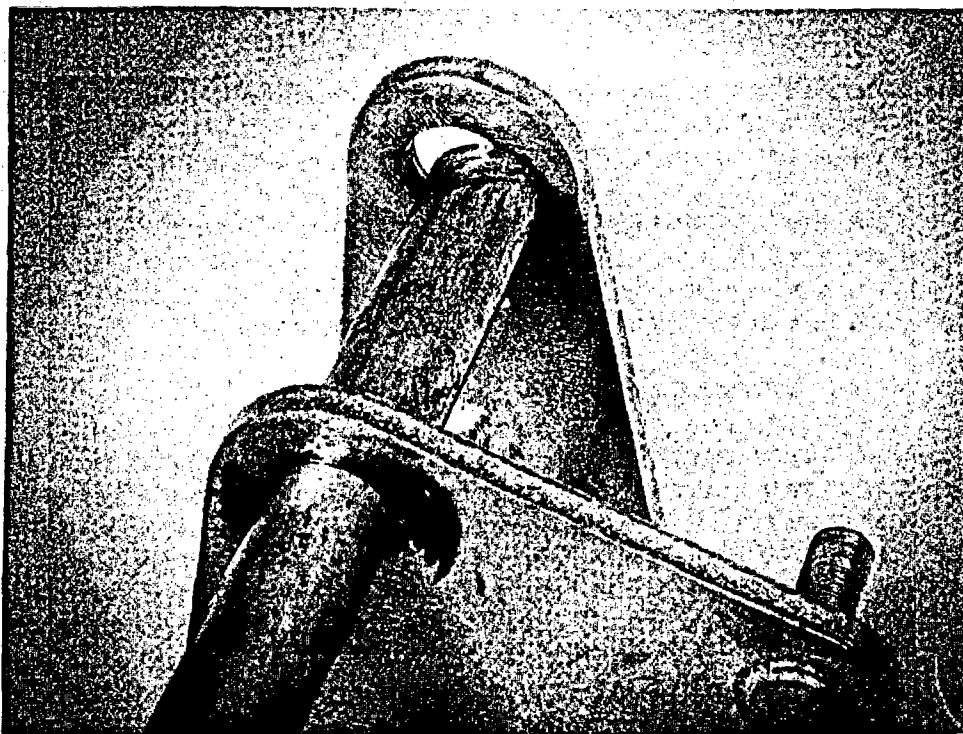
Figure 4-10. Demonstration of the Pole Lever Misalignment Caused by Cracks in Welds #1 and #3.

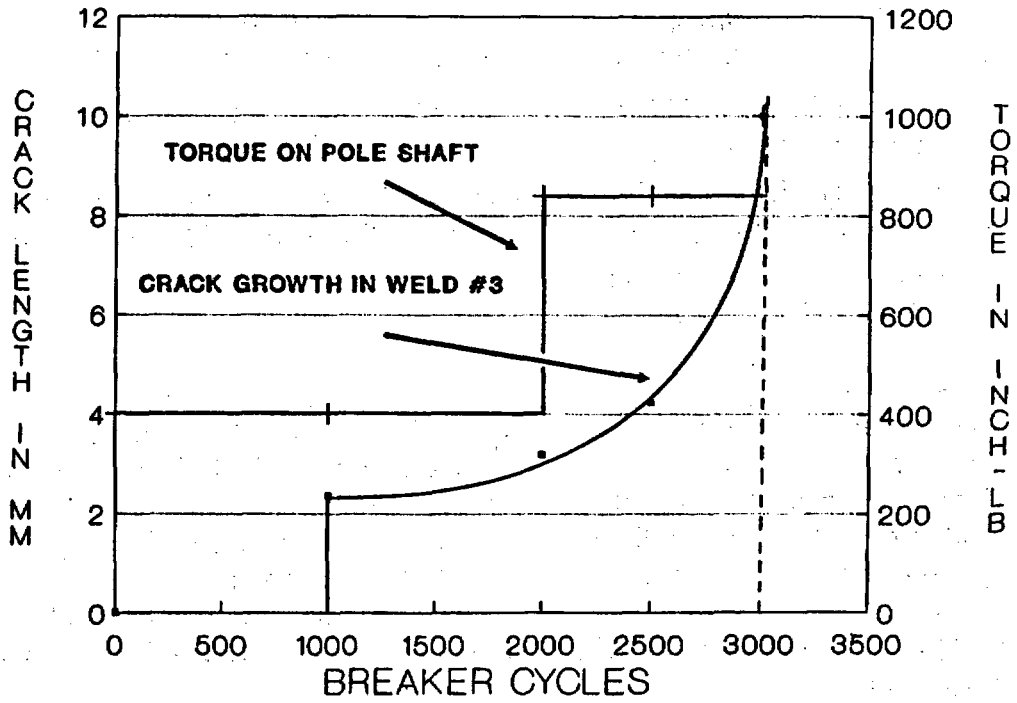
Figure 4-12. Failure of the First Pole Shaft Weld

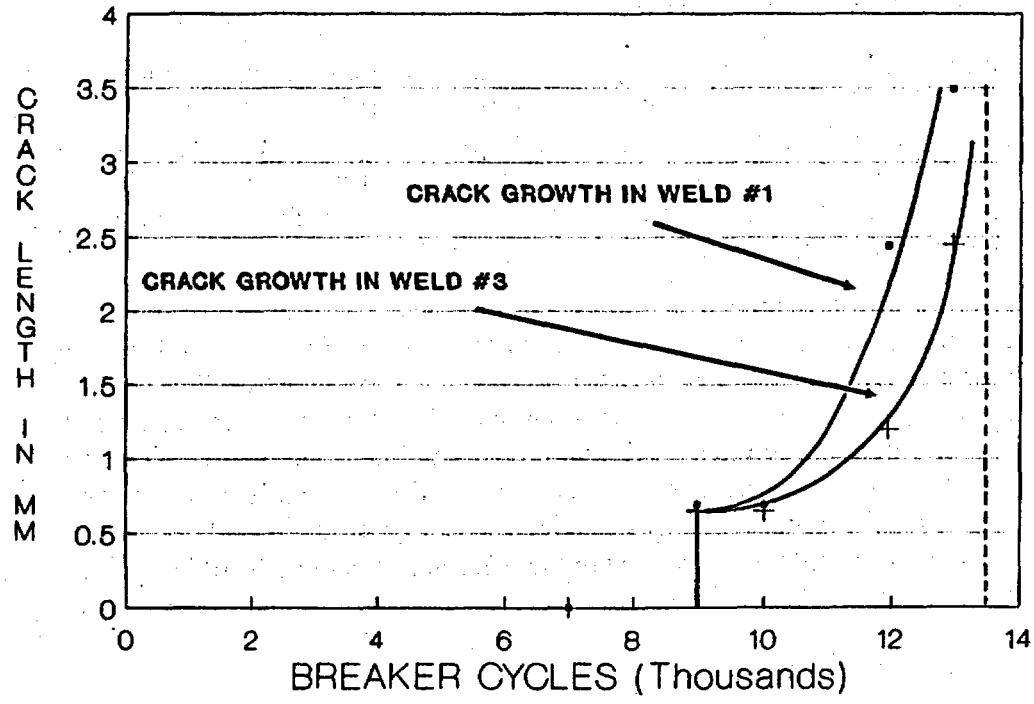
Figure 4-13. Failure of the Second Pole Shaft Weld

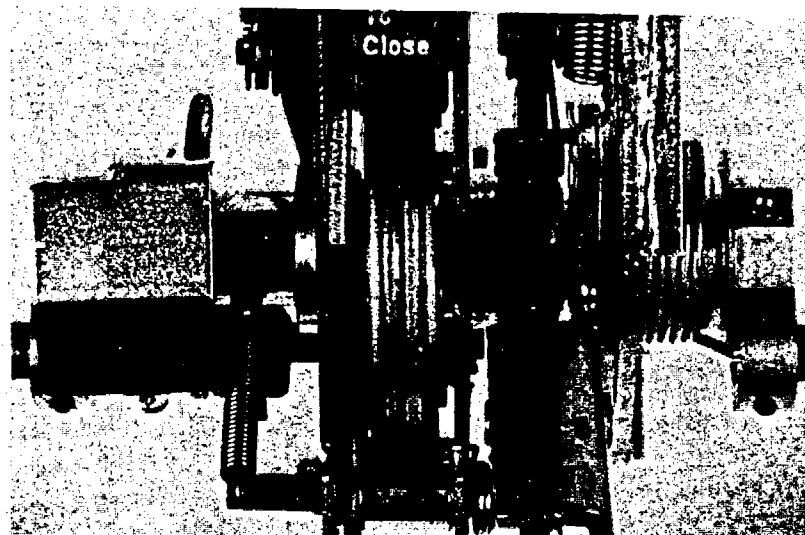
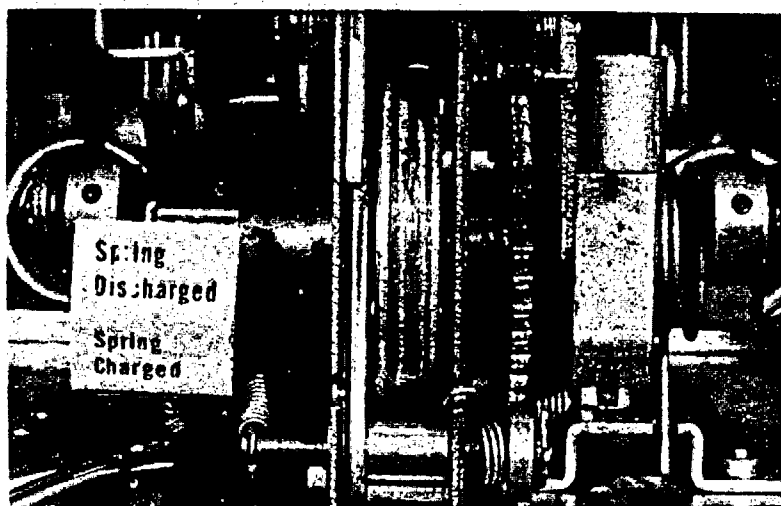
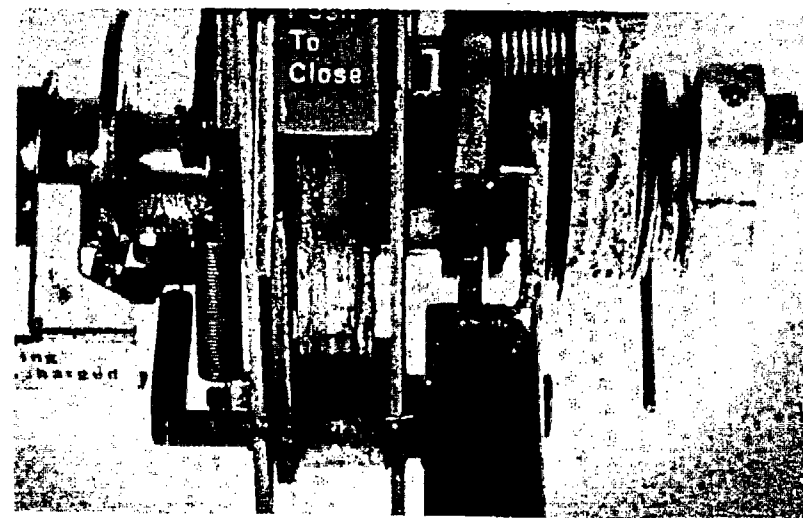
Figure 4-14. Wear in the Cam Assembly

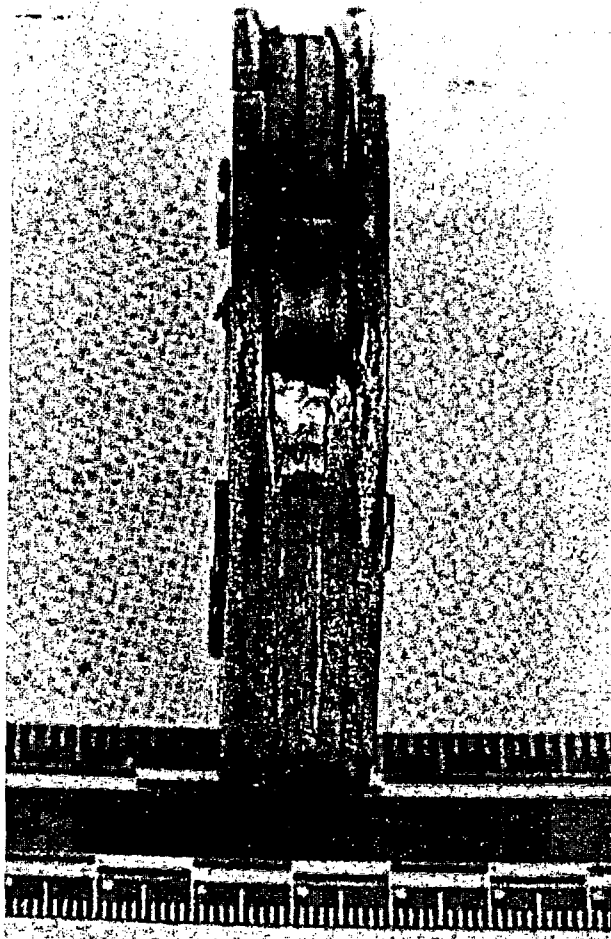
Figure 4-15. Severe Wear in Cam Segments and grooving in stop roller

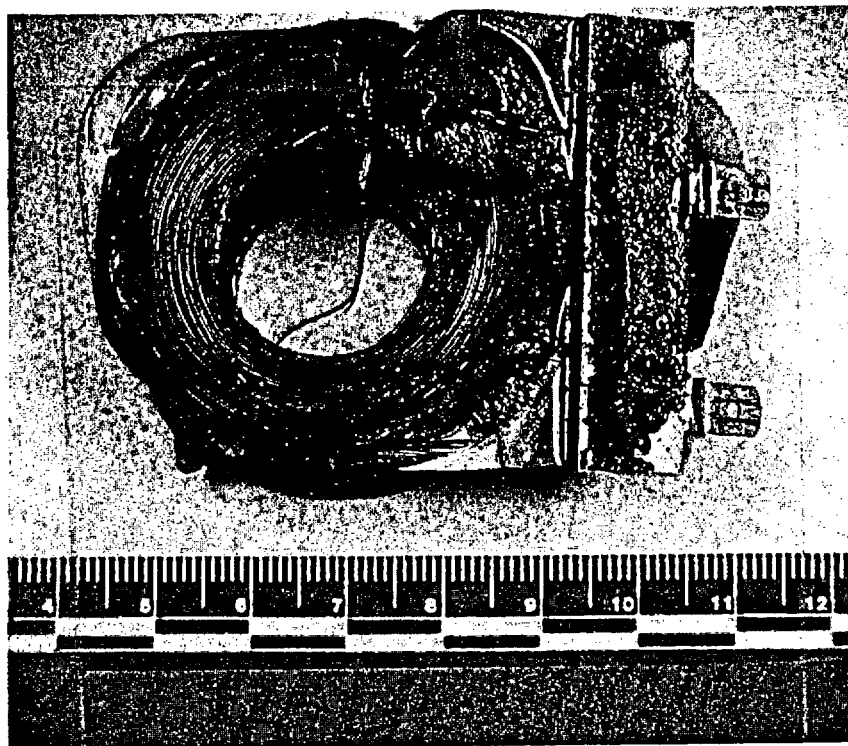
Figure 4-17. Burned Closing Coil After 20,724 Cycles

We conclude that aging in any of these three coils has minimal effects on breaker operation. However, the STA and closing coils are vulnerable to quick burnout due to excessive heat generated by an extended operation, which is primarily caused by the aging of various elements in the operating mechanism and the associated linkages whose binding or sluggish motion caused the coils to burn out instantly.

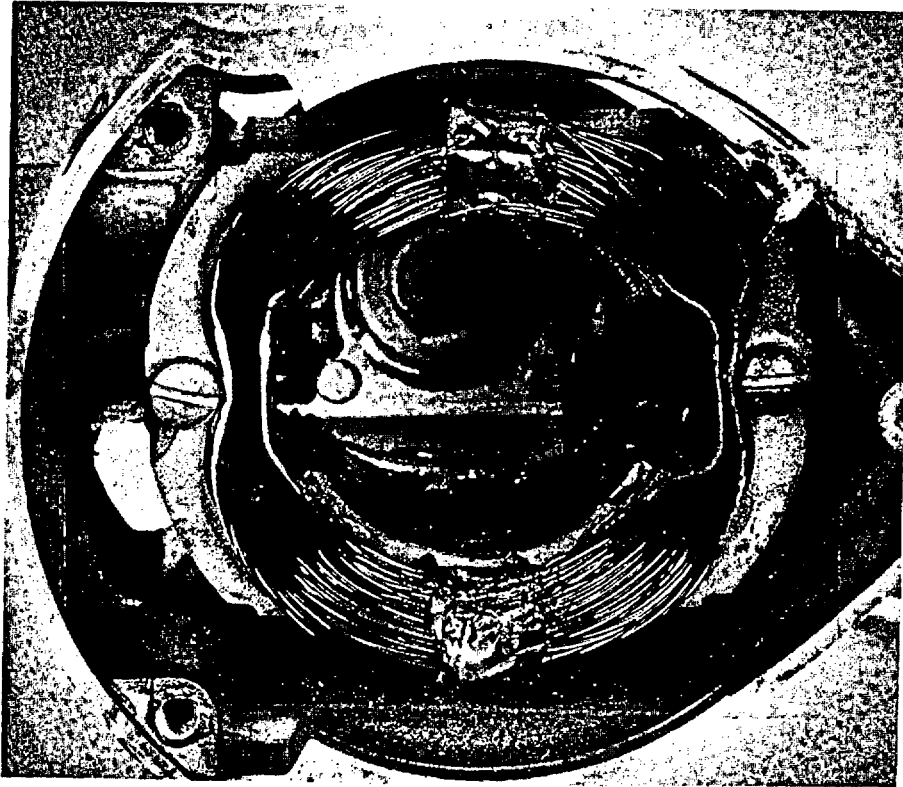
Figure 4-19. Degradation of the Insulation on the Motor Stator

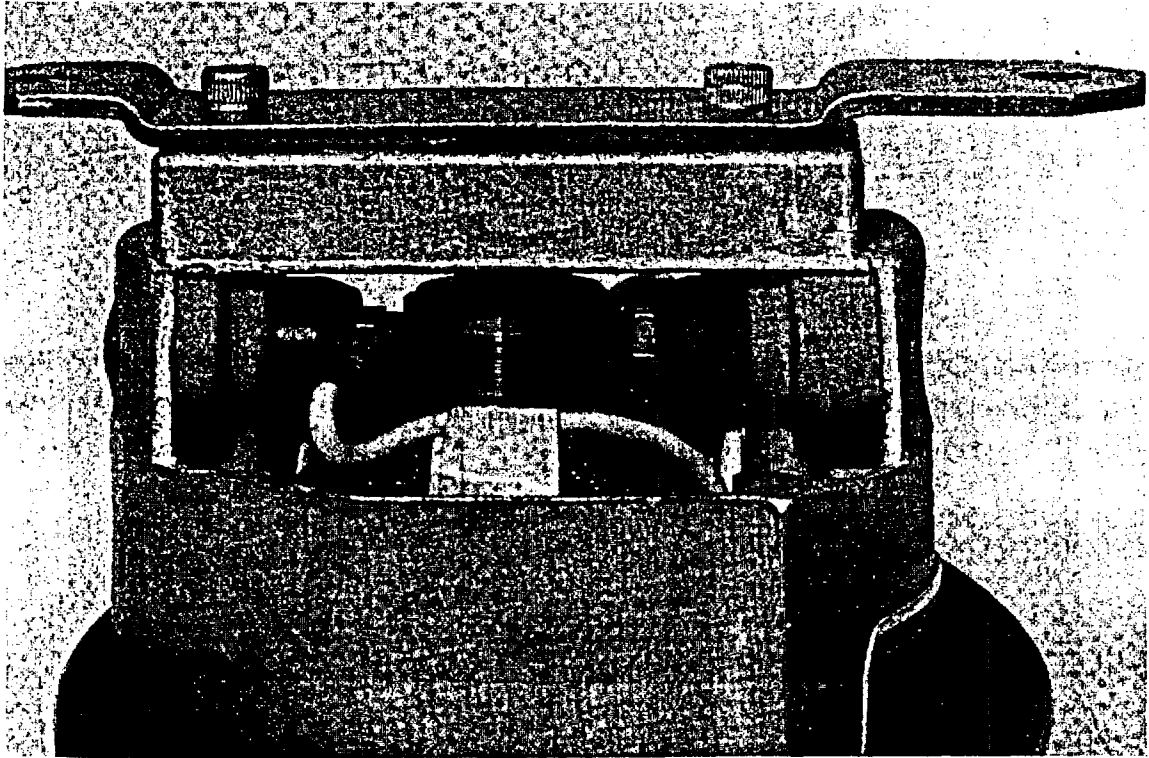
Figure 4-20. Carbon Deposits on Armature Contact Surface

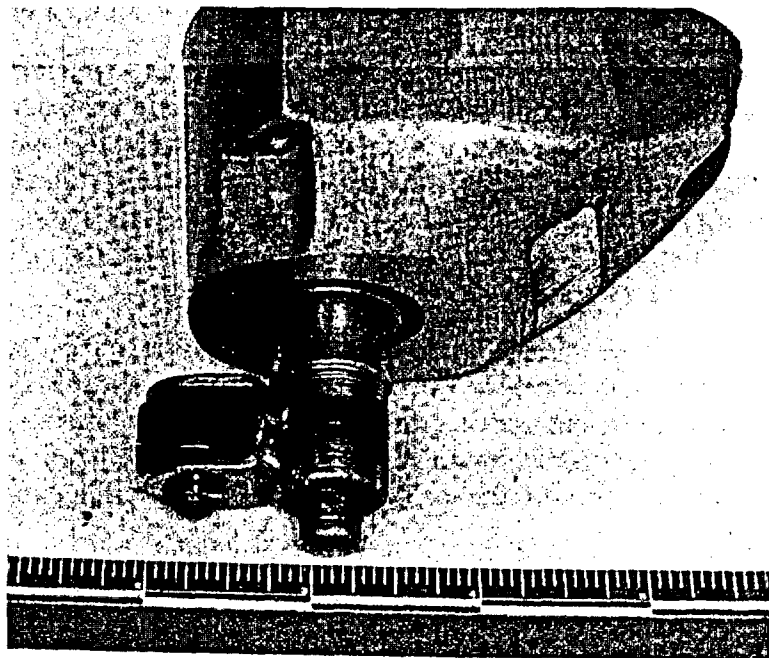
Figure 4-21. Wear on the Motor Crank and Handle

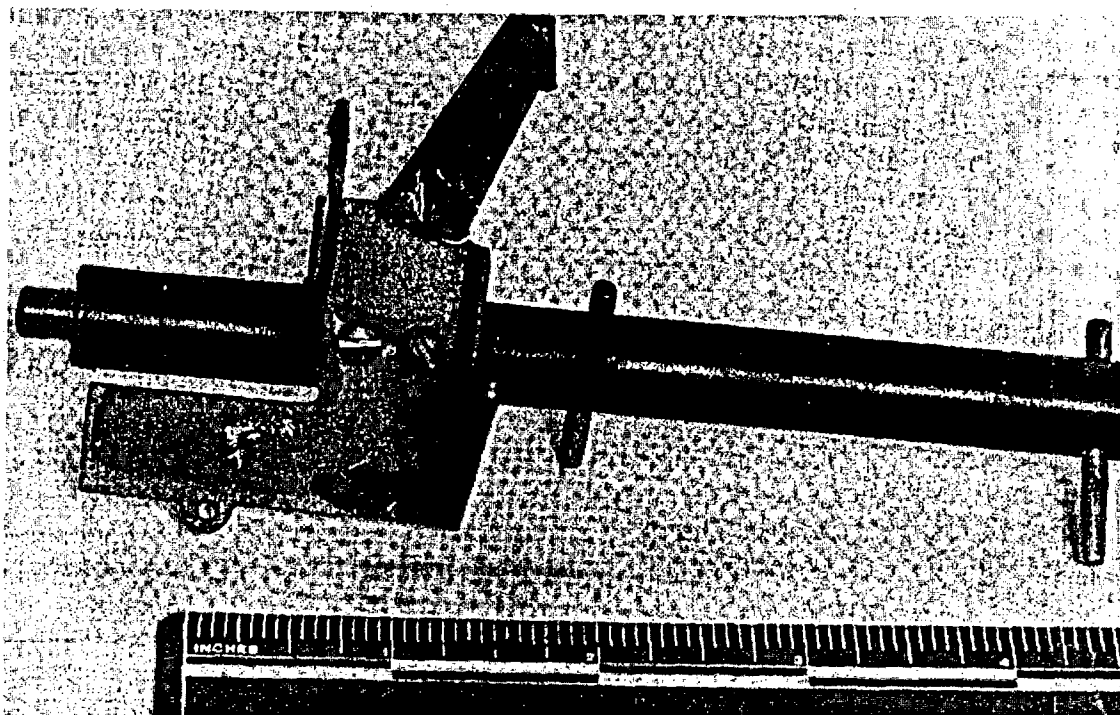
Scanning electron microscope (SEM) examination revealed that cracks started at the sharply angled corner of the wing. Under vibratory motion of the bar, the crack propagated fast like a brittle fracture. Hydrogen embrittlement from the zinc electroplating process is suspected to be the cause. Hydrogen embrittlement can happen when electroplating is done improperly. The proper procedure includes relieving all stresses from the shaft before electroplating and

Figure 4-22. Fracture of the Wing on the Trip Bar

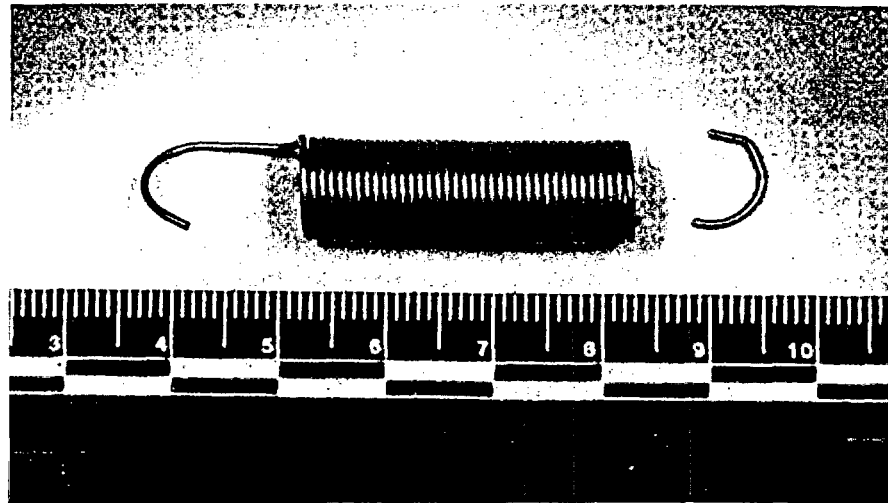
During the test two different vintages of smaller springs were used for the trip indicator and the oscillator reset; one set came with the original breaker and the others were purchased from a current inventory for replacements. The older springs lasted over 13,000 cycles without any deterioration, while one of the newer springs failed after 5861 cycles and the second one after 2286 cycles.

Figure 4-23. Broken Spring of the Trip Indicator Reset

- When procuring a new breaker or spare parts, careful attention should be given to their design adequacy (procure as safety related).
- For the indicator and reset springs, to minimize the damage to the surface and to reduce the tensile stresses on the inside surface of the bend area of the end hooks, it is recommended that a smooth transition bend should be made instead of a sharp bend.

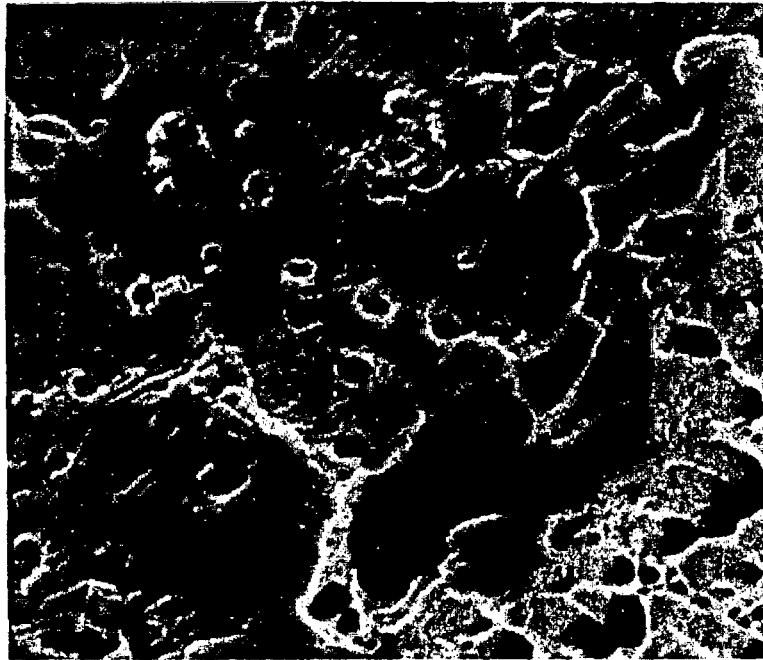
Figure 4-24. Striation Marks on Fractured Spring Surface

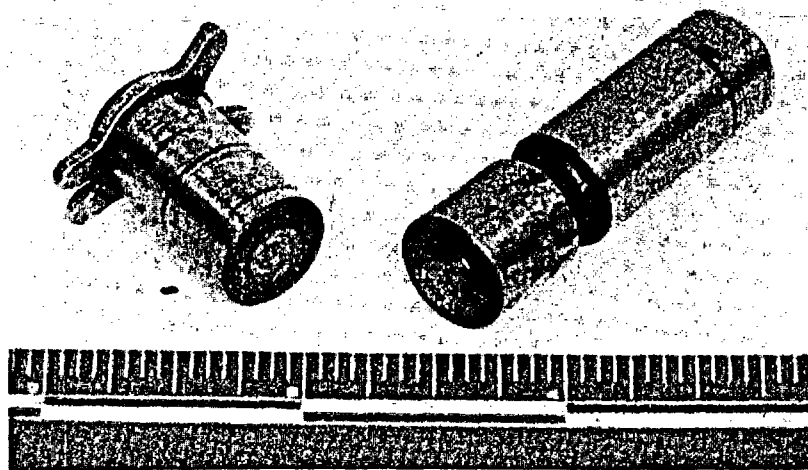
The second pole shaft with a 120 degree weld in the #3 lever developed cracks in the #1 and #3 lever welds at about the same time. When these cracks became large at about 13,000 cycles, misalignment of the first two levers was noticed, as shown in Figure 4.10. This probably caused higher torque and bending moments on the phase A pole shaft pin which broke (see Figure 4.26) at 13,593 cycles. The metallurgical examination of the fractured surface revealed that the cracking of this pin was primarily due to an improper heat treatment of the stainless steel. Improper machining might have left raisers which initiated the crack under excessive bending moment and finally the crack propagated intergranularly to break the pin (see Appendix C, section C.2.3).

Figure 4-26. Fractured Phase A Pole Pin

- For the pole pin connecting the Phase A of the breaker contacts, smooth corners should be machined, free from surface defects.
- Improper welding practices at the pole shaft levers should be avoided.

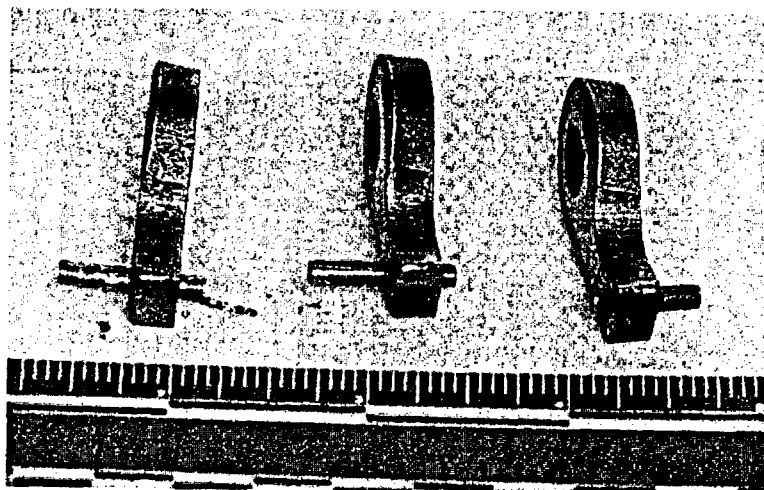
Figure 4-27. Wear in the Ratchet Wheel Pawls

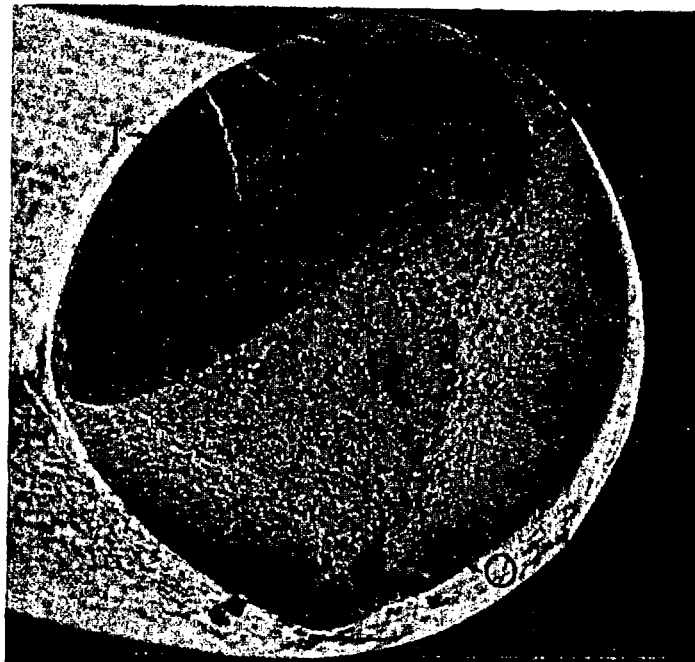
Examinations of the wire surfaces of the bent area (where failure occurred) revealed some subtle differences between the inside surface (marked as I in Fig. C-1) and the outside surface (marked as O in Fig. C-1). The inside surface has shallow surface cracks (Fig. C-3 a), while this kind of cracking is absent on the outside surface although deep drawing marks are clearly visible as (Fig. C-3 b). These marks were formed when the wire was originally made. The shallow, longitudinal cracks on the inside surface were probably developed during the mechanical bending process to make the hook.

Figure C-1. SEM micrograph of the fracture surface of the indicator spring. Mag: 100x.

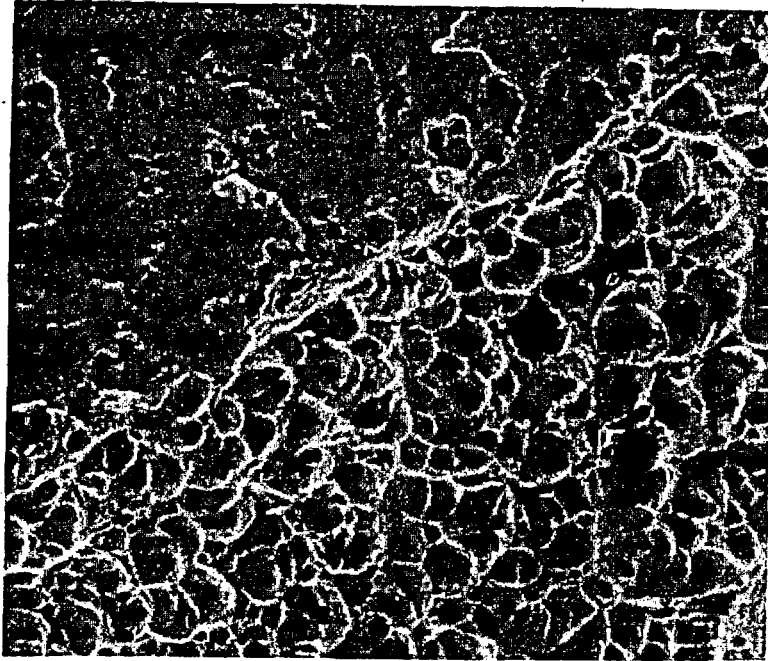
Figure C-2. SEM micrograph shows striation marks in the transition area from fatigue crack growth to final fracture. Mag: 2,000x.

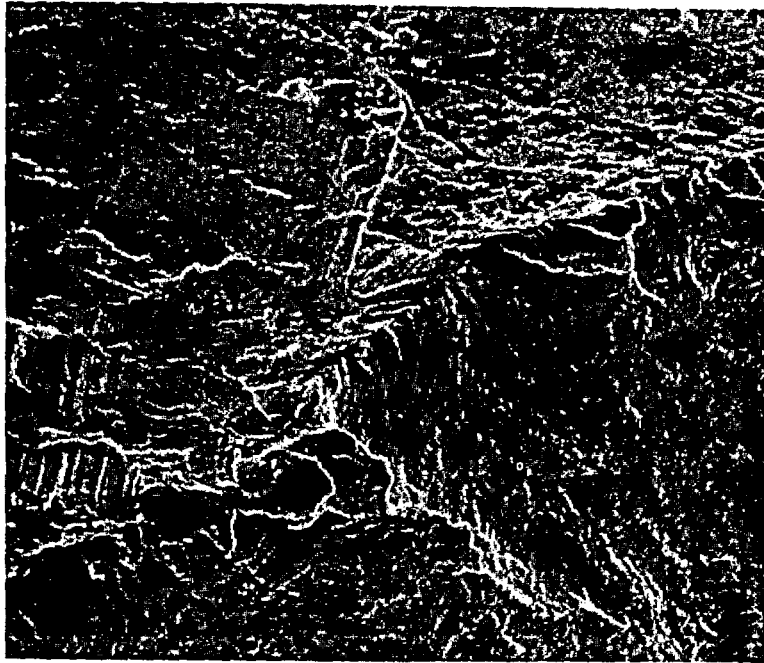
**Figure C-3. a)SEM micrograph shows axial surface cracks on the inner surface. Mag: 1,000 x.
b)SEM micrograph shows drawing marks on the outer surface. Mag: 1,000 x.**

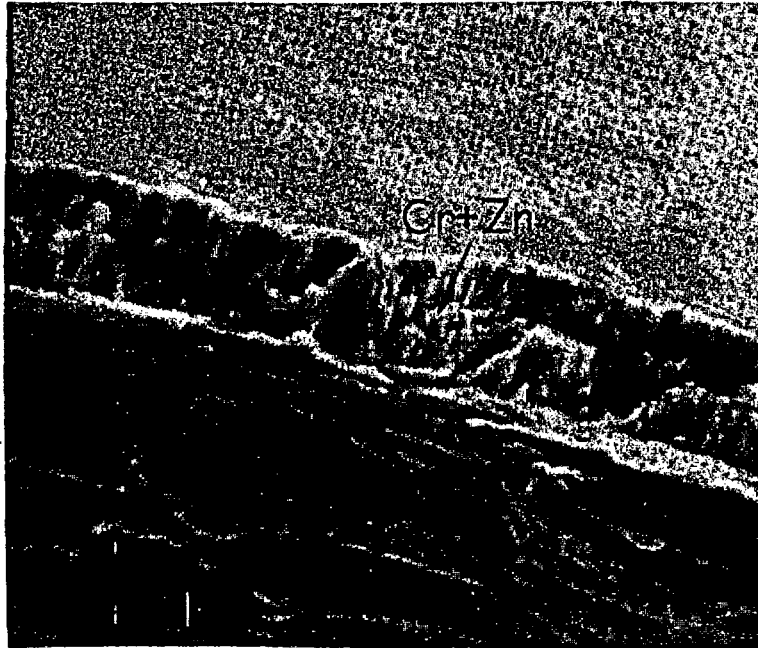
Figure C-6. SEM micrograph of the fracture surface that shows the surface coating. Mag.: 3,000 x.

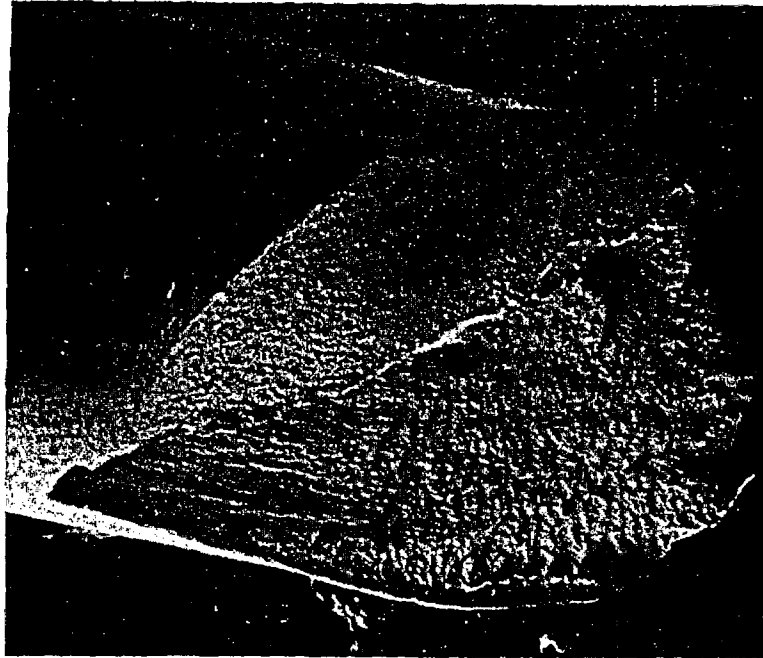
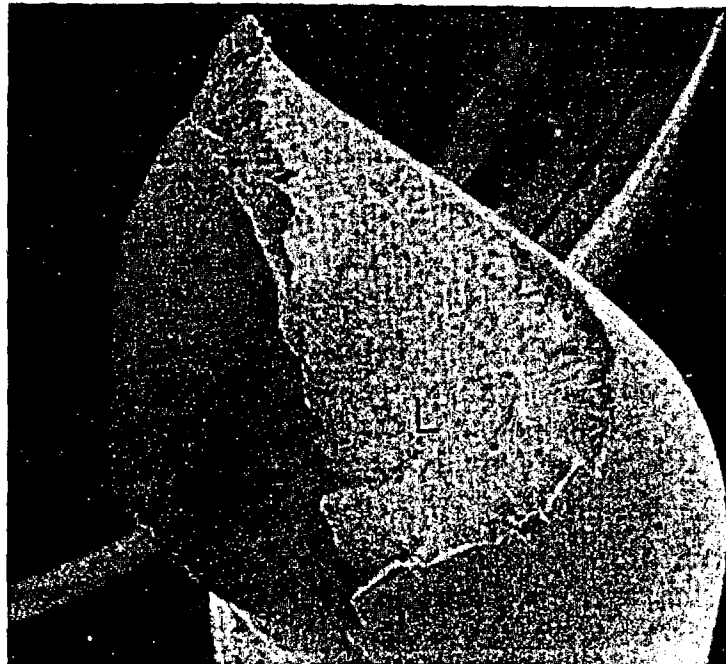
Figure C-7. SEM micrograph of the matching fracture surfaces. Mag.: a) 50x b) 43x.

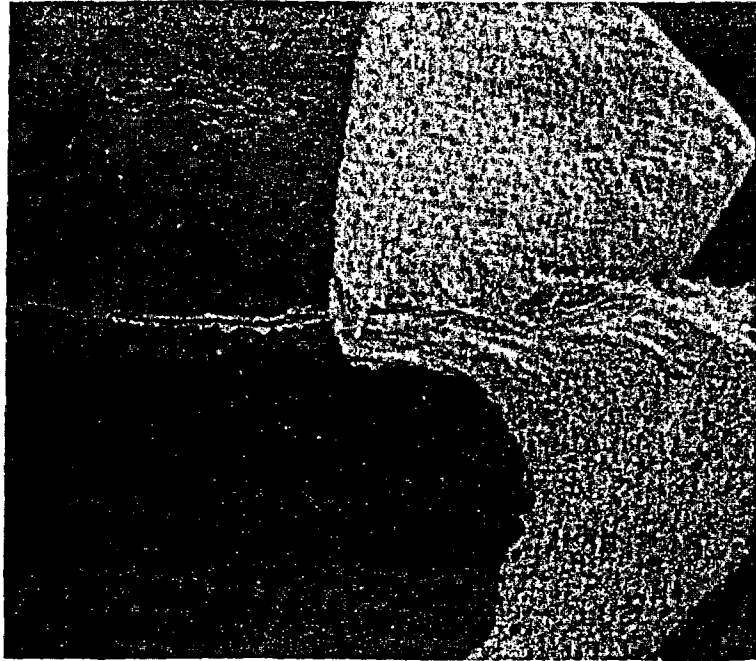
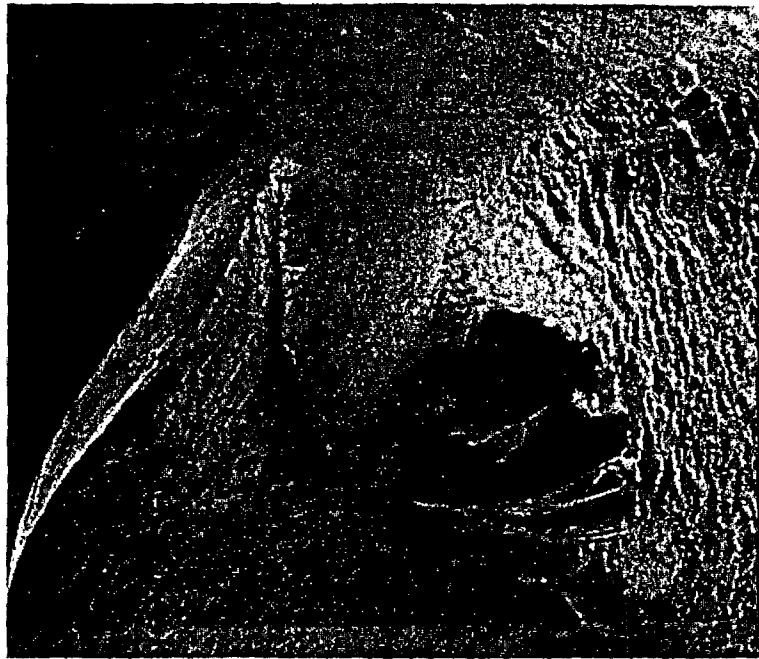
Figures C-10 a) and b) show a longitudinal (axial), splitting crack initiating at the front of the fatigue crack when the crack had propagated to a length as large as half the wire cross-

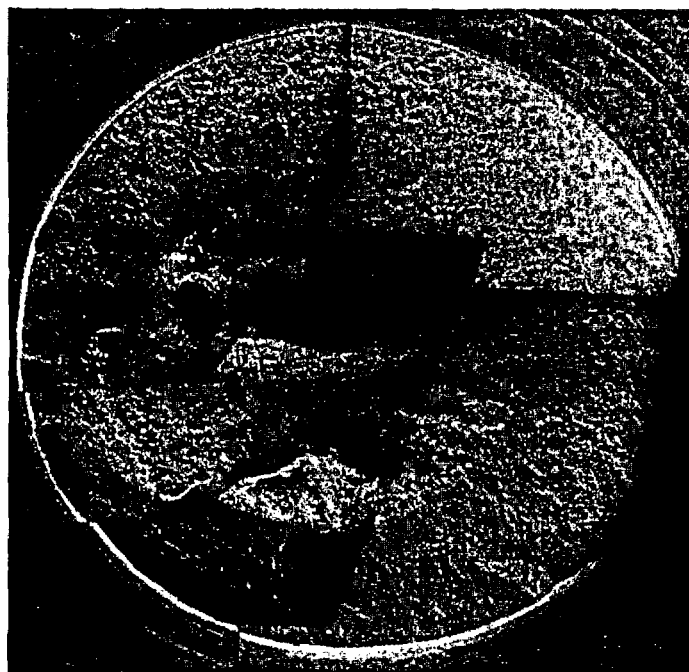
Figure C-11. SEM micrograph of the fracture surface of the failed pin. Mag.: 21.5 x.

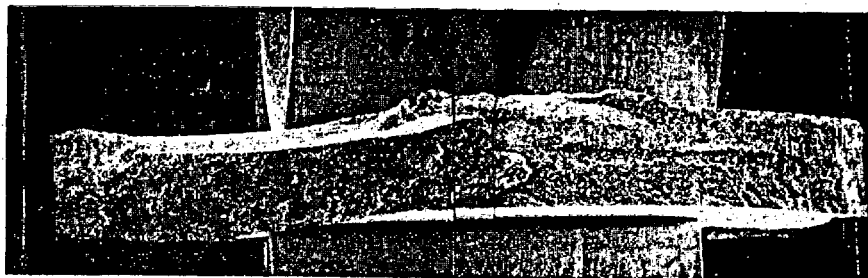
Figure C-13. SEM micrographs of the fracture surface of the trip shaft lever. Mag.: 15x.

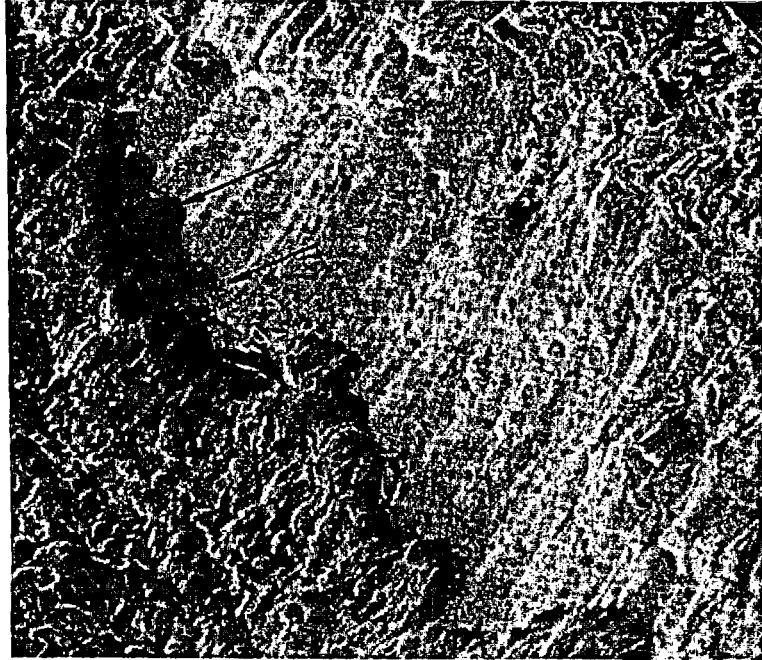
Figure C-14. SEM micrographs of the fatigue fracture surface of the trip shaft lever. Mag.: 100x.

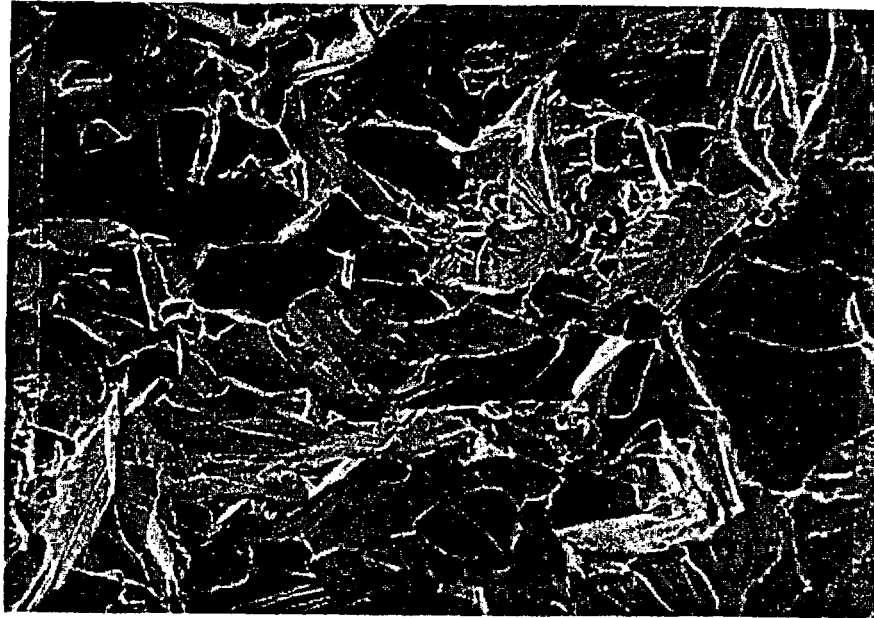
Figure C-15. SEM micrographs of the fast fatigue fracture surface. Mag.: 500x.

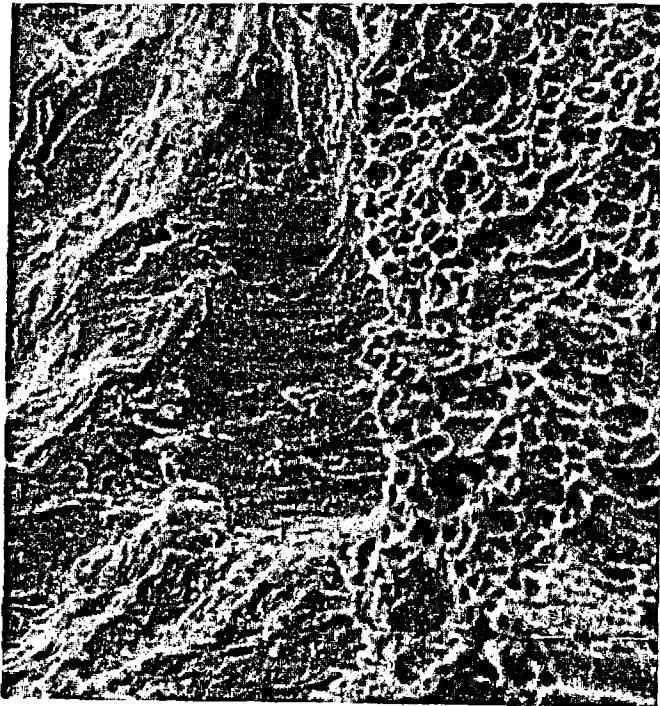
**Figure C-17. SEM micrograph shows a transition from fatigue crack growth to final fracture.
Mag.: 1,000 x.**

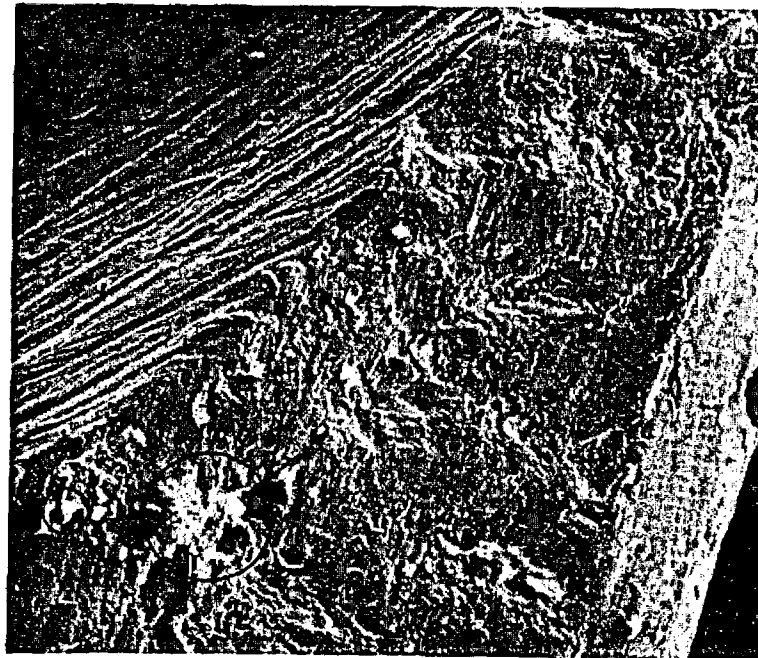
Figure C-18. SEM micrograph shows chevron marks (V's) and the slag inclusions (marked with circles). Mag.: 100 x.
