# **INDIAN POINT 2 REACTOR COOLANT PUMP SEAL EVALUATIONS**

**M. Subudhi and J.H. Taylor**  
**Engineering Technology Division**  
**and**  
**J.H. Clinton, C.J. Czajkowski, and J.R. Weeks**  
**Materials Technology Division**

**August 1987**

**DEPARTMENT OF NUCLEAR ENERGY, BROOKHAVEN NATIONAL LABORATORY**  
**UPTON, LONG ISLAND, NEW YORK 11973**

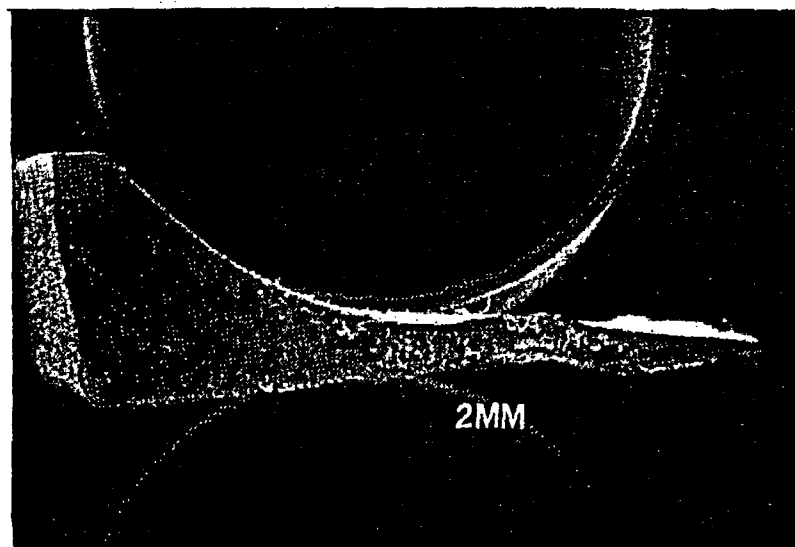
Figure 15: Cross Section of Double Delta Seal in Cut A-A of Figure 14.

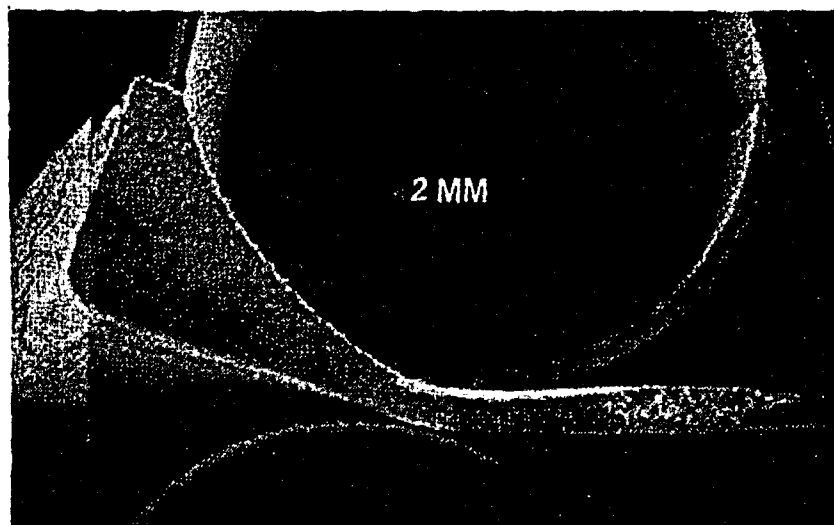
Figure 22: Higher Magnification Fractograph of the Worn Edge of Figure 20.

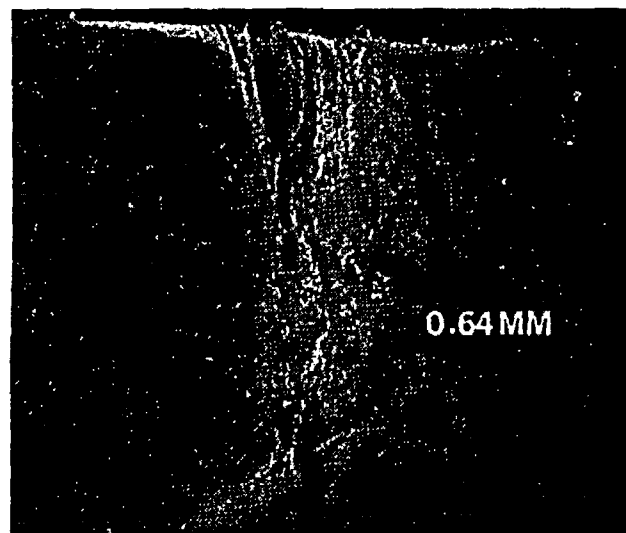
Figure 24: Higher Magnification Fractograph of Cracking in the Circled Area of the "O" Ring.

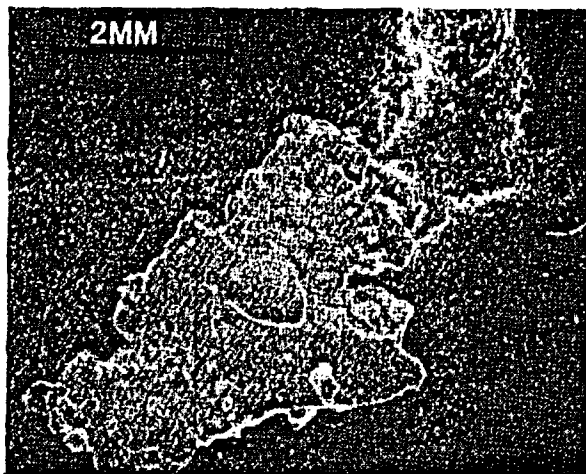
Two samples of debris from the inside surface of the seal (see Figure 12) were subjected to EDS examination. Figure 25 is an SEM photograph of the first sample taken. The corresponding EDS scan (Figure 25a) showed that the sample had iron (Fe), manganese (Mn) and aluminum (Al) associated with trace gold (Au) and palladium (Pd) from the sputter coating process.

Figure 25: SEM Photo of the First Sample of the Debris Examined.

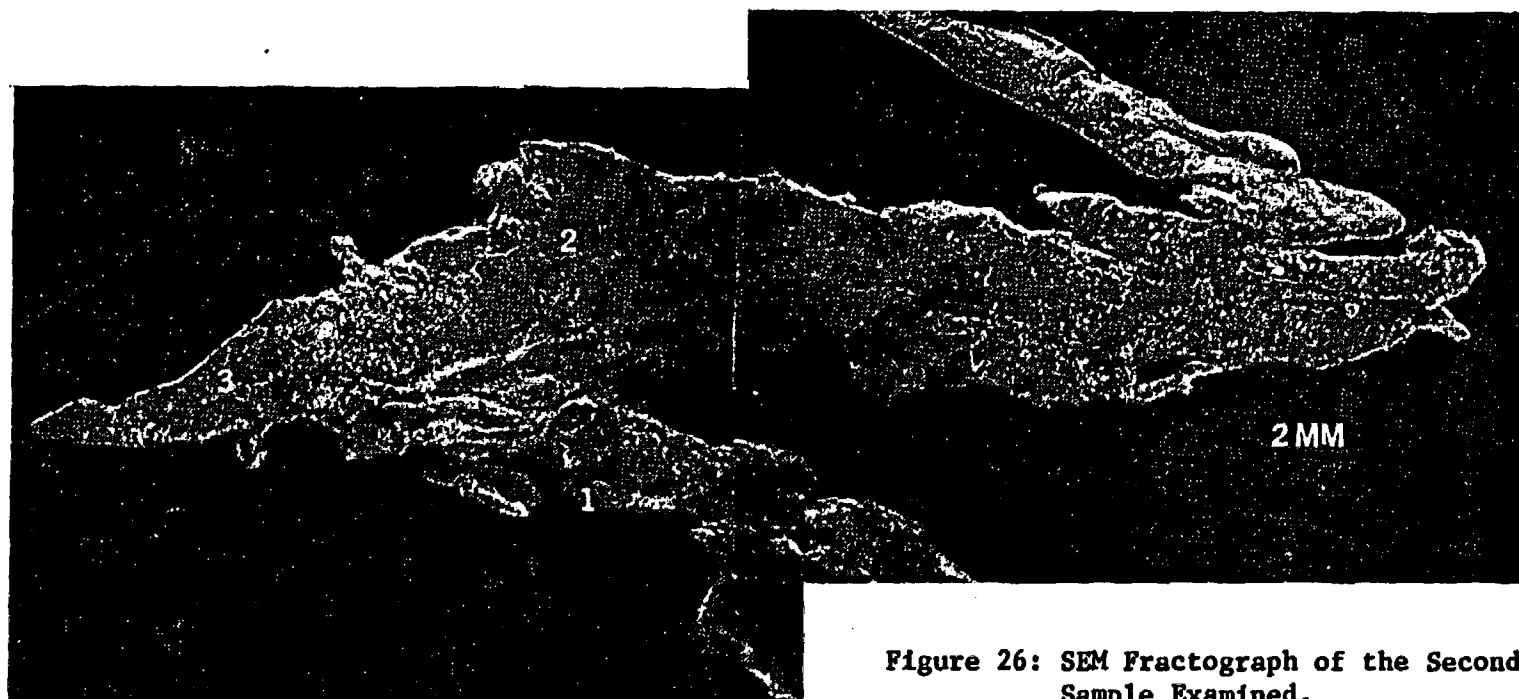
Figure 26 is a fractograph of the second sample of debris taken from the seals inside surface. The three scans associated with the specimen (Figures 26a-26c) has Mn and Fe associated with them with one scan also exhibiting a Pd and nickel (Ni) peak.

Figure 26: SEM Fractograph of the Second Sample Examined.

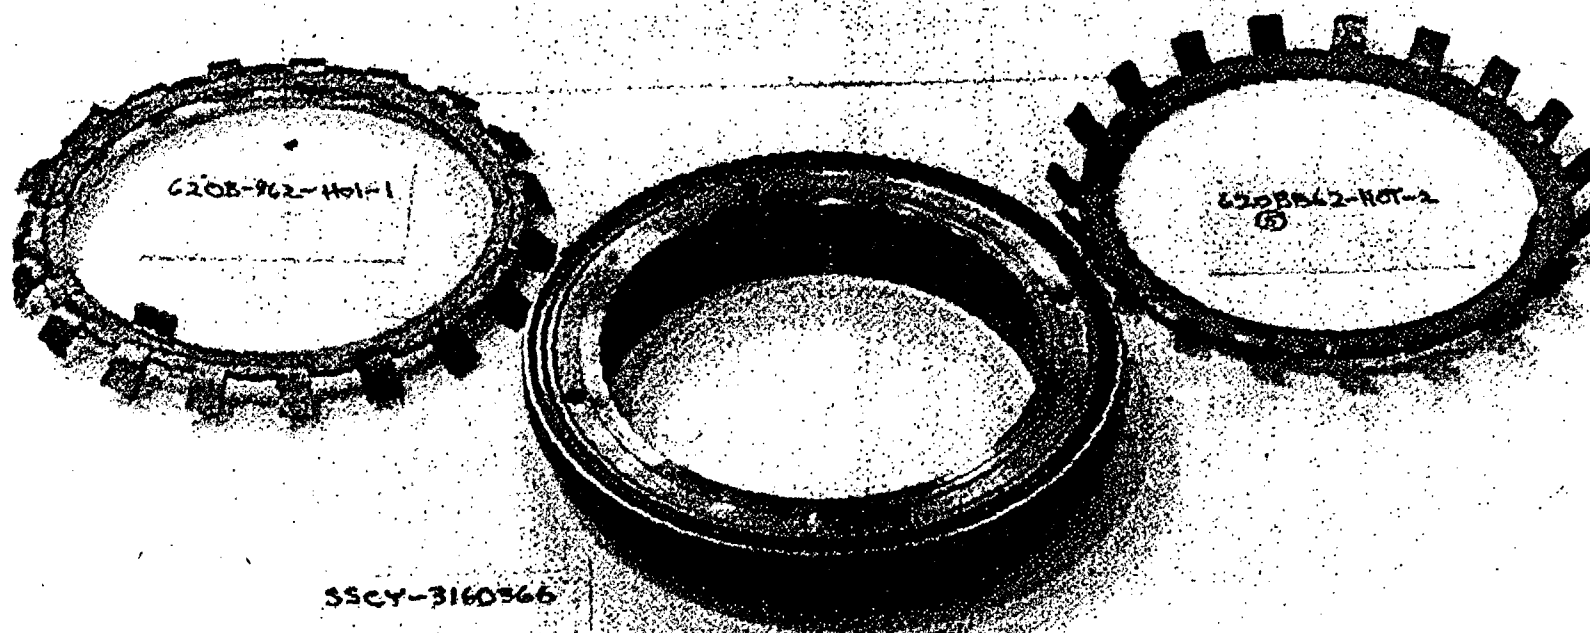
BNL ID: 3R/C/D-CN3-554-86

**Number 3 Seal Runner Assembly (BNL #3B/C/D-CN3-554-86 and BNL #3B/C/D-CN3-556-86).**  
The runner is flanked by two lock washers from the top of the seal assembly. Photographic enlargement is not sufficient to allow a close examination of the aluminum oxide insert on the runner. The lower surface of the runner assembly is deeply stained with oxide and crud.

NO. 3 SEAL RUNNER AND  
TWO LOCK WASHERS

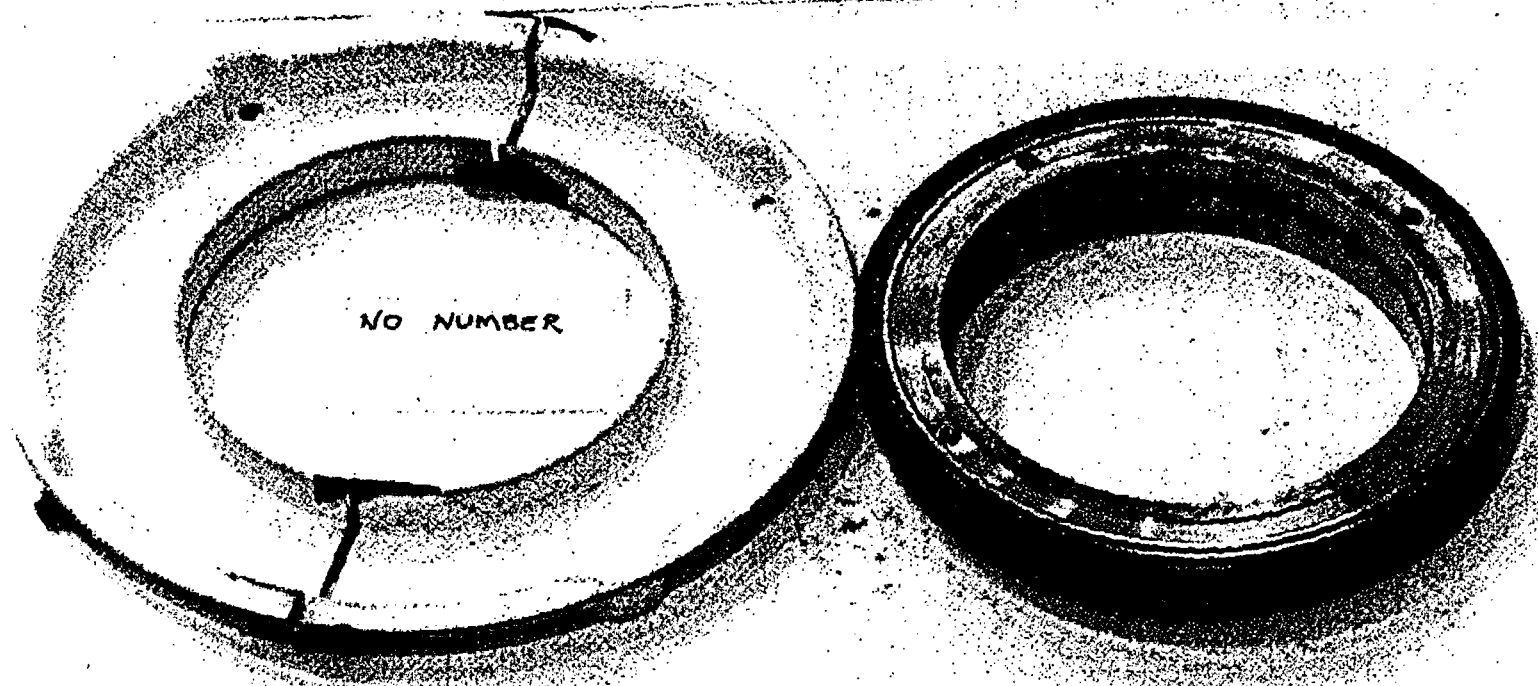
BNL 111:3E-CN3-553-86

**Number 3 Seal Runner Assembly (BNL #3E-CN3-553-86 and BNL #3E-CN3-557-86).**  
Photographic enlargement is not sufficient to allow a close examination of the aluminum oxide insert on the runner. Smudged areas on the insert surface are probably a result of handling during or subsequent to removal of the runner from the pump. The lower surface of the runner assembly is deeply stained with oxide and crud. A protective cover for a number 1 seal faceplate also appears in the photographs.

NO. 3 SEAL RUNNER: OPPOSITE FACE
