# NRC Lessons Learned - External Events

Rebecca Karas  
Office of New Reactors  
U.S. Nuclear Regulatory Commission  
February 8, 2012

# **Experience with North Anna Power Station Restart after 23-8-2011 Virginia Earthquake**

# **Experience with Fort Calhoun Nuclear Station after 2011 Flooding**

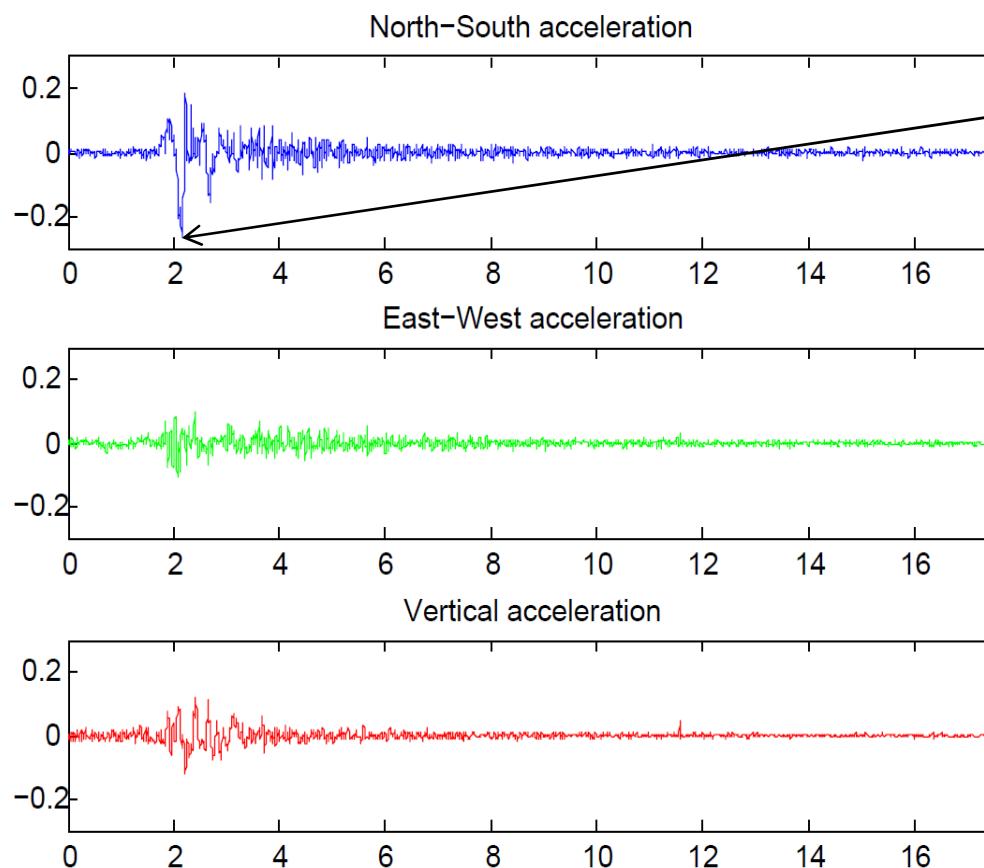
# Recorded Motion at North Anna Plant from Mineral, Virginia M5.8 Earthquake

PGA = 0.26 g

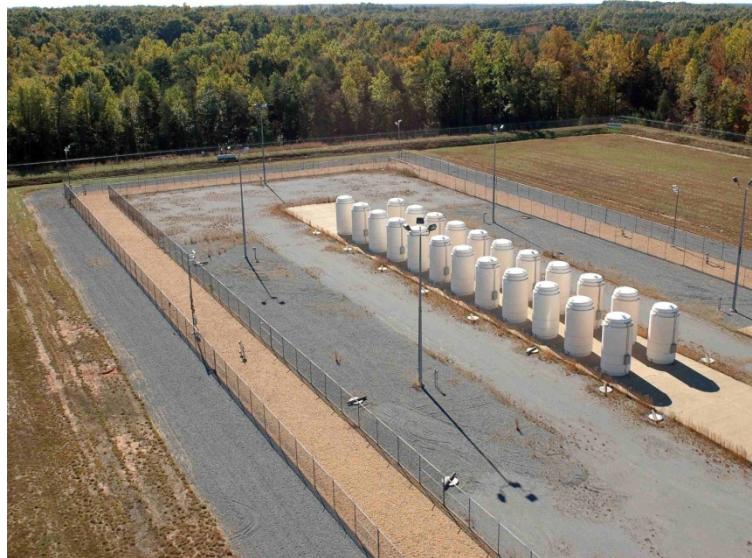
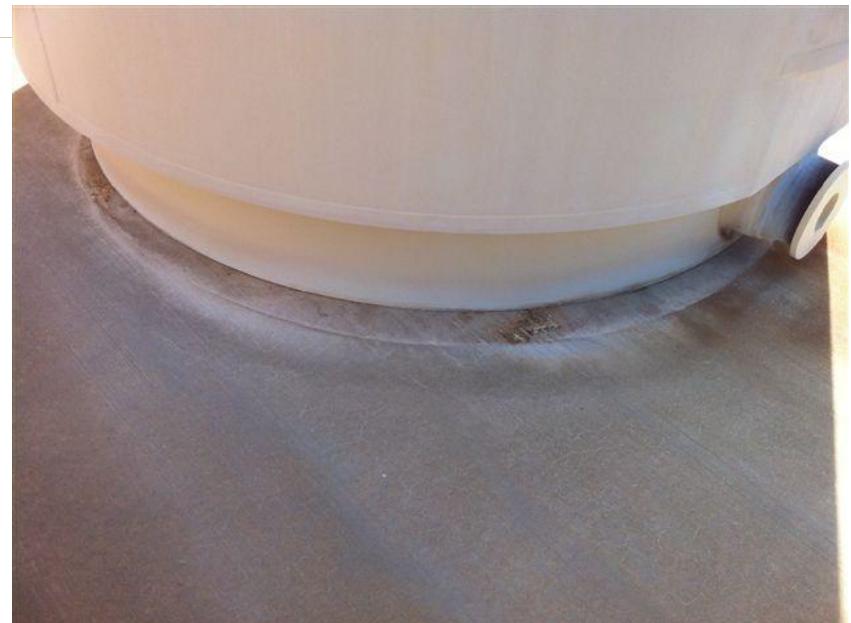
## Dry Cask Storage

25 of 27 TransNuclear vertical casks moved between 1 and 4 ½ inches

NUHOMS horizontal modules had small gaps and corners cracked

All radiology and temperatures normal

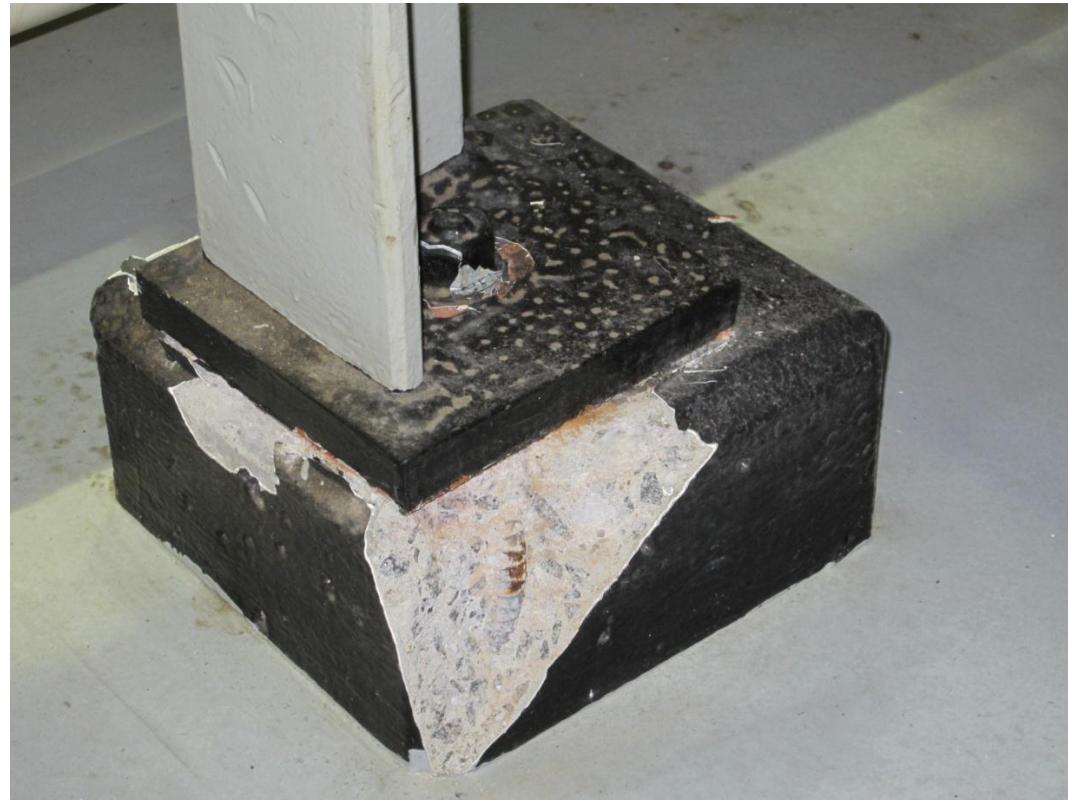
# U2 Turbine Building

Powdex  
Demineralizer  
Tanks Base  
Pedestal (non-  
safety related)

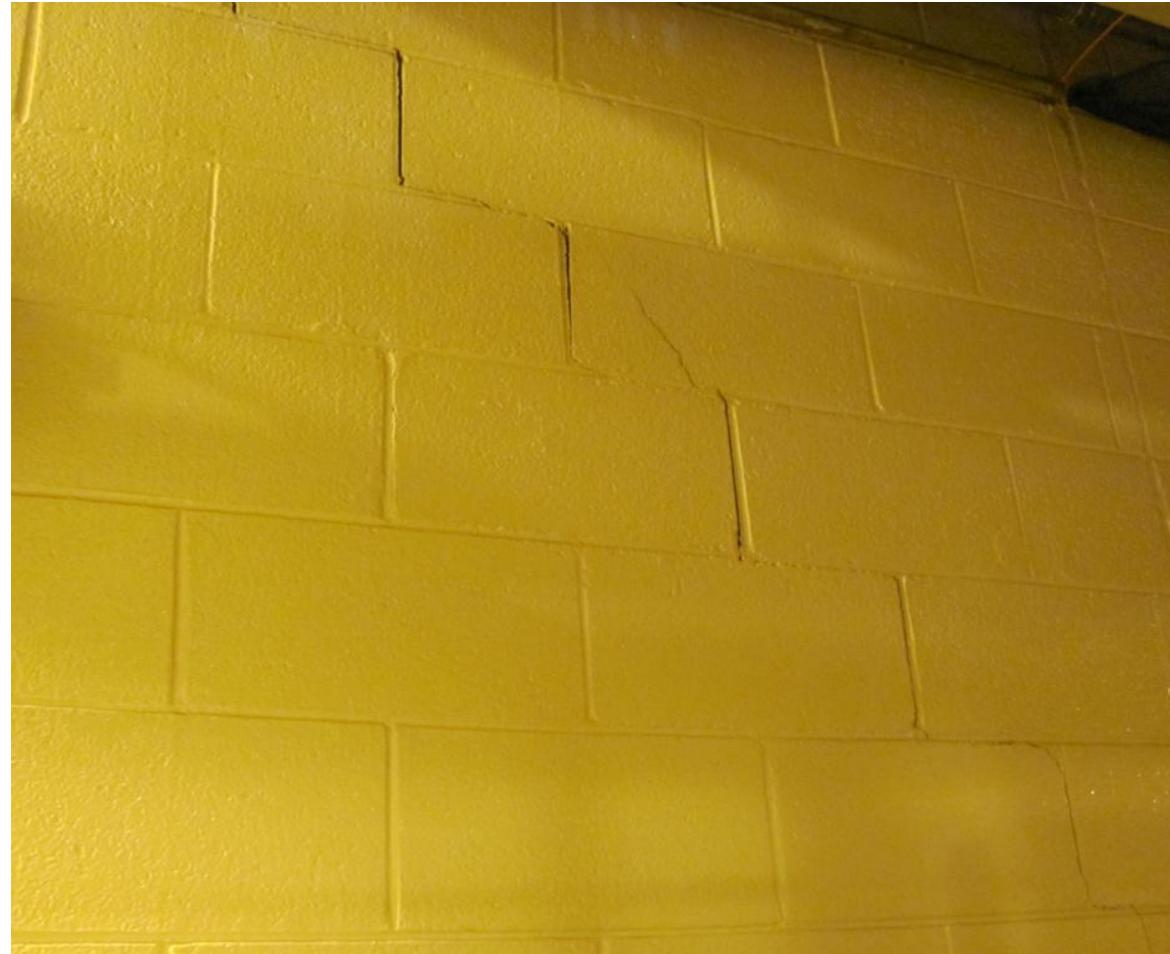
# Turbine Building Hallway

Crack In  
Unreinforced  
Non-Safety  
Related  
Block  
Wall

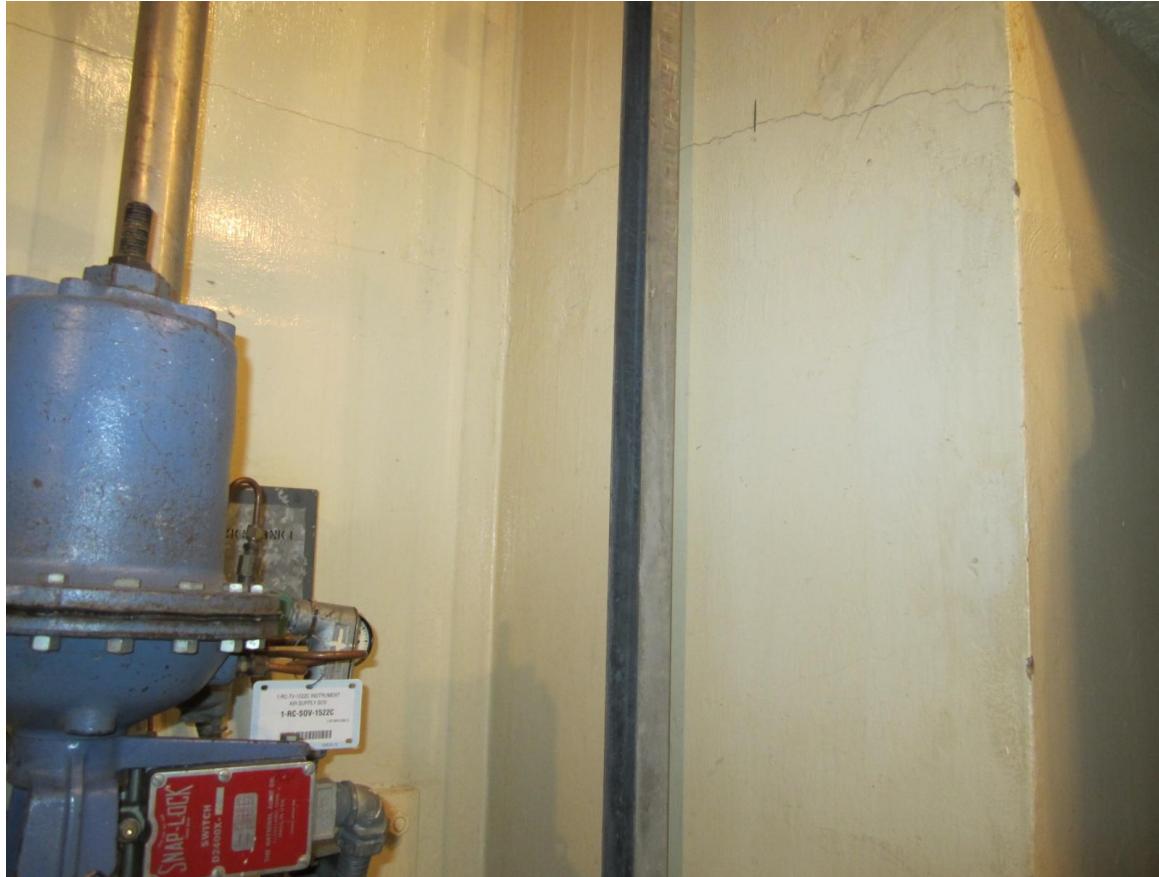
# Unit 1 Containment

Surface Crack In Interior Containment Wall

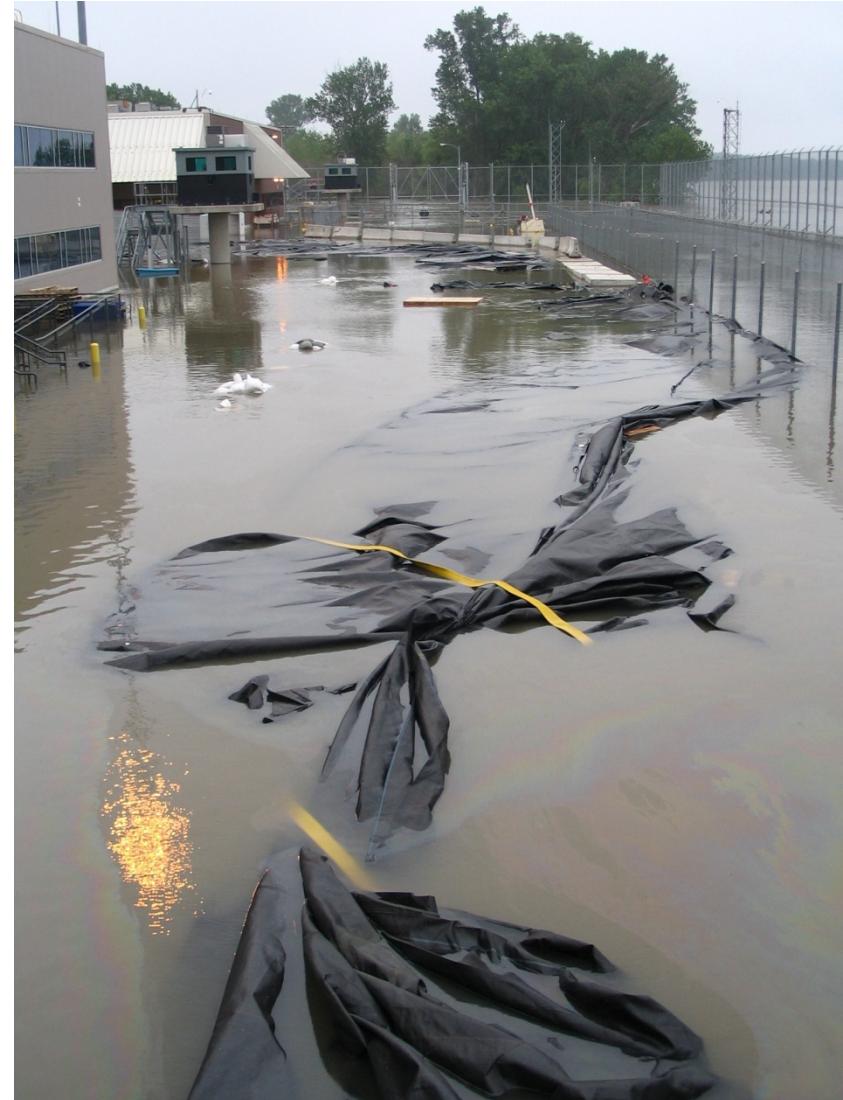
# Failure of Aquadam

- On June 25, 2011, the river level at Fort Calhoun peaked at 1006 feet and 10 inches.
- On June 26, 2011, a small front-end loader ran into the Aquadam puncturing it
- Failure threatened the normal transformers and caused plant operators to disconnect from offsite power
- The NRC entered monitoring mode of emergency response

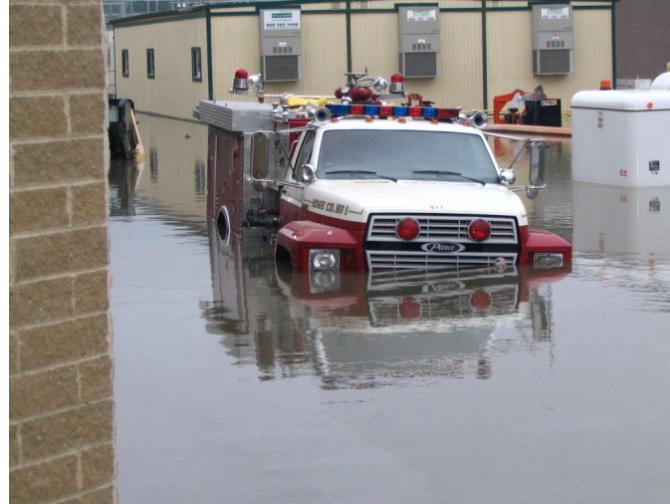
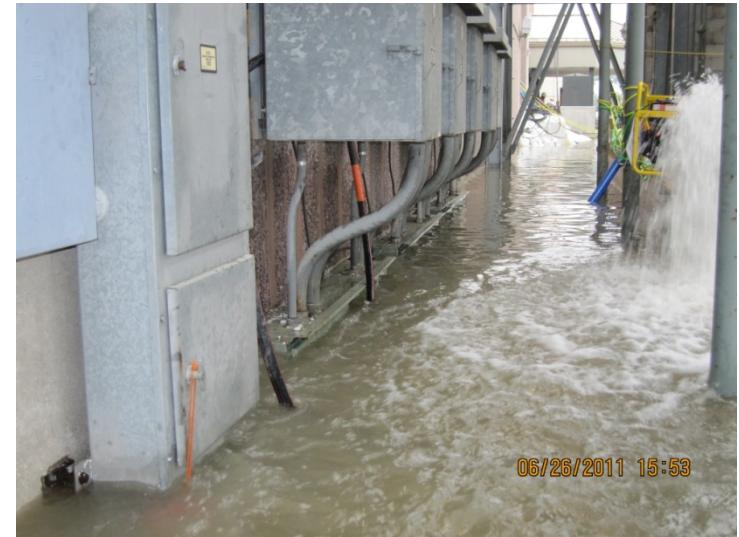
# Failure of Aquadam

June 26, 2011

- The licensee's pumper truck for backup cooling water was partially submerged
- Actions by plant workers kept water out of the normal transformers
- Water entering a manhole quickly made it's way to the intake structure and threatened the raw water pumps
