**Subject:** DBNPS Slides for Public Meeting

# Davis-Besse Nuclear Power Station

**Nuclear Regulatory Commission  
Public Meeting  
January 5, 2012**

# Shield Building Condition Evaluation

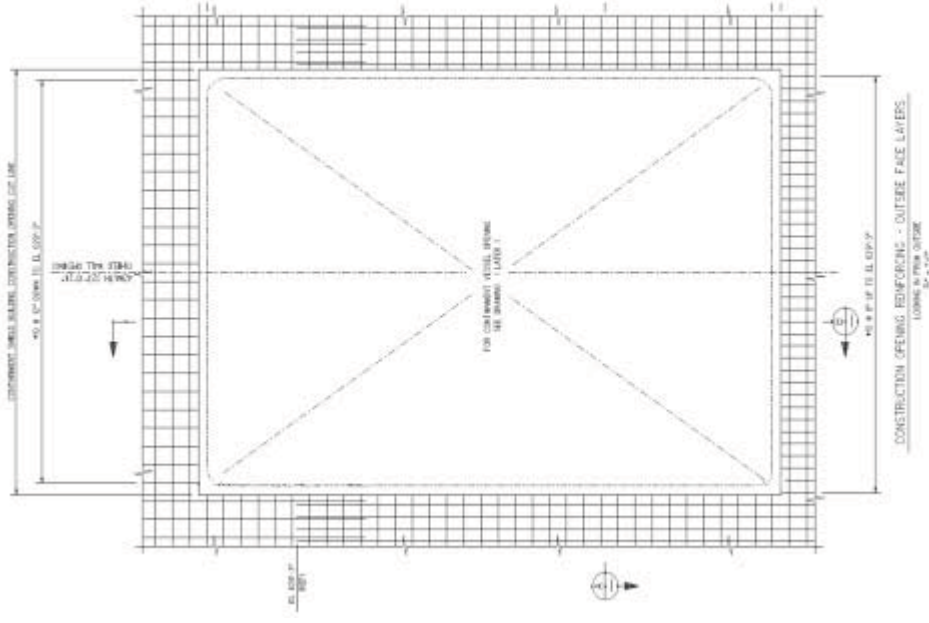
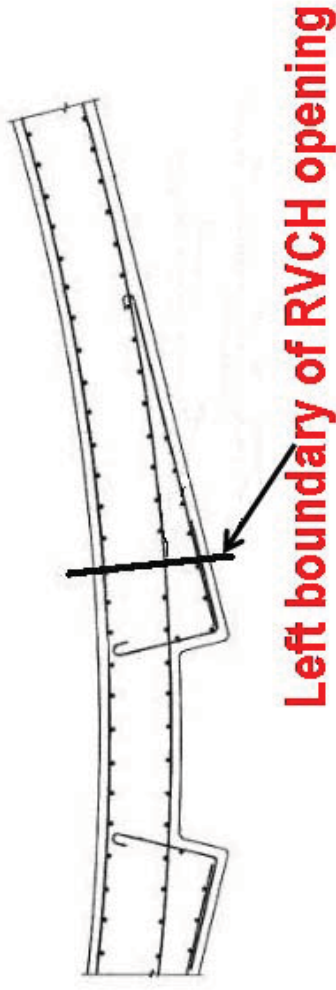
# Initial Investigation Around Construction Opening

- Decision made to “chip back” concrete to observe indication
- No indications remained on bottom or left side of opening after chipping
- Chipping at top of opening revealed the crack extended beyond the construction opening

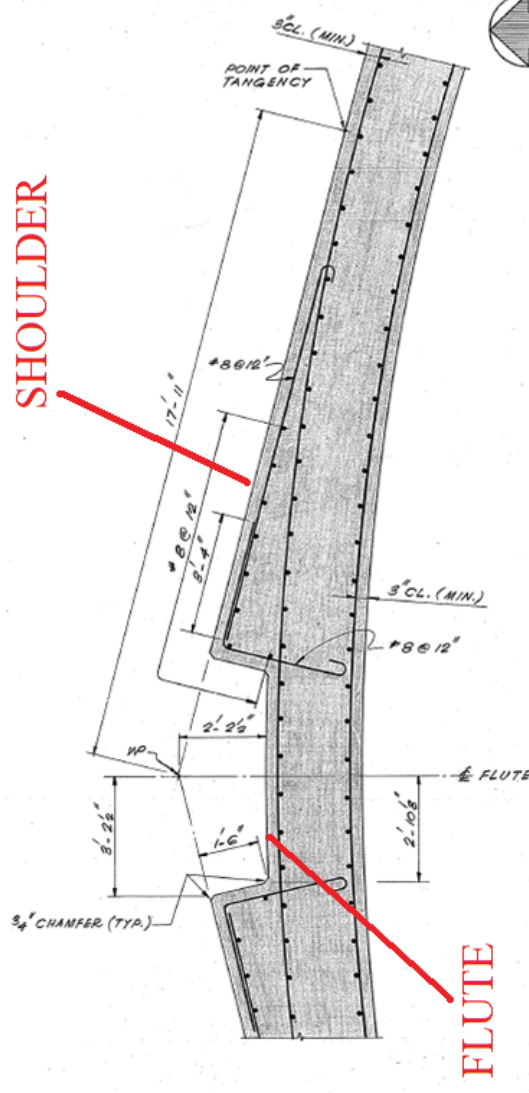
# Impulse Response Inspection

- 15 of 16 flute shoulders
- 6 of 8 flutes
- 8 of 8 shell regions between flute shoulders
- Main Steam Line Rooms and Fan Equipment room
- Vertically to the top of Shield Building wall

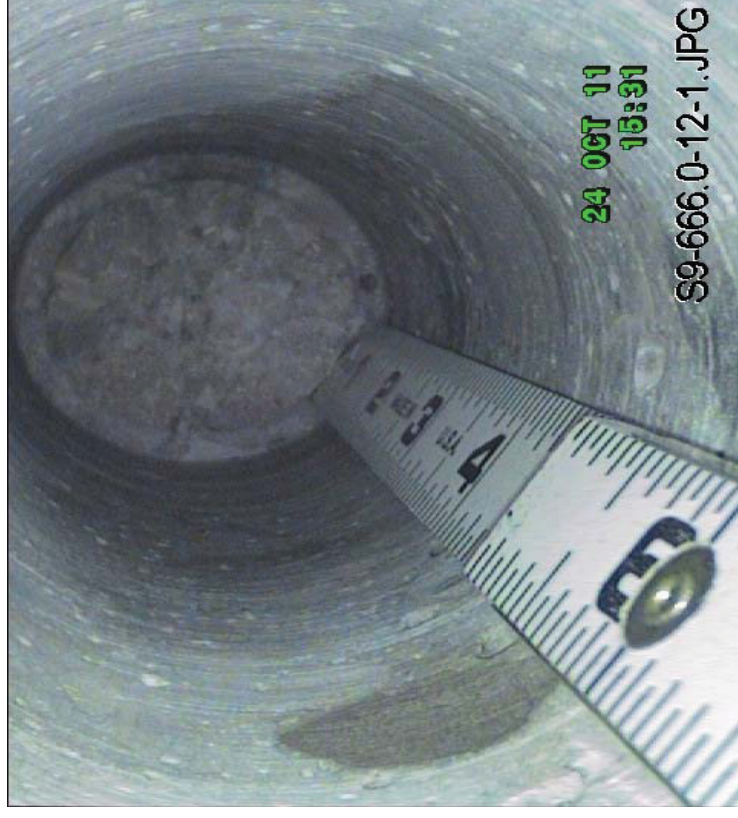
# Shield Building Core Bores

- 70 core bores performed
- Core bore pairs were used to validate the IR results
- Measured cracks were adjacent to the Shield Building outer rebar mat

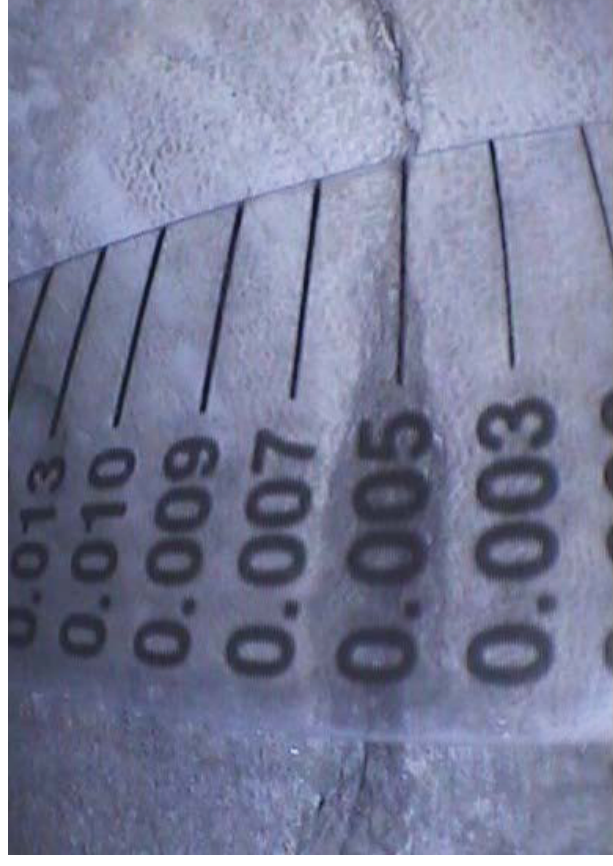
# Shield Building Core Bores

- **All measured cracks were very tight**
- **Eight deep core bores were taken that reached the interior reinforcing steel mat. Confirmed cracking only in outer rebar mat.**
  - 2 in flute shoulders
  - 4 in flutes
  - 2 in Main Shell Region

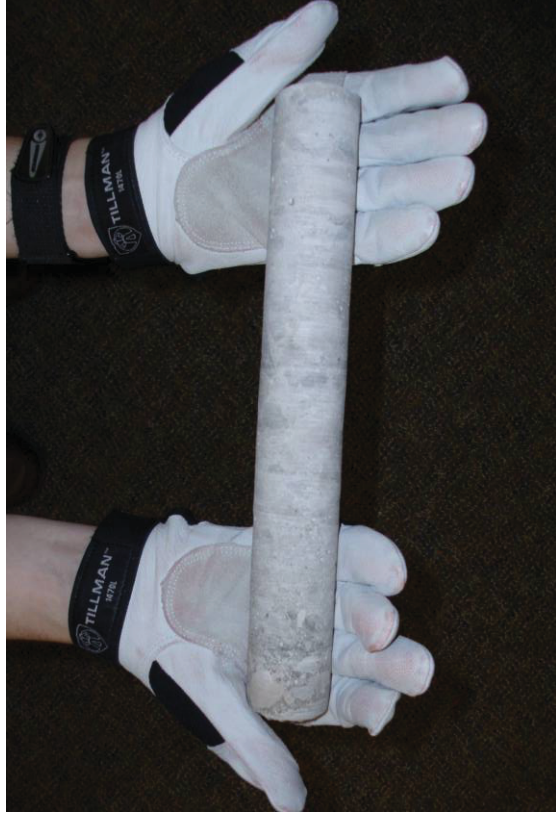
# Laboratory Evaluation of Shield Building Concrete

- **Initial Laboratory evaluation of two core bores performed by CTL Group**
- **Results of tests indicate**
  - Concrete is in good condition with no apparent deficiencies that would affect its continued service
  - Carbonation is at a depth consistent with the age of the concrete
