**From:** Feintuch, Karl  
**Sent:** Friday, February 10, 2012 12:53 PM  
**To:** Browning, Tony; Byrne, Thomas  
**Subject:** Operating Experience regarding Byron Loss-of-offsite-power event - Duane Arnold notification  
**Attachments:** Beaver Valley LER.PDF; Fitz LER.PDF; NMP LER.PDF; EN 7624 Byron 2.pdf; EN 7636 Byron.pdf

SUBJECT:  
Beaver Valley Power Station, Unit No. 1  
Docket No. 50-334, License No. DPR-66  
LER 2007-002-00

Enclosed is Licensee Event Report (LER) 2007-002, "Undetected Loss of 138 kV 'A' Phase to System Station Service Transformer Leads to Condition Prohibited by Plant Technical Specification."

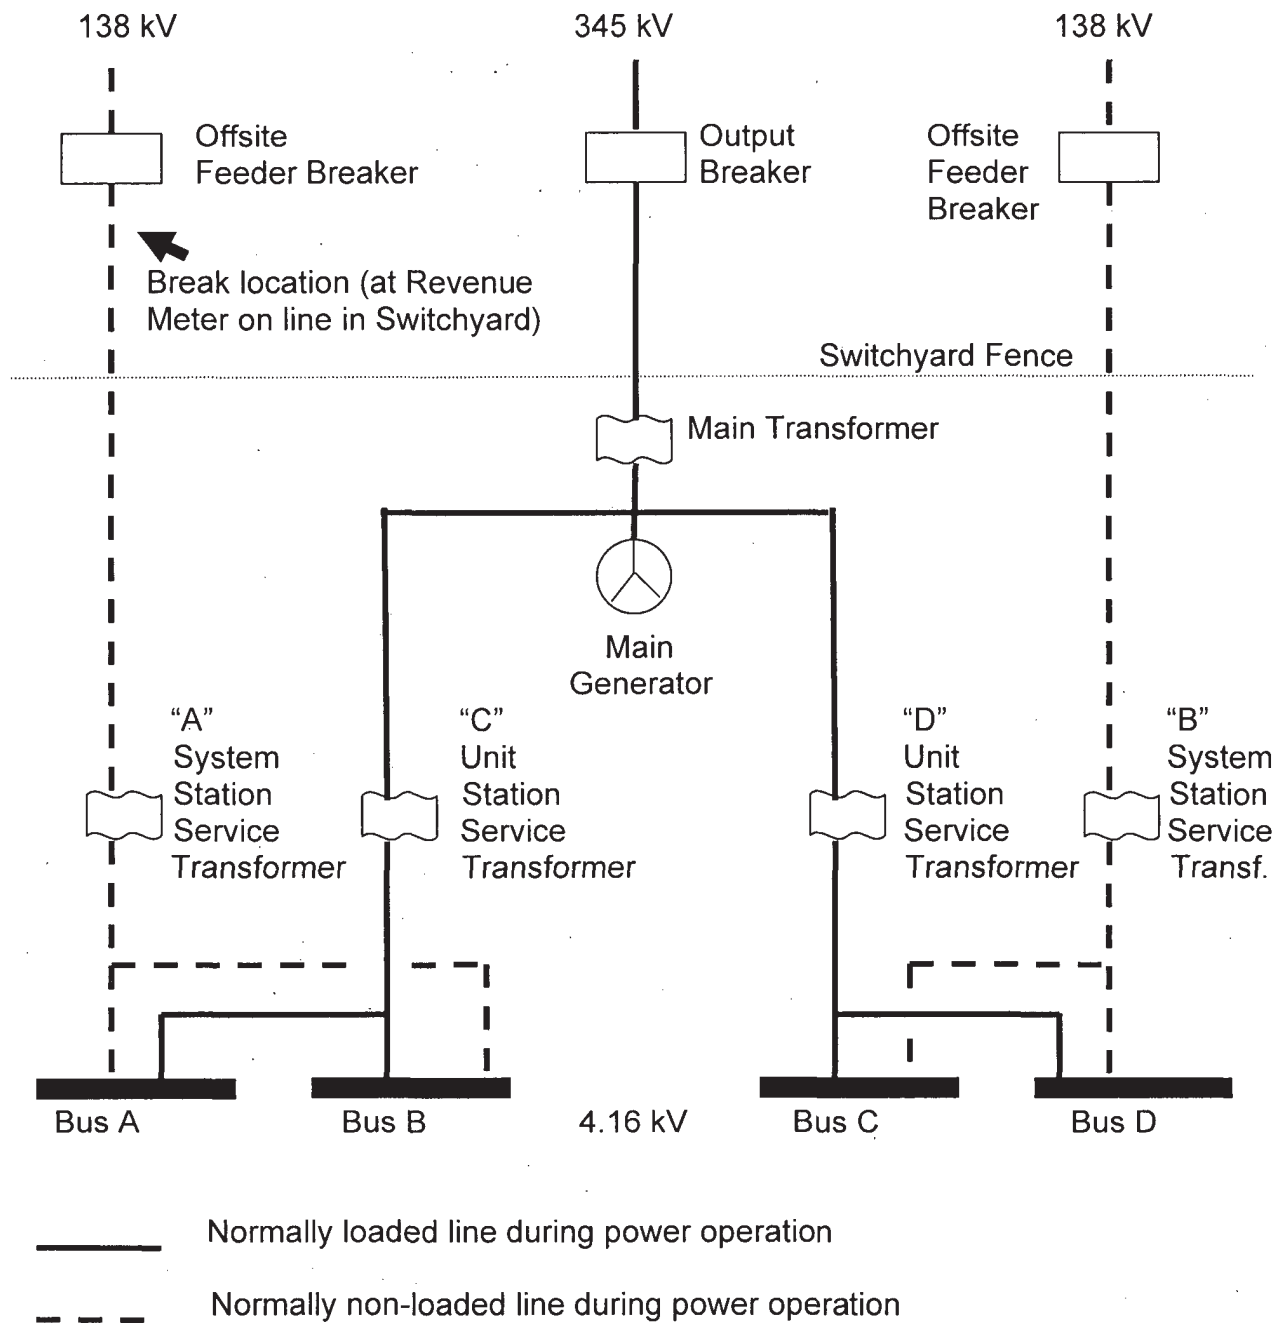
### Simplified Unit Electrical Distribution Drawing

During a non-routine walkdown of the offsite switchyard on 11/27/2007, a site construction supervisor discovered that the 'A' phase conductor on a Beaver Valley Power Station Unit No. 1 (BVPS-1) three-phase 138 kV power line had broken off in the switchyard. This break occurred between the offsite feeder breaker (OCB-92-FDS) and the line running onsite to the 'A' train System Station Service Transformer (SSST) located inside the site security fence. The switchyard walkdown was being performed to investigate line voltage differences. The terminal broke on the switchyard side of a Revenue Metering Current Transformer/Voltage Transformer (CTVT), which was installed in 2006 to track the station's power usage through this line. During normal station power operation, there is no appreciable current going through this 138 kV line as the station busses (loads) are normally powered from the unit generator. [See simplified power sketch on page 7.]
