**From:** Khanna, Meena *ink*  
**Sent:** Monday, August 29, 2011 7:24 AM  
**To:** McCree, Victor; Leeds, Eric; Giitter, Joseph; Hiland, Patrick; Thomas, George; Kulesa, Gloria; Martin, Robert  
**Cc:** Franke, Mark  
**Subject:** Earthquake at North Anna Summary Report - Friday 8-26 (3).docx  
**Attachments:** Talking Points for North Anna NPP Seismic Event final word.docx; Earthquake at North Anna Summary Report - Friday 8-26 (3).docx

## ***Talking Points for North Anna NPP Seismic Event***

### Report on Status of Activities at the North Anna Site (August 25 & 26, 2011)

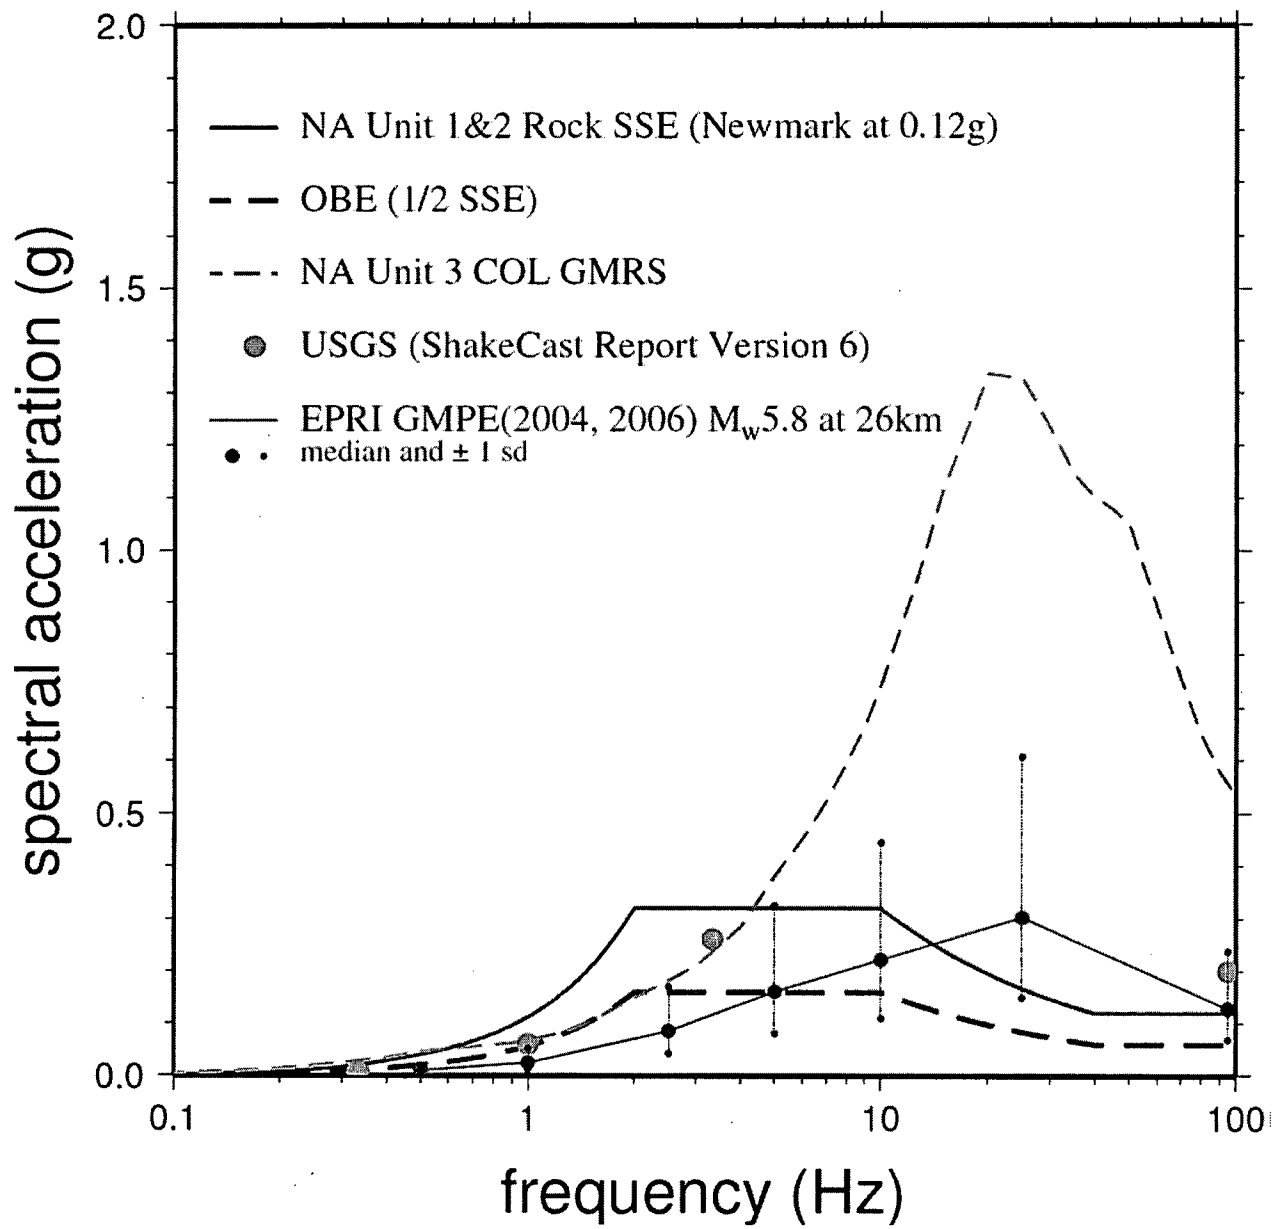
- NRC staff performed an independent analysis using the best estimate of the earthquake location and magnitude together with the EPRI ground motion prediction equations. The staff's calculation is lower than USGS' estimate on the ground motion at the site (see attached Figure).
