ABOVE-GRADE TAILINGS IMPOUNDMENT
EROSION AND RILL REPAIR PLAN

AS-BUILT			
Umetco Minerals Corporation 2754 COMPASS DRIVE, SUITE 280, GRAND JUNCTION, CO 81506			
GAS HILLS, WYOMING			
ABOVE-GRADE TAILINGS IMPOUNDMENT DESIGN ENHANCEMENT EROSION AND RILL REPAIR PLAN			
DESIGN: JHH	DRAWN: JHH	SHEET	
CHECKED BY:	DATE: 12-8-2010	2	
ENGINEERING APPROVAL:	HS & EA APPROVAL:	OF	
		7	
1 1-2012	AS BUILT	R.W.Q.	
NO.	DATE	REVISION - DESCRIPTION	BY
		DWG: GH-AG-REPAIR-12-11-AB

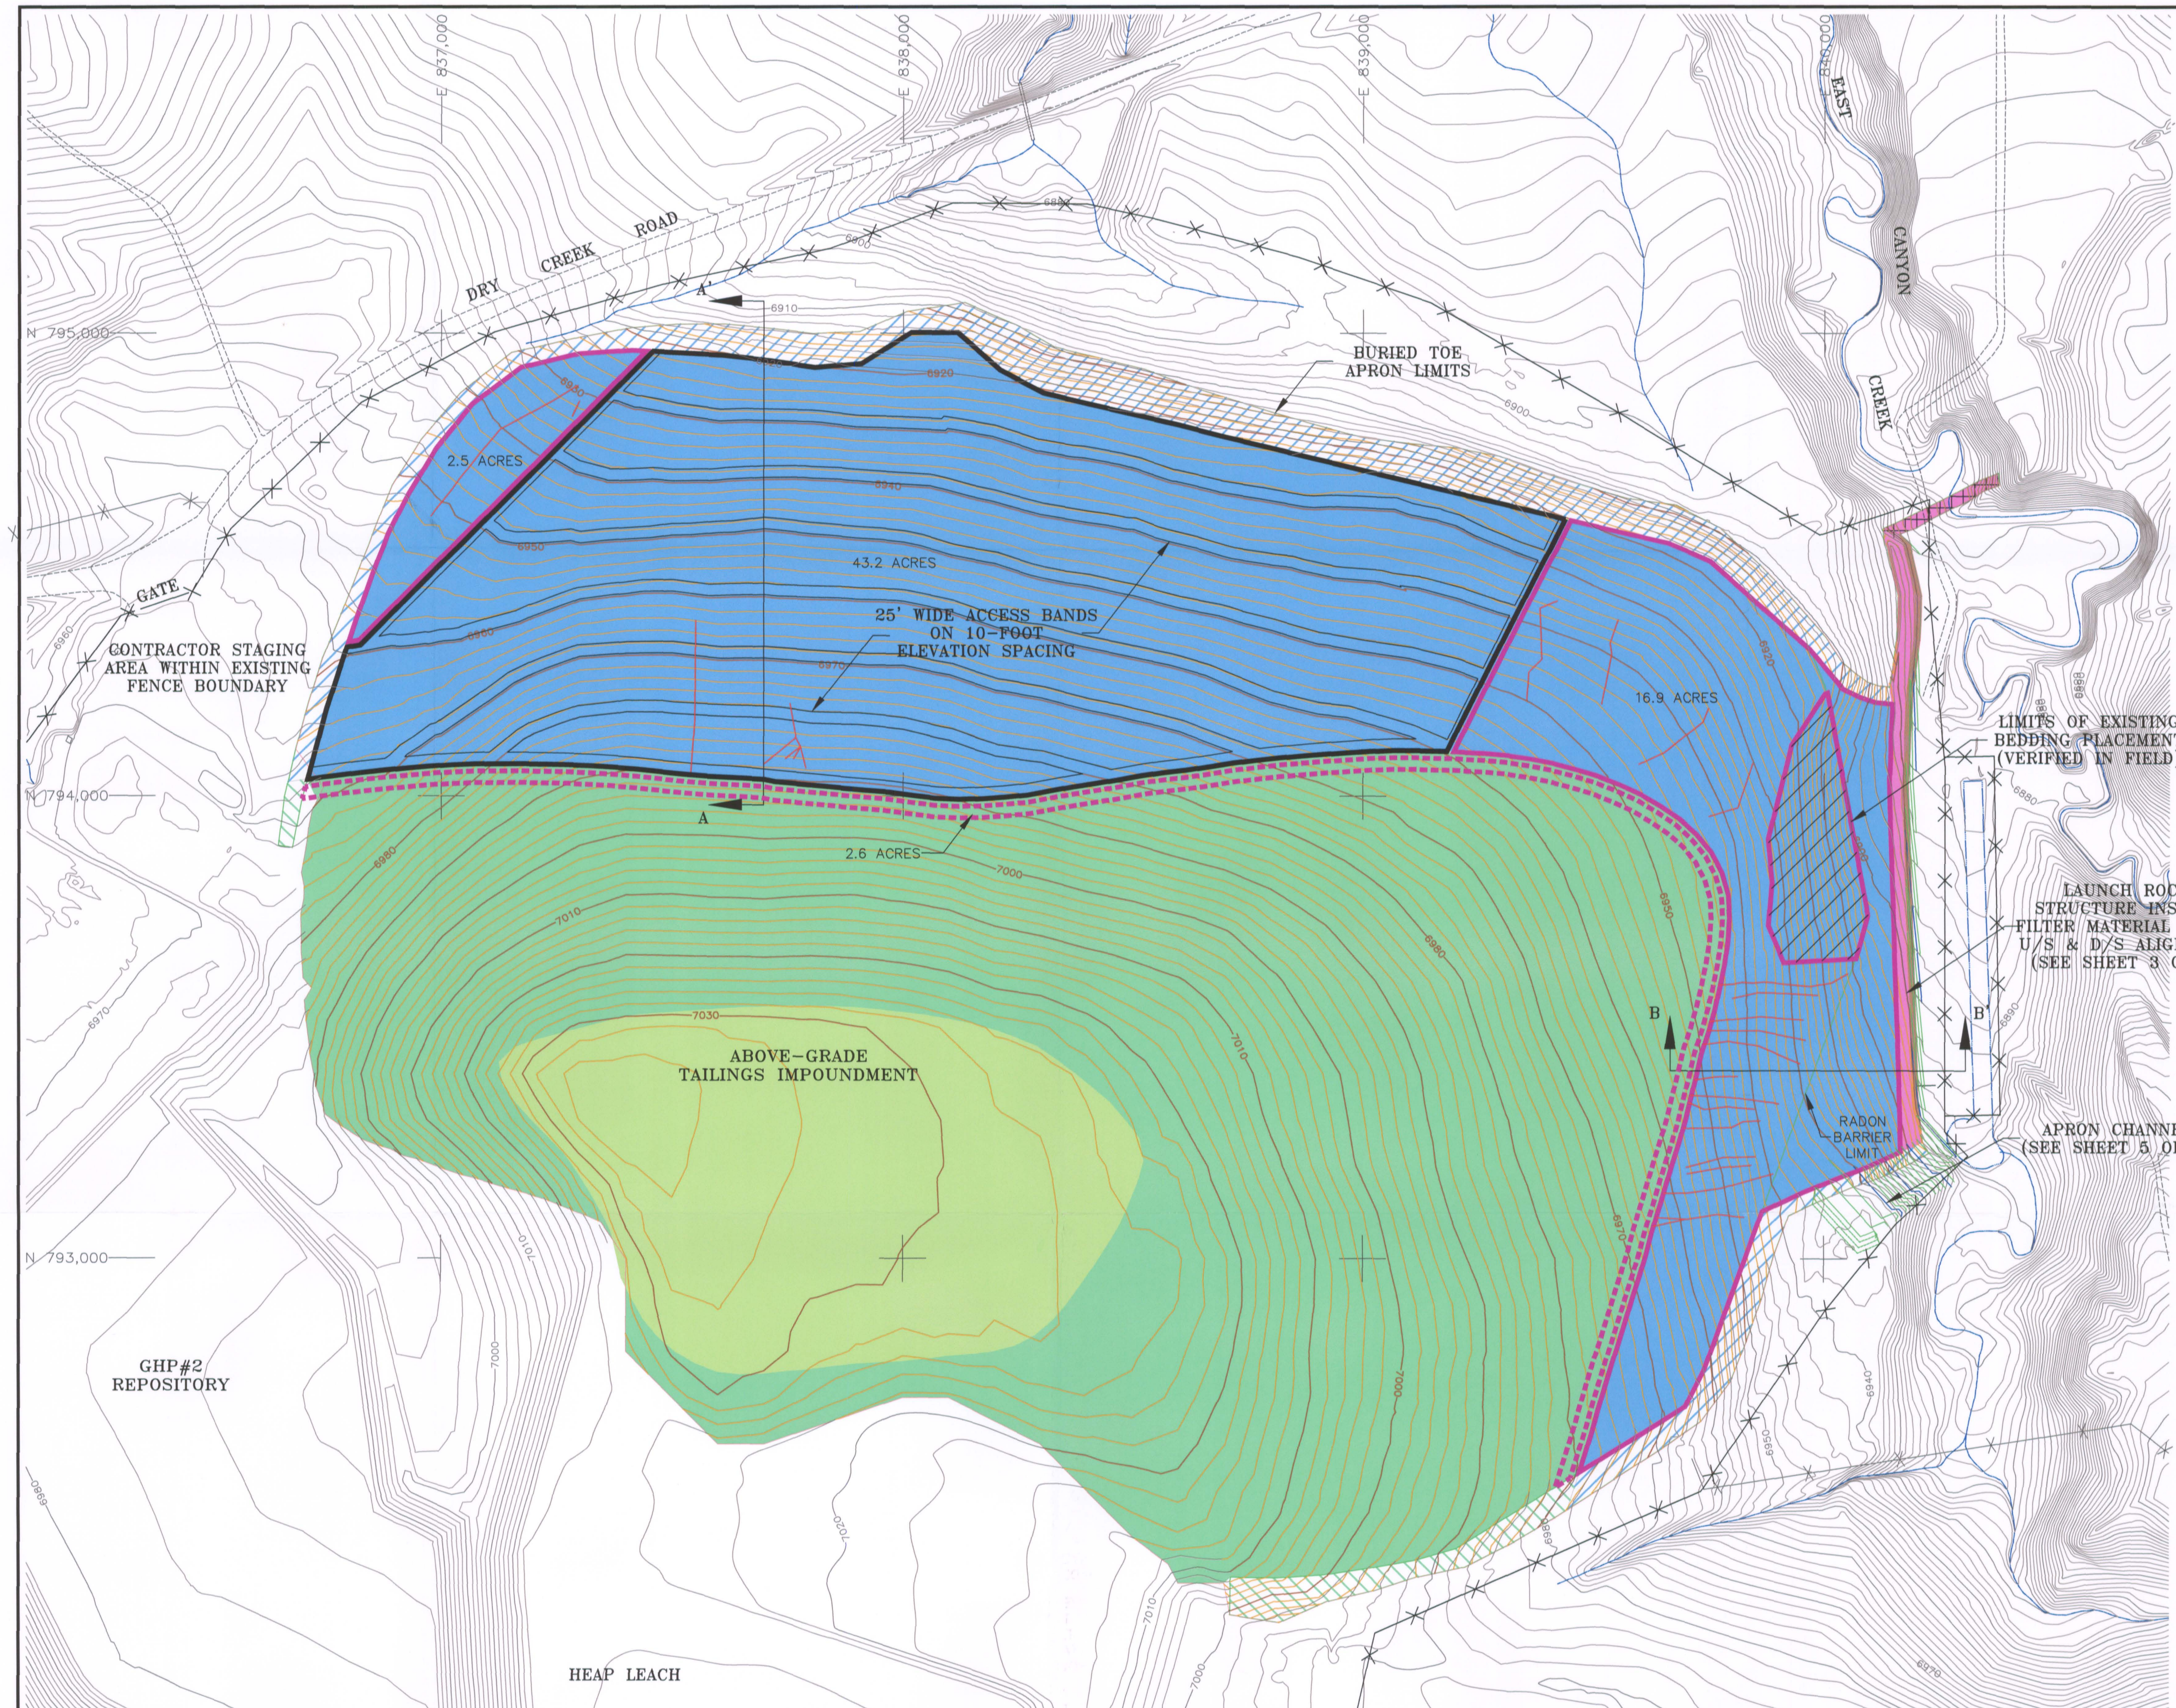
- RILL FEATURES IN EXISTING TYPE C RIPRAP
 - NEW DESIGN CONTOURS
 - 6 INCHES OF TYPE A RIPRAP
D₅₀ = 1.0 INCH
 - 6 INCHES OF TYPE B RIPRAP
D₅₀ = 3.0 INCH
 - 6 INCHES OF TYPE B RIPRAP
BELOW GRADE TOE APRON

- 2.) PRIOR TO INITIATION OF RILL REPAIR ACTIVITIES, TEST EXCAVATIONS WERE MADE TO VERIFY THE INTEGRITY OF THE RADON BARRIER OR CLAY LAYER IN THE VICINITY OF EXISTING RILL FEATURES. ONE EXCAVATION WAS MADE ON THE ABOVE-GRADE TAILINGS IMPOUNDMENT. NO ADDITIONAL EXCAVATIONS WERE REQUIRED. IT WAS DETERMINED THAT THE RADON BARRIER LAYER HAD NOT BEEN DISTURBED. ALL SOIL MATERIAL REMOVED FROM THE TEST EXCAVATIONS WAS REPLACED IN ACCORDANCE WITH THE SPECIFICATIONS.

- 3.) IN AREAS DESIGNATED FOR RIPRAP REMOVAL AND REPLACEMENT, THE EXISTING RIPRAP MATERIAL WAS REMOVED IN PANELS AND/OR SECTIONS NO WIDER THAN 50 FEET AND TEMPORARILY STOCKPILED ON THE ADJOINING COMPLETED PANEL. REMOVED RIPRAP WAS REPLACED AS SOON AS PRACTICABLE AFTER THE MINIMUM 3-INCH THICK TYPE A BEDDING LAYER HAD BEEN PLACED AND APPROVED. IN GENERAL, THE REMOVAL PANELS WERE ORIENTED PERPENDICULAR TO THE SLOPE AND THE ACTUAL WIDTH OF PANELS WERE DETERMINED BY THE CAPABILITIES OF THE CONTRACTOR'S EQUIPMENT. ALL RIPRAP AND BEDDING MATERIALS WERE PLACED IN ACCORDANCE WITH THE SPECIFICATIONS.

- 4.) IN THE AREA DESIGNATED TO RECEIVE BEDDING MATERIAL VIBRATED INTO THE EXISTING RIPRAP, THE 30/70 BLENDED BEDDING MATERIAL WAS SPREAD UNIFORMLY OVER THE SLOPE BETWEEN THE ACCESS ROUTE BANDS. TEST PANELS (ON THE EXISTING SLOPE) WERE PREPARED TO DETERMINE THE MOST ACCEPTABLE METHOD AND AMOUNT OF BEDDING MATERIAL TO BE APPLIED ON THE SLOPE TO ENSURE THAT A MINIMUM OF 4 INCHES OF BEDDING MATERIAL WAS VIBRATED INTO THE BOTTOM PORTION OF THE EXISTING 12-INCH LAYER OF TYPE C RIPRAP. THE NUMBER OF PASSES AND SIZE OF VIBRATORY EQUIPMENT WAS ALSO DETERMINED ON THE TEST PANELS. THE ACCESS ROUTE BANDS WERE PLATED WITH A MINIMUM 3-INCH LAYER OF TYPE A BEDDING WHICH ACTED AS A RUNNING SURFACE AND BEDDING LAYER FOR THE RIPRAP REMOVED TO CONSTRUCT THE ACCESS BAND.

- 5.) FILTER LAYERS WERE CONSTRUCTED ALONG THE U/S AND D/S SIDES OF THE EXISTING LAUNCH ROCK STRUCTURE. THE FILTER SECTIONS WERE INSTALLED ALONG THE ENTIRE LENGTH OF THE STRUCTURE. FILTER DETAILS AND ABOVE-GRADE TAILINGS IMPOUNDMENT CROSS-SECTIONS ARE SHOWN ON SHEET 3 OF 7.

- 6.) AN APRON CHANNEL WAS CONSTRUCTED ON THE SOUTHEAST SIDE OF THE ABOVE-GRADE TAILINGS IMPOUNDMENT. DETAILS OF THE APRON CHANNEL ARE ARE SHOWN ON SHEET 5 OF 7.
