Subject: FYI - Revised One Pager on North Anna Earthquake Issue

Summary of Earthquake Information for the North Anna NPP as of September 9, 2011

North Anna Independent Spent Fuel Storage Installation **Response to Earthquake**

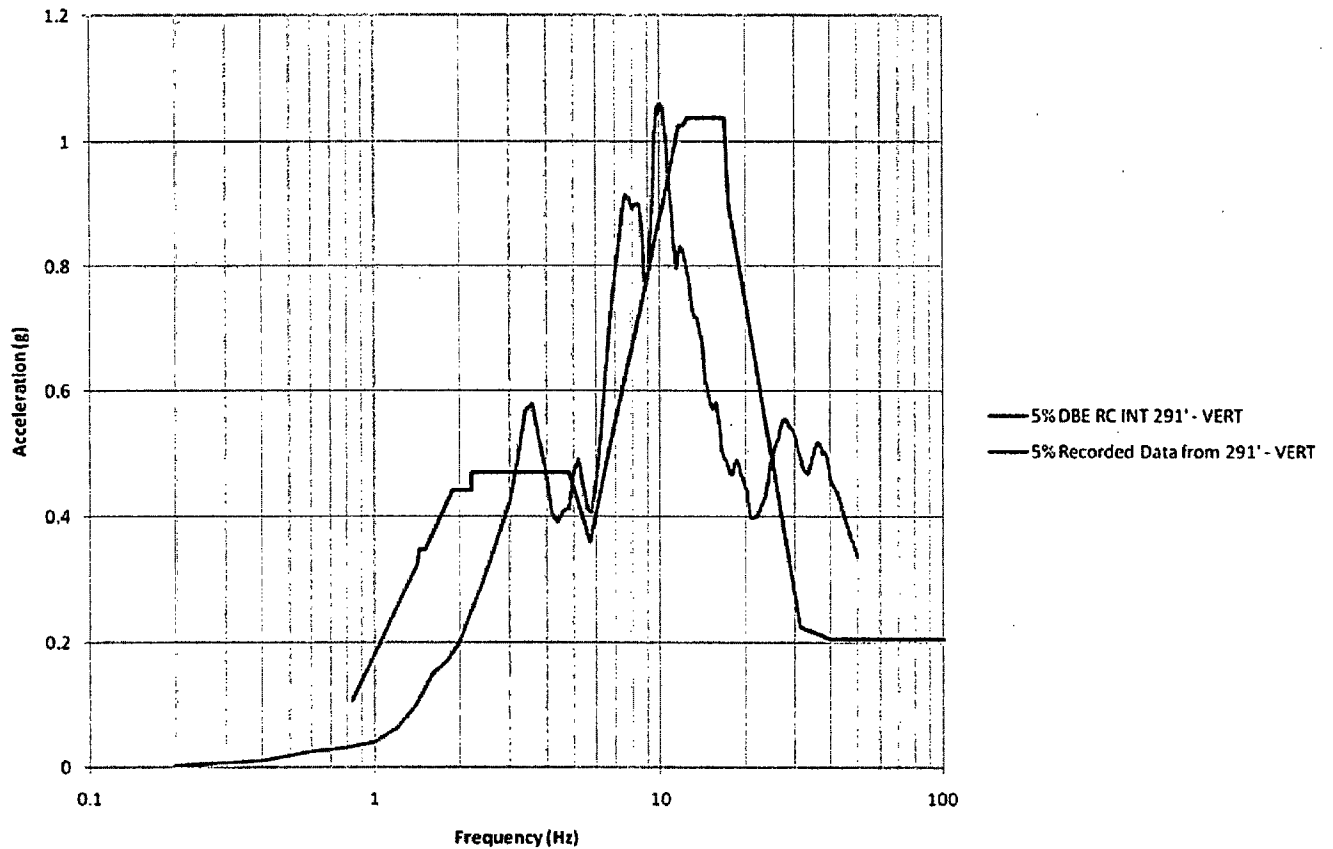
Kinematics Data (at 5%) for Containment Elevation 291' - Vertical Direction

- Preliminary data provided by the licensee indicate that the DBEs at different elevation levels have been exceeded in both the horizontal and vertical directions at different frequencies (see attached sample figure).
- The licensee's inspections have not identified any safety related equipment which failed during the event except for the 2H EDG. When it became evident that the DBE had been exceeded, the licensee declared all the safety related equipment in both units inoperable and took action to place the units in cold shutdown.
- Preliminary data from the licensee's investigation about the 2H EDG failure indicates that a cooling water system gasket may have been installed incorrectly.

The figure above, as submitted by the licensee, compares the observed ground motion in the vertical direction to the exceeded design motion at various frequencies. The blue curve is from the observed readings and the purple curve is the design spectrum at the same elevation level.
