Susquehanna Siphon and Vent Block Leak

John Wise
Division of Spent Fuel Management
Regulatory Conference
November 18-19, 2015

Susquehanna spent fuel loading campaign – Nov. 2014

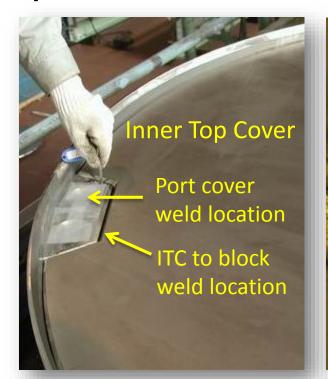
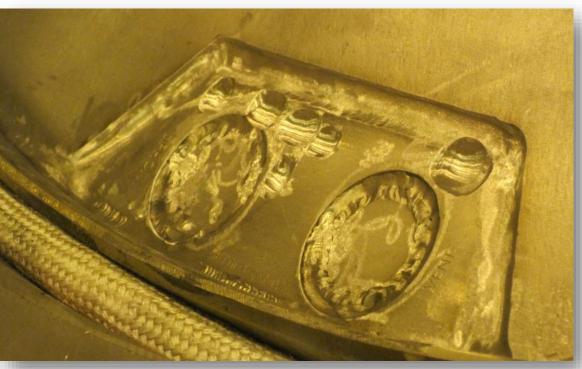
Indications after welding the port covers

PT examination identified six rejectable indications per the ASME Code – these areas were excavated to bring into Code compliance

- Subsequent helium leak testing identified leaks in two of the excavations
- Base metal buildups were performed on the six excavations and a 1/8th inch weld overlay was deposited over the entire repaired region
- This area ultimately passed liquid penetrant and helium leak testing
- The DSC met all the Technical Specification requirements before being placed on the ISFSI pad

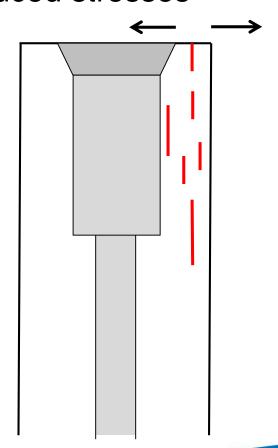
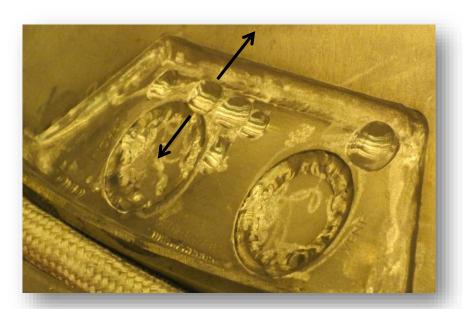
Material separation at plate inclusions due to weldinduced stresses

- Use of forged material rather than rolled plates
- Use of weld overlays
- Adjustments in welding practice to reduce stresses

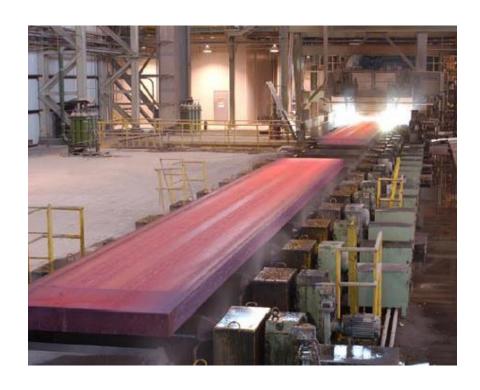
Rolled plate inclusions

Elongated in rolling direction
