RIC 2002

Circumferential Cracking of Reactor Vessel Head Penetration Nozzles

Dominion Energy

March 6, 2002

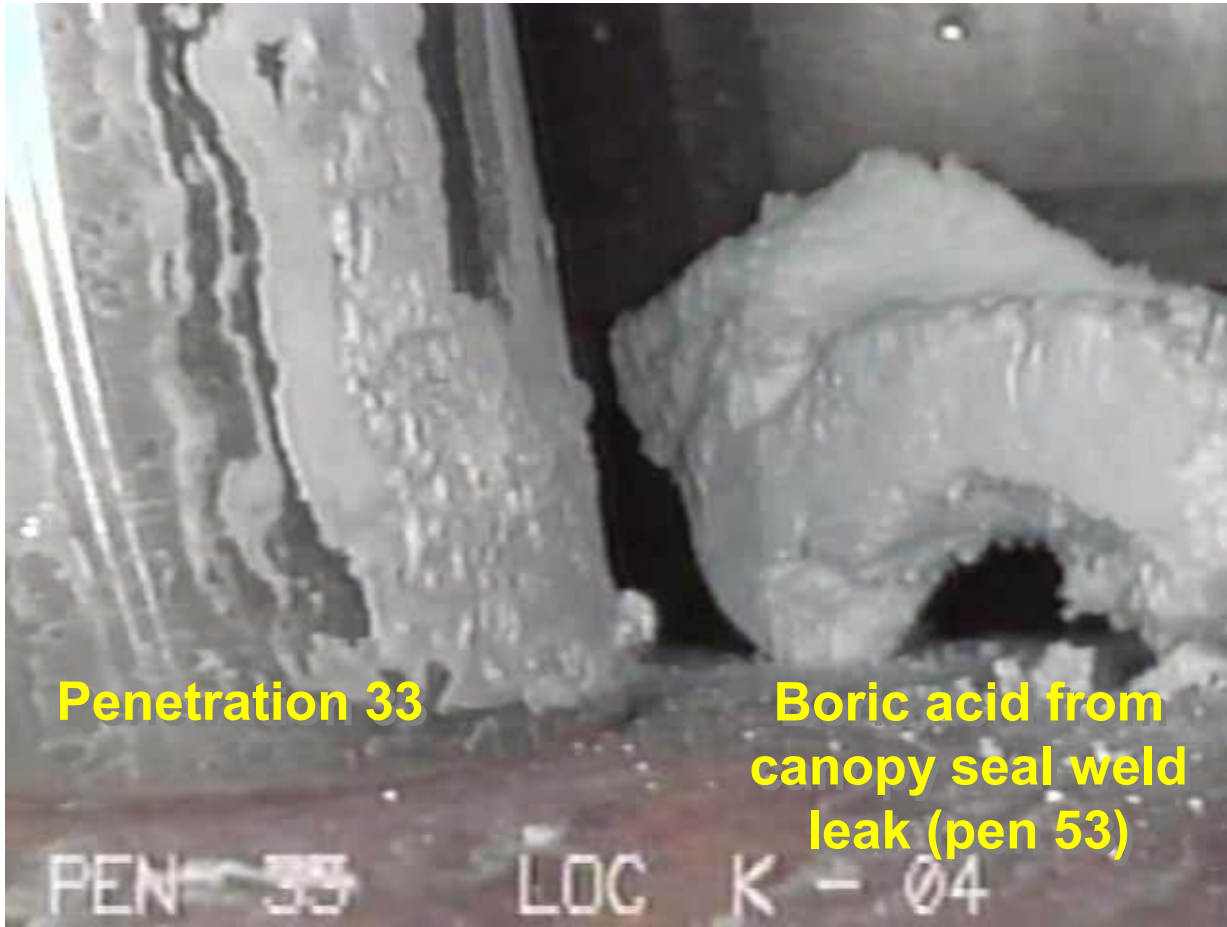
North Anna Unit 1

- Penetration not in boric acid field from canopy seal weld leak
- EC of tube showed non-recordable indications in tube (98% coverage)
- EC showed 4.3 mm indication in the clad (not recordable)
- UT of tube ID – no recordable indications but limited to 97 degrees
- LP of weld – indications in clad and crater crack in the weld (crater crack was ground out)
- Removed thermal sleeve to obtain full access – full access UT revealed no recordable indications including a circumferential UT scan

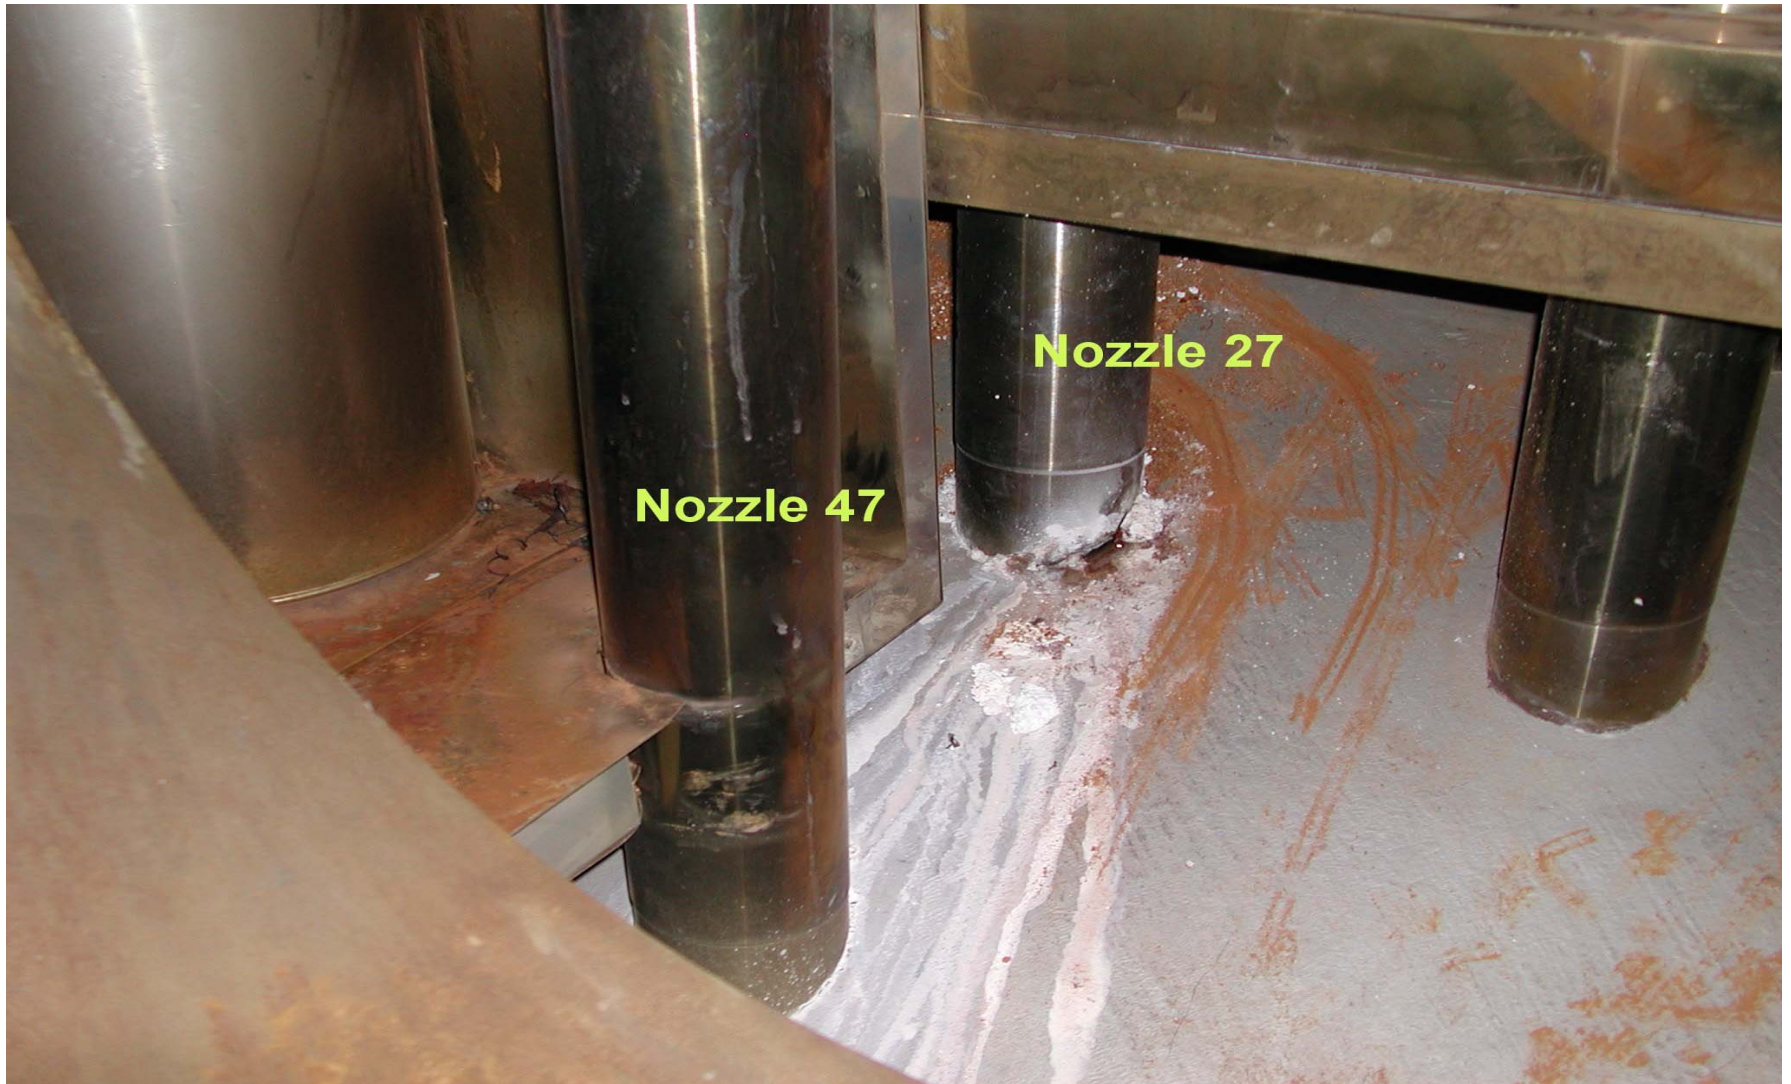
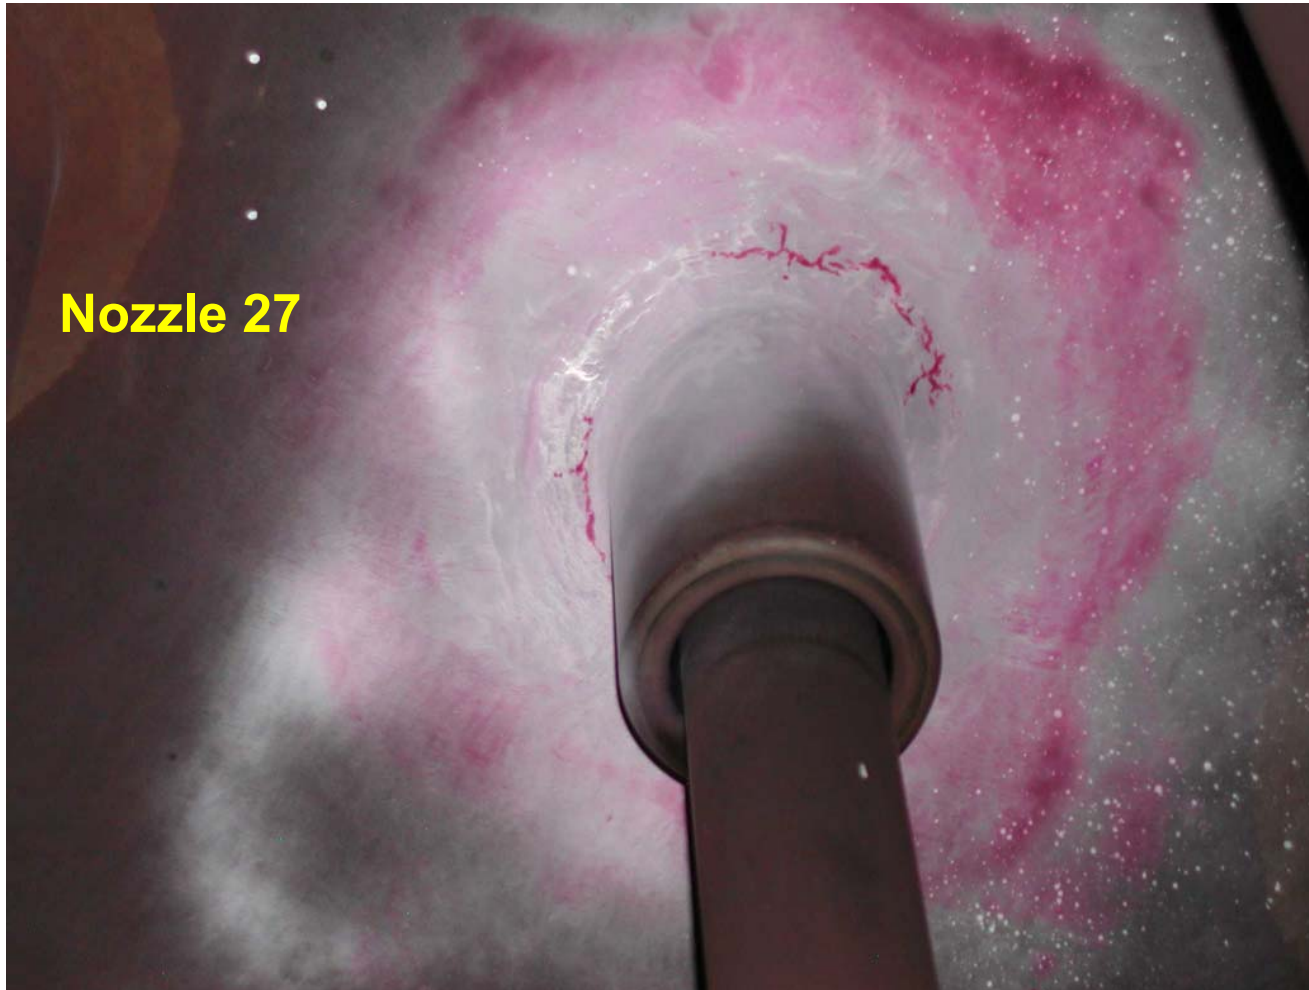
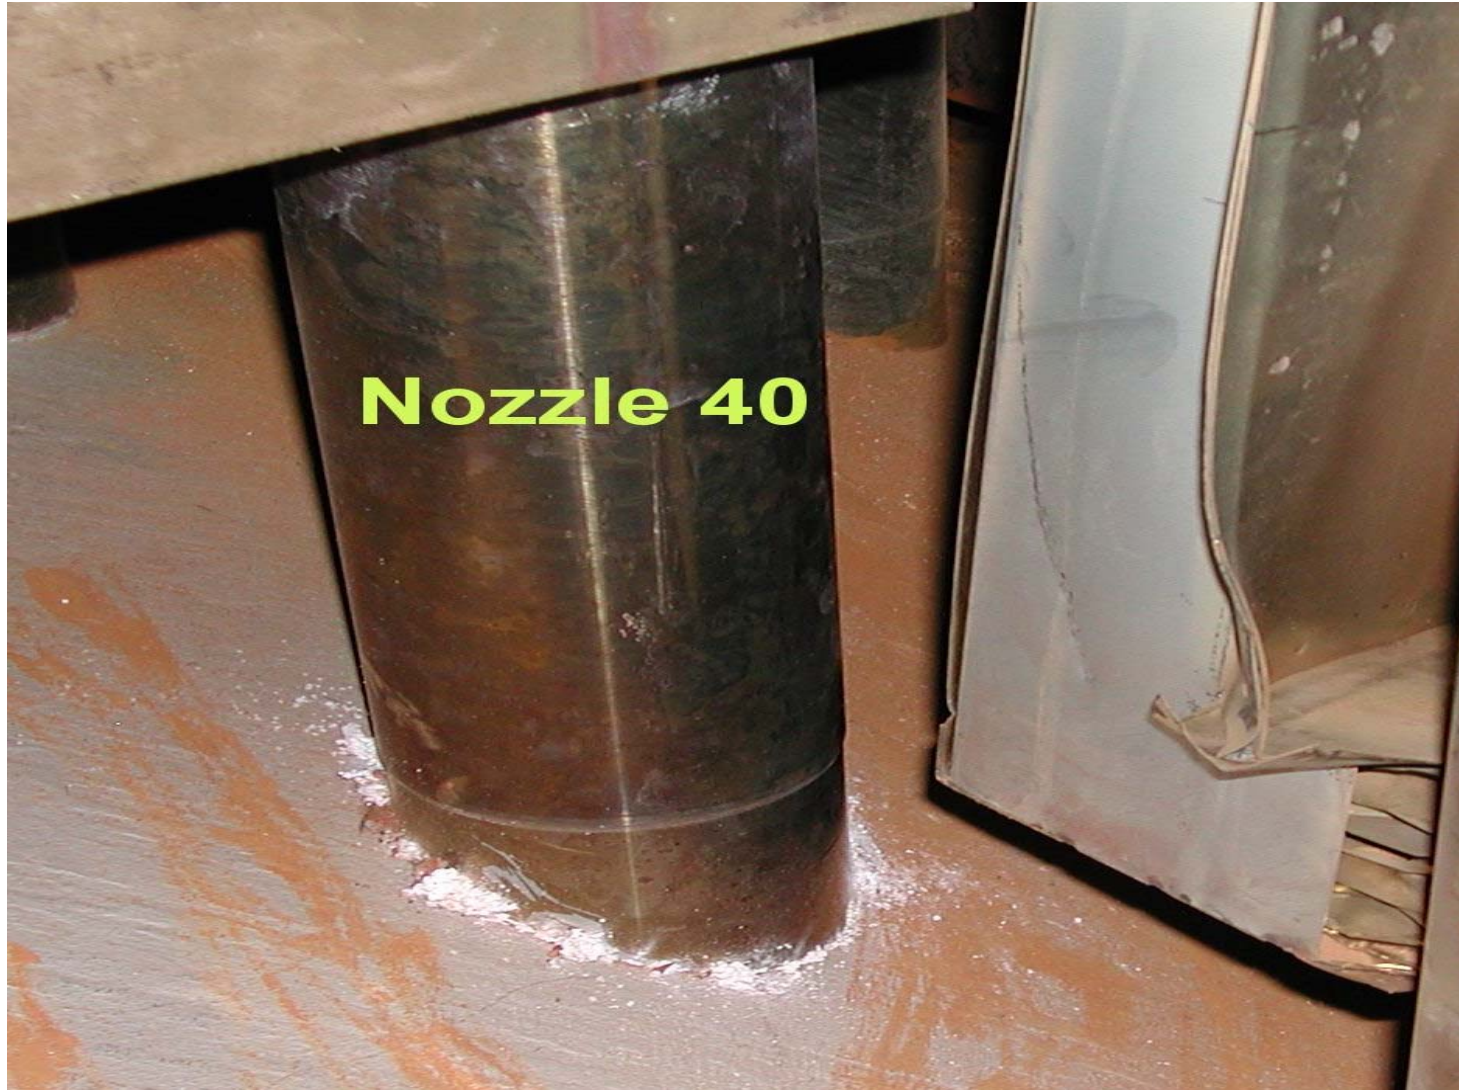
- 6 penetrations were reported to the NRC as a non-emergency 8-hour report in accordance with 10 CFR 50.72(b)(3)(ii)(A) and 50.73(a)(2)(ii)(A), a condition that results in a principal safety barrier being seriously degraded
- All indications confined to weld, hasn't propagated to tube
- All 6 penetrations repaired
- Dose expended: 161 man-rem
- Templating performed for future head replacement

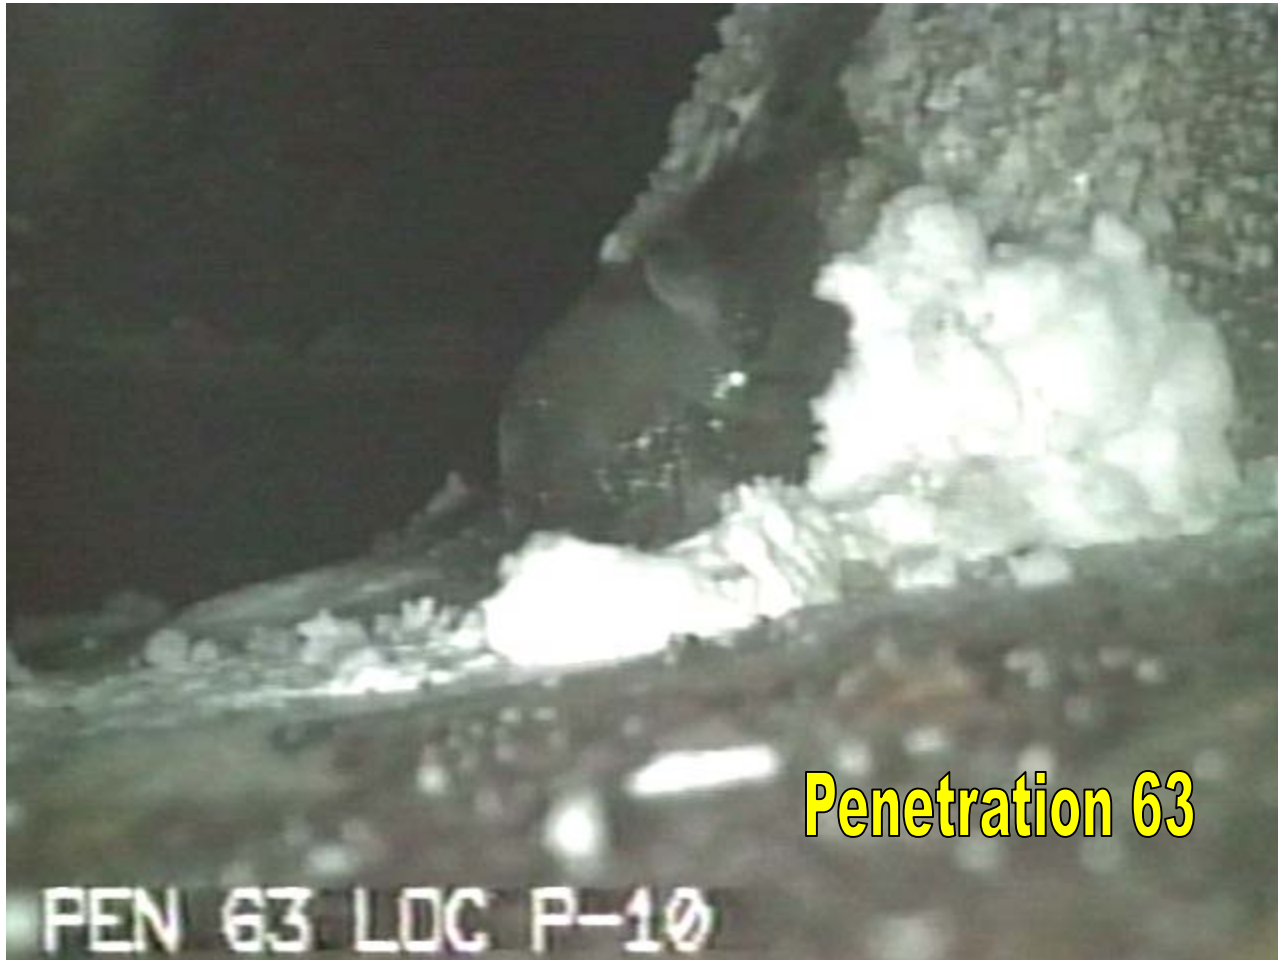
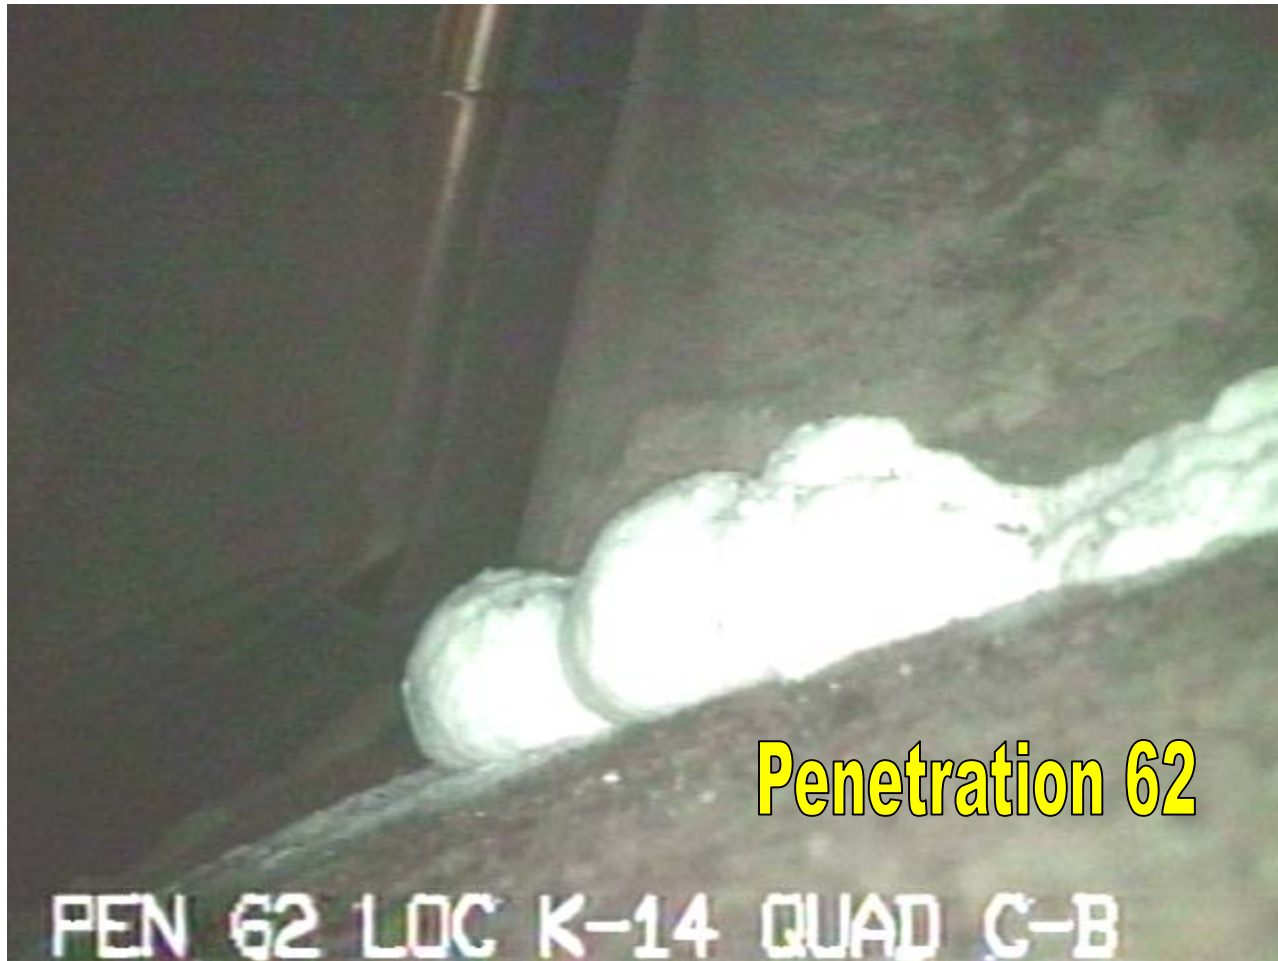
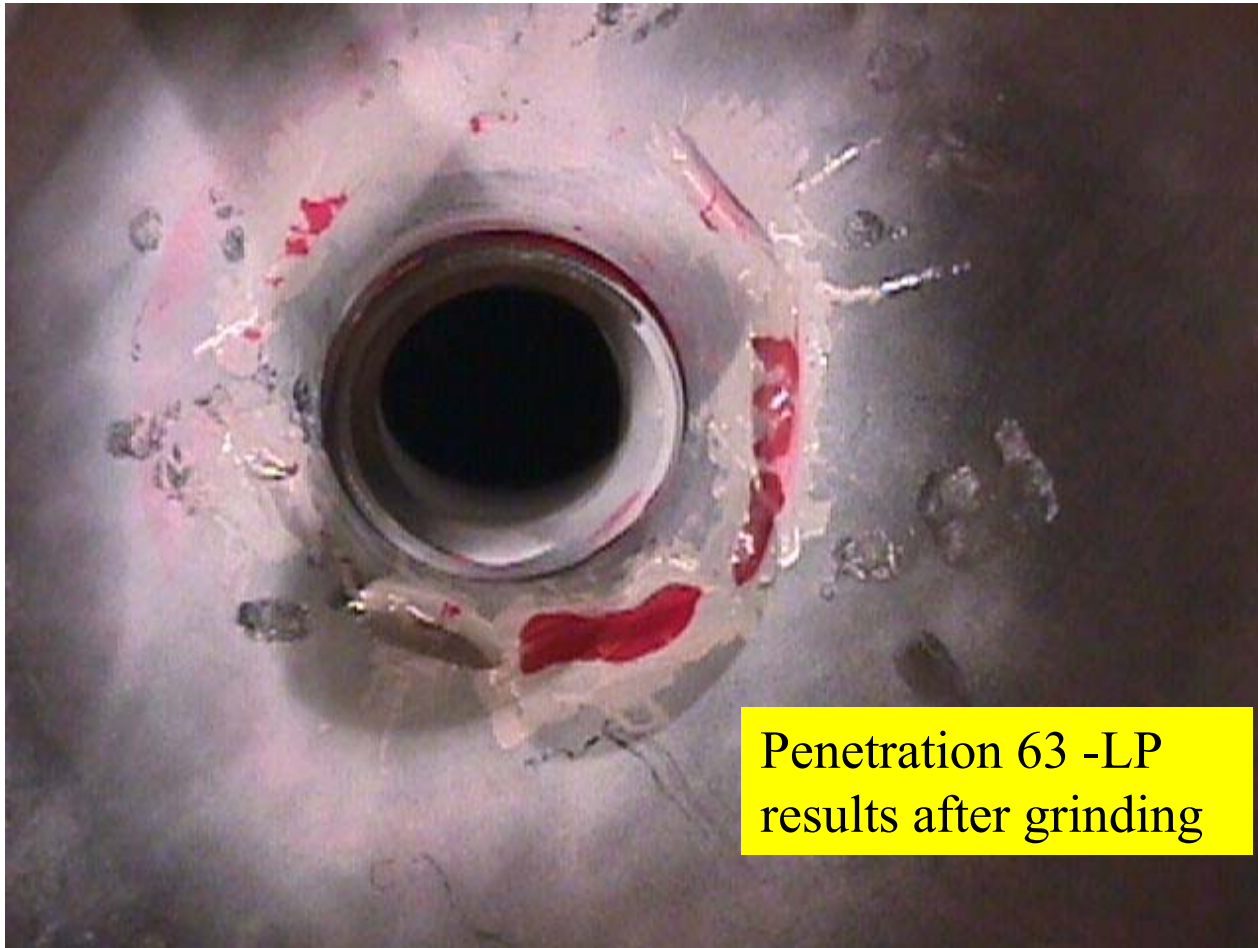
- NDE campaign (continued)
 - Boat sample removed from one penetration
 - Failure analysis revealed solidification or “hot” cracking confined to the Alloy 182, or butter, material.
 - A few of the hot cracks were connected to the wetted surface.
 - Some PWSCC noted which may have connected the hot cracking to the surface or may have occurred after the hot cracking connected to the surface
 - Ringhals Unit 2 found fabrication flaws between J-groove weld preparation and vessel in 1992. Identified after grind out of penetration 63
 - Dose expended: 69.947 man-rem

- NDE campaign
 - Thermal sleeves removed on penetration 62, 63 to facilitate inspection (penetration 51 is T/C)
 - Performed EC in tube – indications on all tube IDs
 - Performed axial and circumferential UT – axial indications shallow and accepted by flaw evaluation
 - Bypassed EC in J-groove weld and went straight to LP examination. Indications in clad believed to be from original fabrication similar to Unit 1
 - Manual grinding and then remote grinding on penetration could not clear indication
 - Temperbead and embedded flaw relief requests approved as repair methodology for all 3 penetrations
