Circumferential Cracking of Reactor Pressure Vessel Head Penetration Nozzles

Industry Experience: Management of RV Head Penetration PWSCC at Oconee Nuclear Station

Duke Energy

March 6, 2002

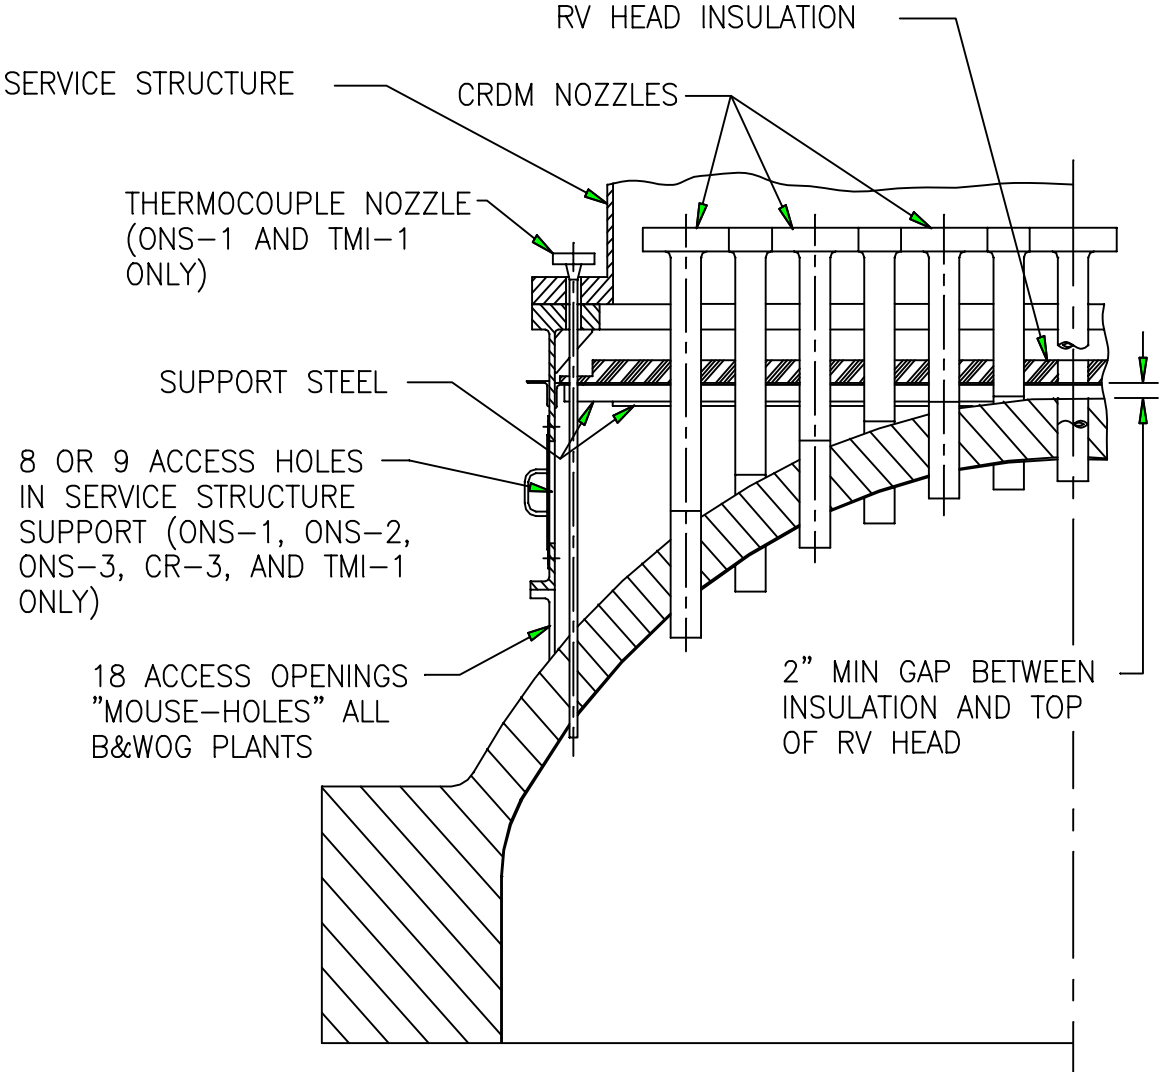
Configuration of RV Head Insulation and Location of Inspection Ports

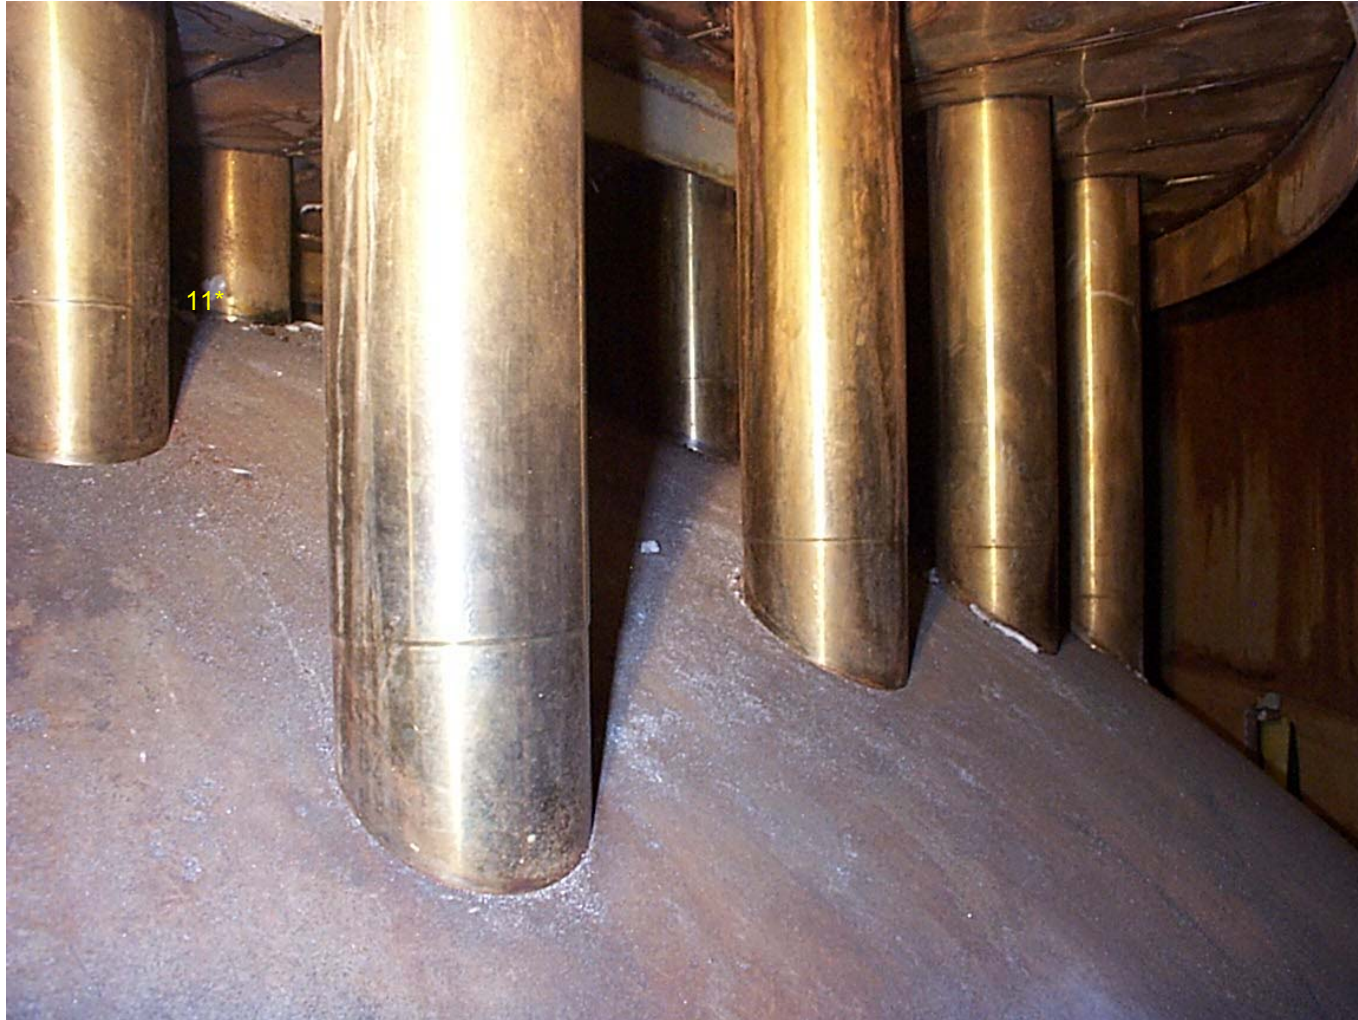
- Amount of boric acid crystals around penetrations can be very small and in some cases $< \frac{1}{2}$ cubic inch
 - Leakage may appear as “popcorn” pushed up around the nozzle, or as a “string” coming from the annulus, or as flow
- All boric acid deposits should be cleaned from head each outage
- Perform additional NDE inspections of nozzles that may be masked by boron or other deposits

Oconee Unit 3, March 2001, RV Head After Cleaning
